## CORRECTION: Playmaster 300W Amplifier

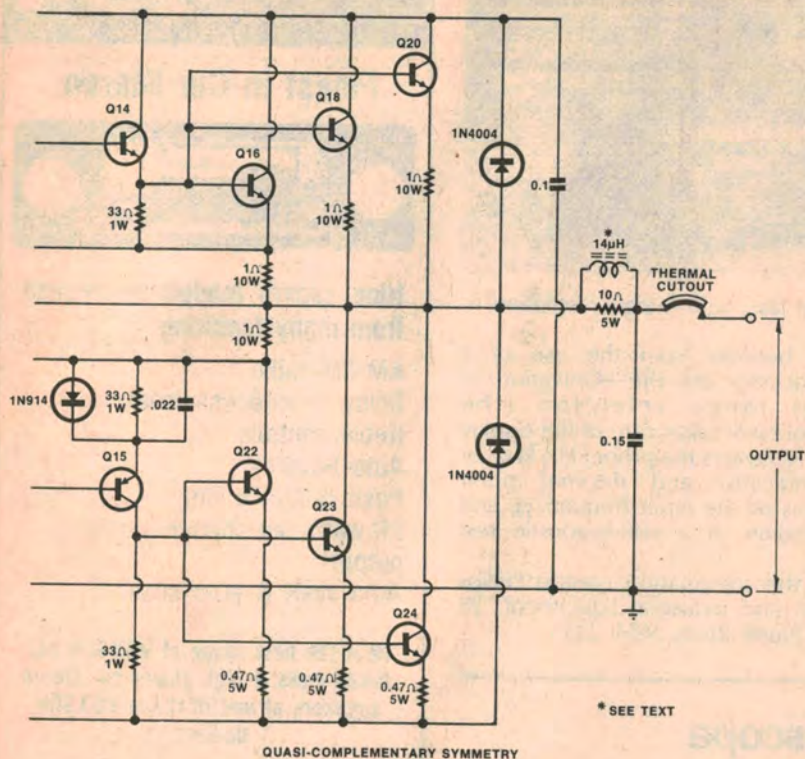
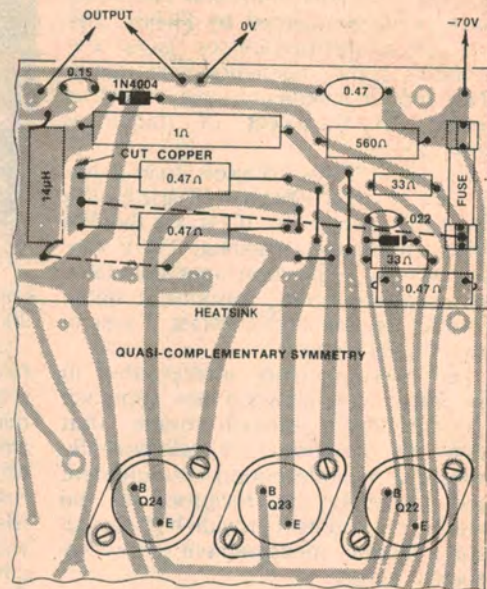
**PLAYMASTER 300** (June 1980, 1/MA/55): In the quasi-complementary circuit shown on page 57, the 1 ohm/10W resistors associated with Q22, 23 and 24 do not ensure current sharing. To ensure current sharing in these transistors the circuit should be modified as shown in these diagrams. On the PCB, replace two of the 1 ohm resistors with 0.47 ohm/5W units and replace the two

parallel links with a third 0.47 ohm/5W resistor. Delete one 0.1µF capacitor, cut the copper pattern as indicated and re-arrange links as shown. The two links shown dotted are on the underside of the board and should be made with insulated wire.
