# McIntosh

**MODEL NUMBER:** MI 2

**DATE:** MARCH 1965

**MODIFICATION:** To eliminate any shape other than a dot when in the "TEST" position.

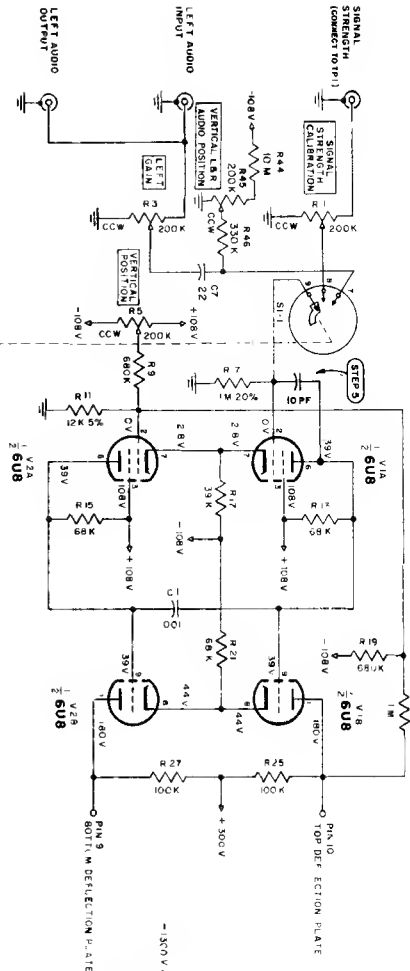
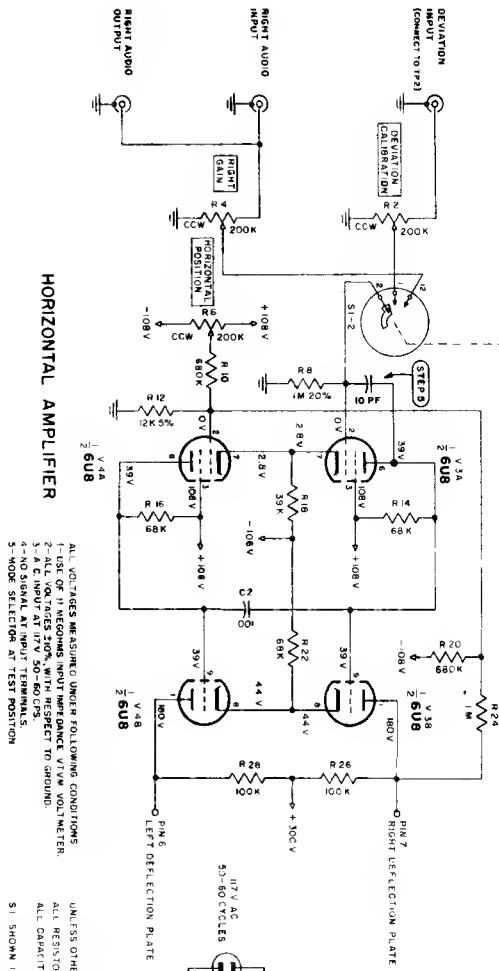
**DESCRIPTION:** This modification can be made to all MI 2's. If a configuration other than a sharply defined spot occurs this indicates possible oscillation in the deflection amplifier. Noise in the deflection amplifier can also cause this condition. Oscillation is caused by coupling between pins 1 and 2 of tubes V1 and V3. Noise can be caused by parasitic oscillations of intensity control neon bulbs and by coupling of power line noise into the + 108 volt supply via the filament winding on the power transformer. These modifications have been made to all MI 3's.

1. There are two 10 w resistors under the chassis, parallel each of these with a 56K 2 w resistor.
2. Remove the neon bulb from the intensity control.
3. Add a 270K ½ w resistor from the center lug of the intensity control to the side lug (at junction of yellow/white wire and 390 K resistor). Add a jumper wire from the center lug of the control to the other lug (junction of orange/white wires).
4. Remove the red/white wire from pin 5 of the 6U8 (6) to pin 1 of the OB 2 (V8). Replace the wire with a 47K ½ w resistor.
5. Add a 10pf capacitor from pin 2 to pin 6 of tubes V1 and V3. Bend the tube socket of pins of tubes V1 and V3 so that pin 1 is as far away from pin 2 as possible. Dress the leads connecting to these pins for maximum separation.

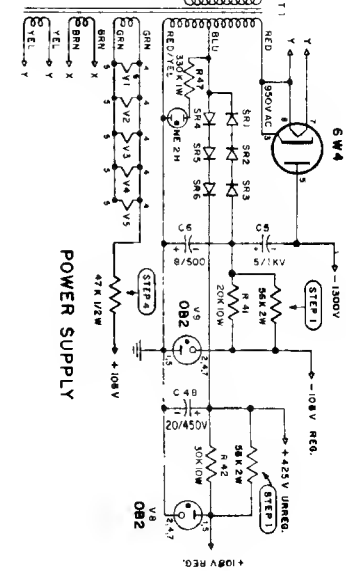
POWER SUPPLY

**DESCRIPTION:** Power transformers have failed in some MI-2/MI-3 units due to intermittent shorts in the 6W4 HV rectifier tube. These shorts are caused by cathode flaking in the 6W4. The problem can be eliminated by replacing the 6W4 with a 3000 volt 3MA semiconductor rectifier. This modification reduces the amount of heat generated within the MI-2/MI-3 and increases the life and reliability of the unit.

1. Remove the MI-2/MI-3 top cover. Remove the 6W4 tube and place an octal plug (Part #127-006) in the socket.
2. Remove the MI-2/MI-3 bottom cover. Cut and remove the jumper wire connecting pin 8 to pin 3 on the 6W4 socket.  
Connect the 3000 PIV rectifier (Part #070-026) to pin 5 and pin 3 of the 6W4 socket. The RED end of the rectifier should connect to pin 3 and the BLACK end to pin 5. This part of the circuit operates at -1300V; therefore, be sure to locate the rectifier and its leads to provide adequate insulation. Use spaghetti on the rectifier leads. Keep the rectifier leads short to avoid rectifier vibration problems.
3. This completes the modifications. Service bulletin 104 also relates to this product. If trouble has been experienced this modification should be installed at this time.
