Unusual Squelch Troubles

By ARNOLD W. WIEGERT

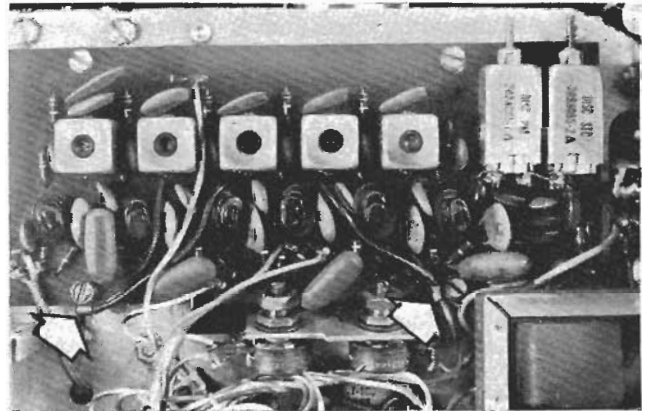
You will have to watch out for one thing when working on the second i.f. board in these sets. If you have to get at the back side while the set is operating, make sure that the two lugs under the bottom mounting screws as well as the ground strip on the back are grounded. The best and easiest way is to take two nuts and thread them over the

mounting screws. Then run a short jumper from there to ground. After you are finished, make sure the mounting screws are good and tight again. Otherwise you are heading for more trouble, again with the squelch. It will be very erratic. Sometimes the squelch will cut off, sometimes it won't until you bang the radio or somebody walks around the room. The reason is simply that the wires attached to the two lugs are actually short ground connections for the ground system in the printed-circuit board and, unless they are securely grounded, all kinds of troubles develop. One of them is low noise output from the discriminator and intermittent squelch due to a drop in gain in the sound i.f. amplifiers.

Lugs under two lower printed-board mounting screws (arrows) must be grounded securely.

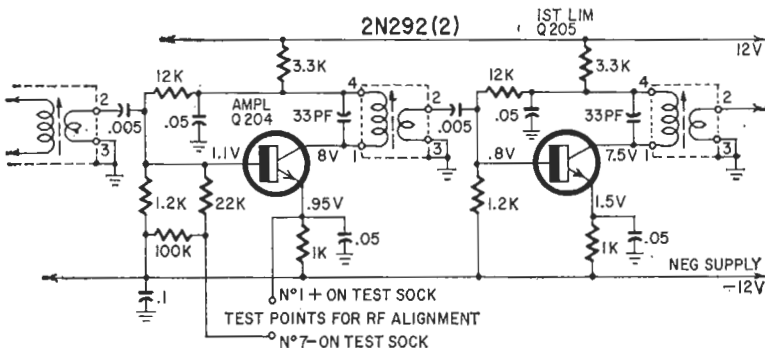
On two sets the complaint was very slow squelch action. It took about 10-15 seconds after receiving a signal before the squelch would cut off. On the first one, all voltages in the squelch circuit checked good and the trouble seemed to be low input to the noise amplifier. Instead of 0.65 volt, the meter showed only 0.4 volt at the discriminator output. After about 5 seconds the voltage started to rise slowly until it reached 0.65 volt and the squelch cut off. Voltage checks in the second i.f. board seemed to indicate poor power supply regulation. With the squelch open, supply voltage to the second i.f. was about 10.5 volts and jumped to 12.5 volts as soon as the squelch cut off. At those voltages this is quite a drop, but a different set worked just perfectly with the same change. (This drop is due to the heavy drain of the class-B output stage when amplifying the noise.)

Several hours later we noticed that the voltage at Q204's emitter (Fig. 1) changed slowly as the noise at the discriminator came up. Checking the transistor showed its leakage was a bit too high. Replacing it with a good one cleared up all our troubles. The second set showed the same symptoms, but this time it was Q205. Again a new transistor cured the set. So watch those jumping voltages and don't let them fool you into a wild goose chase.

Fig. 1—Circuit of second i.f. amplifier board. Trouble here was leaky transistors.

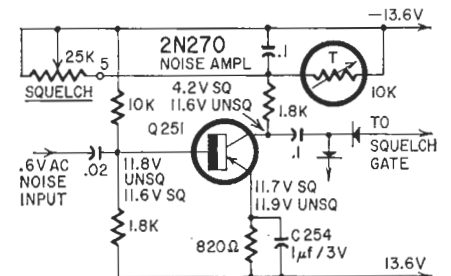
a signal, sometimes it would stay on for minutes or hours and nothing would help. Everything worked fine up to the noise amplifier. Voltage checks around Q251 (Fig. 2) showed that the bias had changed enough to cut the transistor off completely. Remembering the article on Ultra-Kaps in the January 1961 issue of RADIO-ELECTRONICS, C254 (1- μ f 3-volt Ultra-Kap) was not even suspected. But after every other part was found to be good, we finally tested C254 and found it was practically shorted. Replacing it with a 10- μ f electrolytic, because we had no exact replacement at the time, cleared all problems and the set has been working fine ever since.

Fig. 2—Noise amplifier circuit in the Bendix 16RS-1.
