FL1

93.03

Service Information

Alternative service position for FL1 equipment

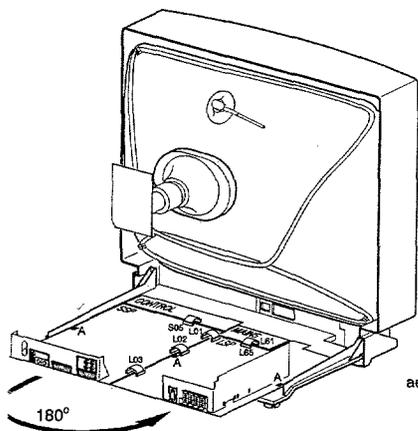
Fig. 1

Disconnect the connections L01, L02 and L03 between the LSP and SSP (see figure 1).

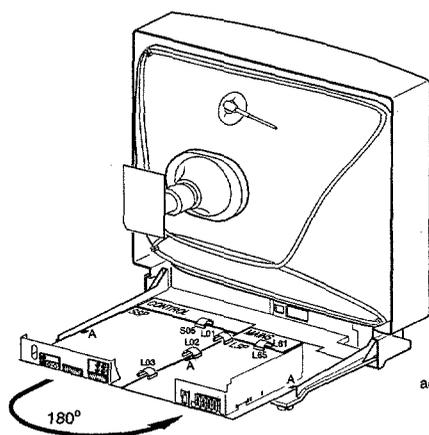
Fig. 1

3. Position d'entretien/réparation pour la réparation du LSP ou du SSP
 - Détacher les connexions L01, L02 et L03 entre le LSP et le SSP (voir figure 1).
