FL1

93.04

Service Information

1. General FL1

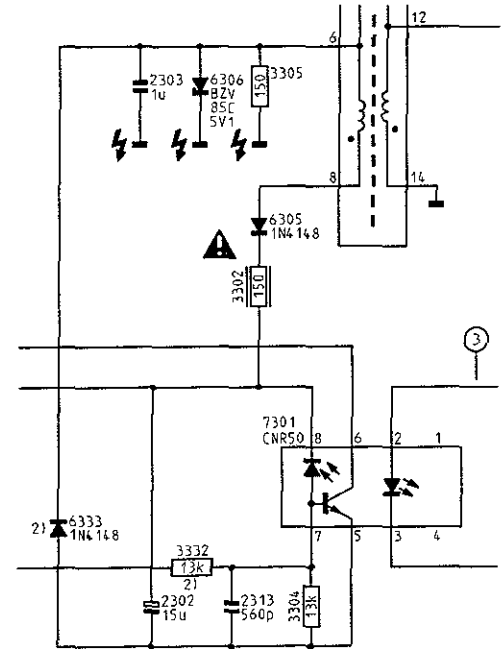
Fig. 7.2

In service manual FL1-PTV AA a part of diagram x is incorrectly illustrated. This part is shown correctly in Fig. 2.
