## Service Information

CL 46532022.015  
220294

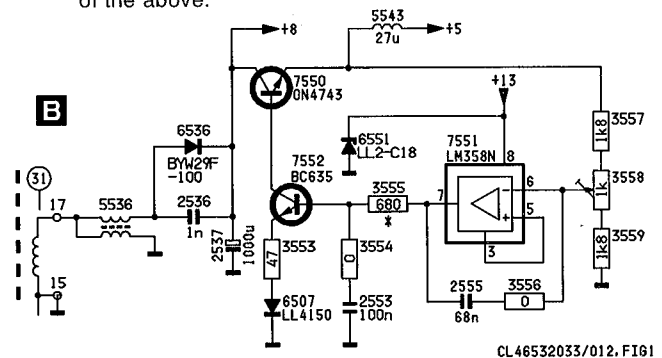
**5. Operational reliability of the LM358 (IC7551) on the LSP of FLx.16 and FLx.17**

In order to increase the operational reliability of the LM358 (IC7551) on the LSP the following modification was introduced from week 9344:

- In the 25", 28" and 33" sets a zener diode (BZX79C18; 4822 130 31024) has been added to position 2551, between pin 8 of position 7551 and position 9240, with the cathode on pin 8 of position 7551.
- In the 29" position 2551 has been modified to an LLZC18 (4822 130 80922) with the cathode on pin 8 of position 7551.

The figure below illustrates the correct situation for both of the above.

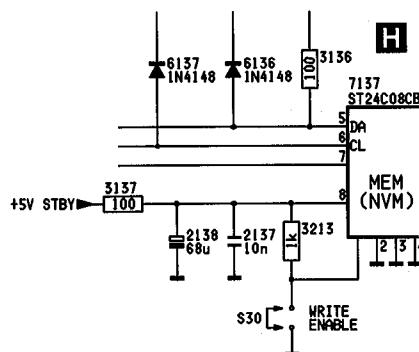
CL46532033/012.FIG2

## 9. Introduction of new SSP with EAROM protection in FL1.10, FL2.16 and FL1.17

The difference between the old and the new SSP is as follows (see figure below):

- Position S30 pin strip 3P added (4822 265 31009)
- Position 3213 1kΩ added (4822 051 10102)
- Position 4127 jumper added (4822 051 10008)
- Positions 4135 and 9228 removed
- Position 7137 modified to ST24C08CB1 (4822 209 32283)

S30 = OPEN: READ ONLY SERVICE SETTINGS  
S30 = CLOSE: READ/WRITE SERVICE SETTINGS
