VINTAGE RADIO

A couple of odd receiver repairs

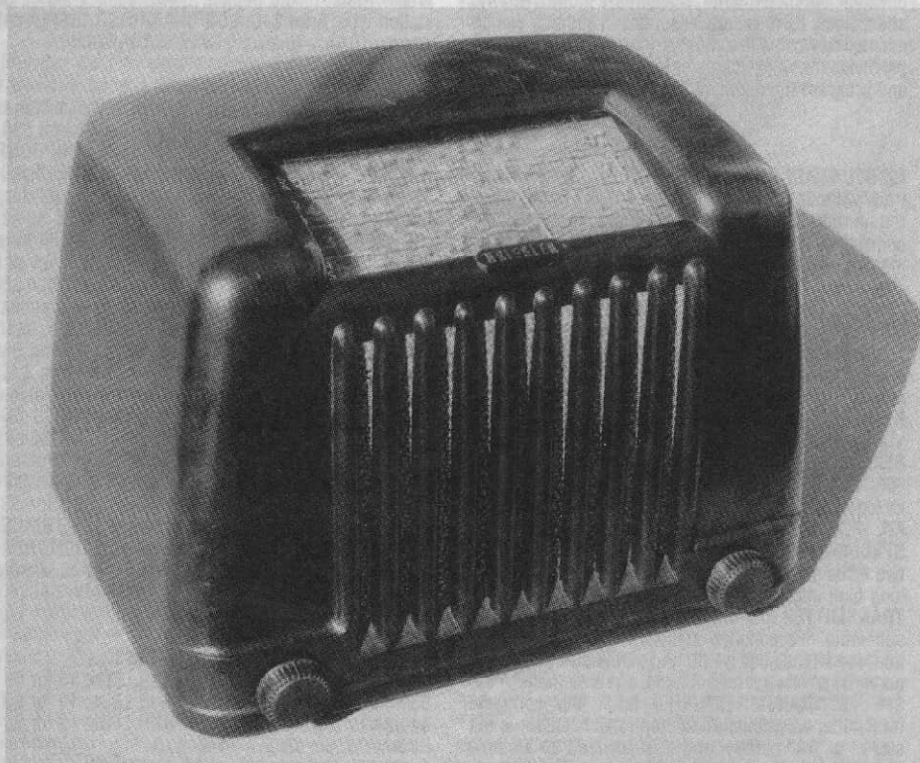
When I finally started working on the set, it was quite obvious what the missing part was. It was positioned between the two positive contacts of a twin high-voltage electrolytic capacitor and could only be a high tension filter resistor. Yet it was not the usual setup.

It would appear that the missing resistor was a high wattage wirewound type because all the current from the rectifier flowed through it before anything was connected to the high tension supply. By contrast, in most small 4-valve receivers, the high tension for the output valve comes from the input side of the filter and a one or two-watt carbon resistor is used in conjunction with a second electrolytic capacitor on the output side to supply the other valves.

This photo shows the 4-valve Kriesler that had the missing component. It also had other problems – mainly faulty paper capacitors.

By this stage of the proceedings, the fault was fairly obvious – a short circuit at the point where the screen voltage of the IF valve is applied to the 6AN7 frequency converter socket. As the socket connection at that point had a 0.05 μ F bypass capacitor to chassis, it seemed likely that this component could be faulty – and it was.

After disconnecting the suspect capacitor (an original paper capacitor I might add), it was found to have a complete short circuit. Replacing this faulty capacitor restored the set to working order once again. But although the set was now working, the high tension voltage was still only 150V at the output side of the filter.

Checking the capacitors with a voltmeter revealed that three of them had high tension voltages across them and these were replaced with modern polyester equivalents. This step saw the high tension voltage rise to 210V.

The remaining paper capacitors were all replaced with 100V green-caps.

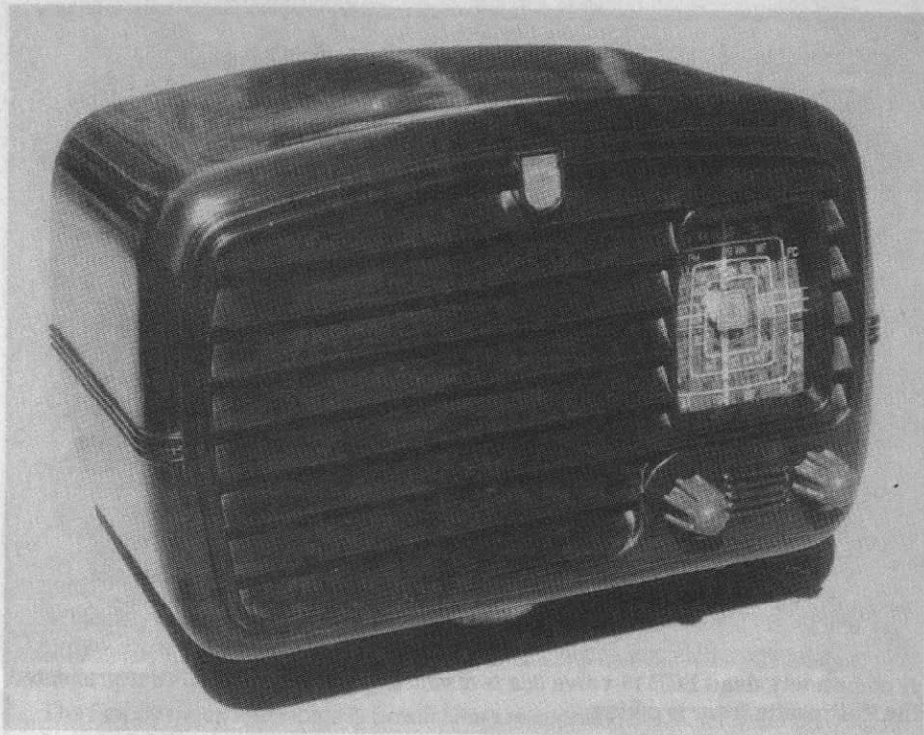
This small Philips 4-valve receiver is a mighty performer for its size. It had a number of problems, including a faulty valve, faulty capacitors & power transformer faults.

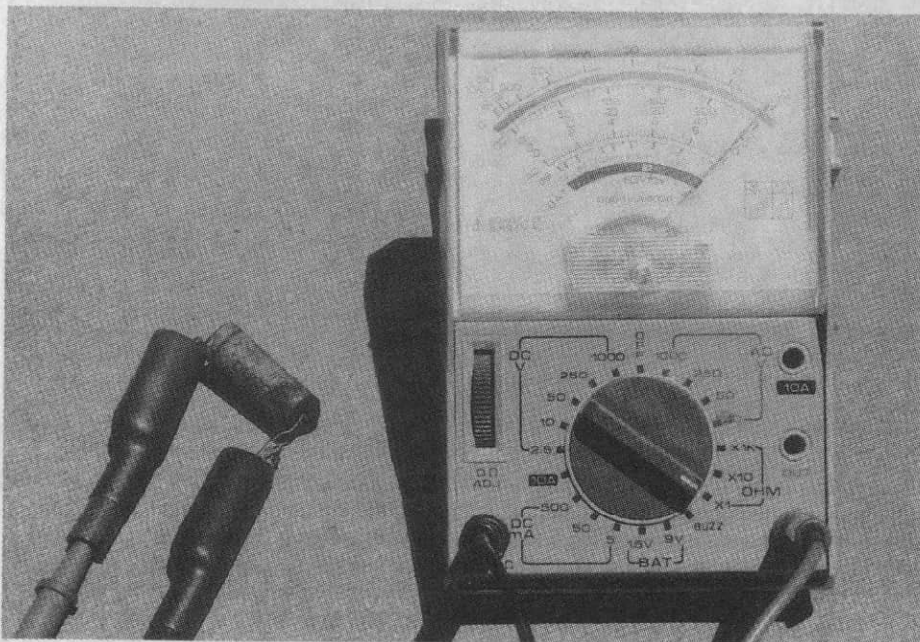
A short-circuited 0.5 μ F capacitor was one of the problems encountered with the Kriesler repair. The routine replacement of paper capacitors can automatically solve many obscure receiver faults.

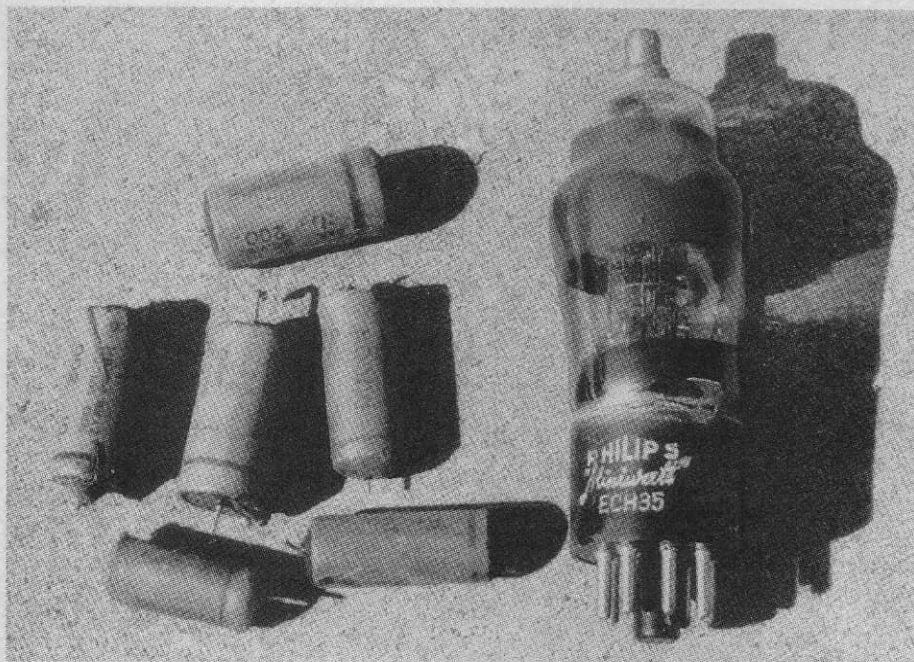
A completely dead ECH35 valve & a few sick capacitors were all that prevented the Philipsette from working.

The little Philips had a valve problem – the ECH35 frequency converter was very dead in the heater department and needed replacing. The remaining three valves tested OK.

electrolytic. The latter looked particularly bad, as the seals at the positive ends were ruptured and split. Despite their appearance, they seemed to be working OK but, of course, they were all replaced.

Replacing all the paper capacitors cured the distortion problem. The exact fault may have been a leaky coupling capacitor to the grid of the output valve. A leaky capacitor in this position is bound to cause distortion. The high tension voltage rose by about 20V after the capacitor replacement job was finished.

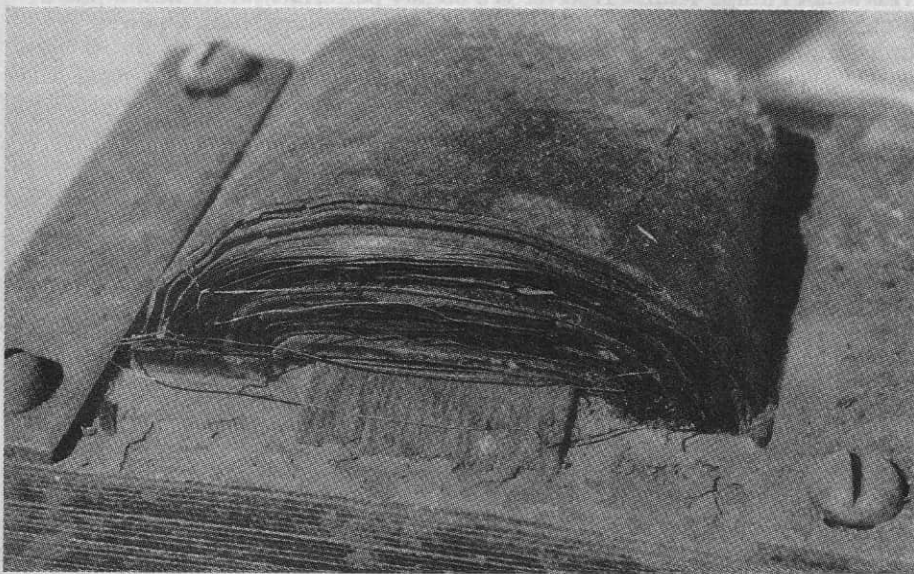
The power transformers used in many Philips & Mullard receivers share this common fault – an exposed high tension winding. The winding protrudes outside the paper insulation that separates the layers (probably caused by the paper shrinking with age). This is not the transformer used in the Philipsette in the story but a similar one in worse condition, to show the problem more clearly.

In addition, it was noticed that some of the high tension winding was exposed and a couple of turns were hanging out in the open. This is a common fault with this make of transformer because the windings come quite close to the edge of the paper that separates each layer. The loose wires were coaxed back in place and held in place with silicone sealant.

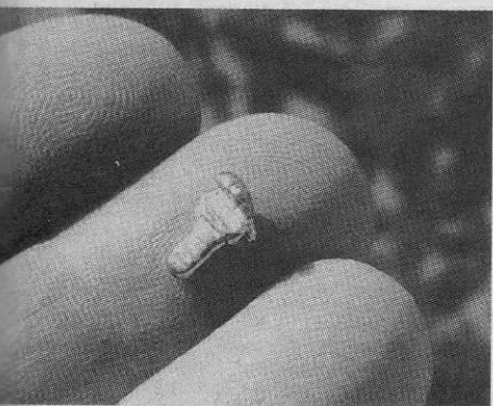
This small blob of solder was shorting out the high tension winding of the Philip's power transformer. The short-circuit only occurred when the transformer became hot enough for the expansion of the high tension winding to sandwich the solder against the core laminations. There's always something different that can cause trouble.

A close inspection of the power transformer revealed a blob of solder wedged firmly between one side of the high tension winding and the core laminations. A molten drop of solder could have only fallen in there when the chassis was upside down. As I had done my work with the chassis on its end, I didn't put it there!

Removing the solder returned the set to normal operation. The solder was acting like a thermal switch and only caused trouble when heat expansion of the windings caused the solder to short the HT winding to the laminations.
