Hi-Fi Products  
**Service Bulletin**

**Model:** CDP35,40,55,65,203

**No. 8**

**Subject:** Intermittent No Eject

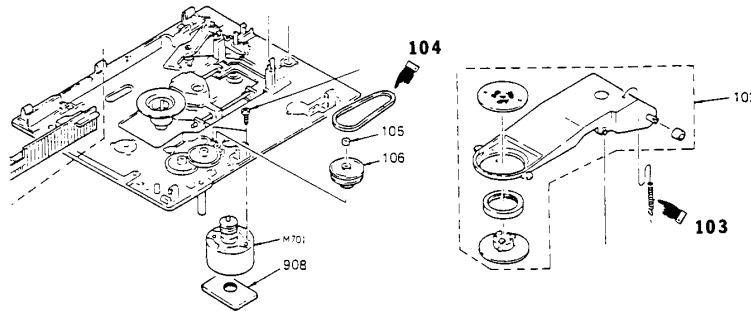
**Symptom:**  
(65)  
Intermittent no eject.

Please note that on CDP35 and 40, the LM belt has a number reference of 105 instead of 104 as is shown below.

Replace the LM belt and the tension spring with the new parts listed.
