SERVICEMAN'S LOG

Carbon based failures are all too common

- Carbon-based failures
- The mosquito that died happy
- Is it electrical or fuel?
- Faulty air-conditioning controller

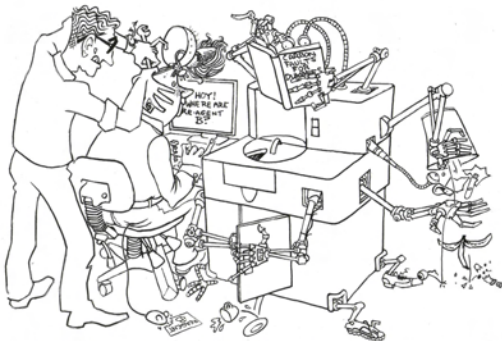
Anyway, back to the "Can't find reagent B" problem. Initially, I spent a few hours on the phone with the Lab Manager, going through various things to check . . . "Have you changed the reagent pack? Is it empty? Has the sig-

REPAIRING A CHEMISTRY ANALYSER'S CARBON-BASED FAILURE

After exhausting all these and other ideas without result, there was nothing for it but to make the 3-hour trip to the lab with my tools and spares to check out the problem with the robot arm. When I arrived about mid-afternoon, I immediately looked into the reagent B bottle and saw that it was nearly empty. As a result, I asked the lab manager to get me a new bottle of reagent, after which the analyser worked perfectly, much to the mixed emotions of the lab manager.
