# TV Products Service Bulletin

**Model:** KP-53XBR45, KP-61XBR48

**No.** 285

**Subject:** Jittering P in P or P & P picture

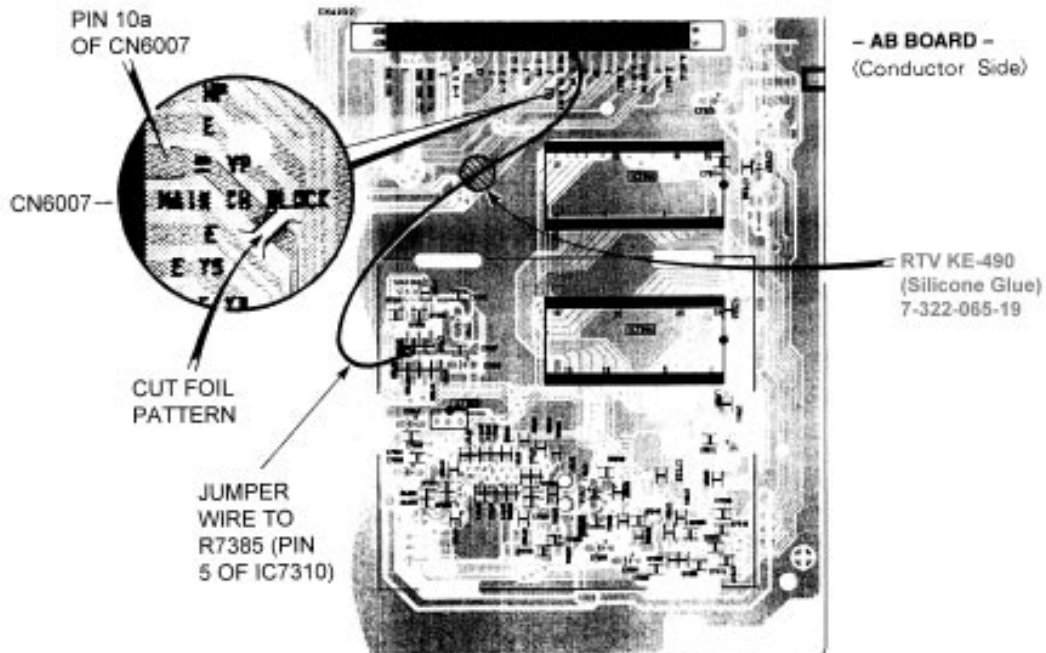
**Symptom:**  
(237)

If customer should experience intermittent jittering P in P (Picture in picture) or P & P (picture and Picture). Please perform the following circuit change on AB board.

**Solution:** Step 1: Cut foil pattern as illustrated below:

Step 2: Add the following wire between Pin 10a of CN6007 and R7385(Pin 5 of IC7310 side).

REF	DESCRIPTION
INSULATED WIRE	AWG 24 OR 26, 4 INCH LENGTH
