# NOTES & ERRATA

## 25W STEREO BOOSTER

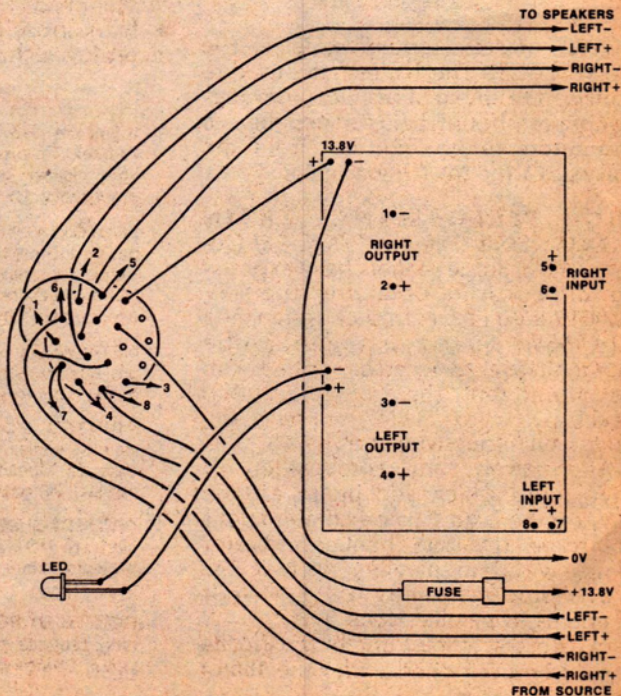
(January 1979, File No. 1/SA/61); The switch wiring diagram on page 42 was not compatible with the overlay diagram on the same page, and also implied the wrong switch rotation. A corrected diagram is reproduced here.
