Modifications for CMOS Die

The CMOS Die of April 1979 (File No 3/EG/11) contained two minor drawing errors, and a reader has also reported that it can develop a bias towards high numbers as the battery runs down. This note deals with both problems.

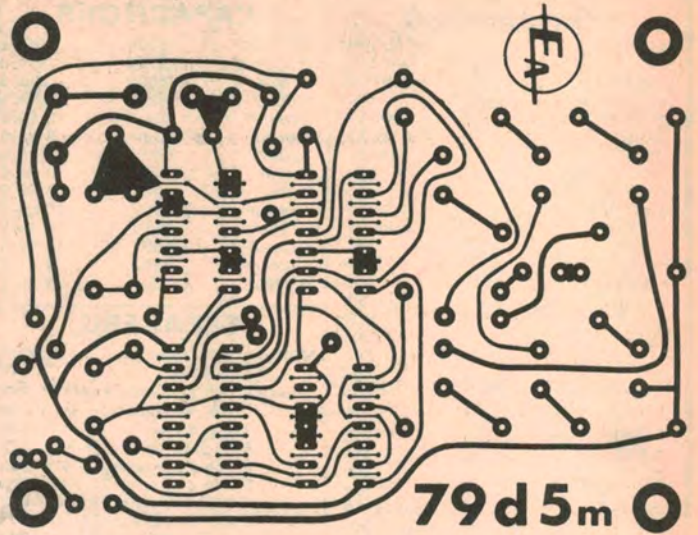
One error concerned the board pattern, whereby pin 2 of the 4017 was connected to pin 3 of 4001B/4, instead of pin 2. The other was a transposition of the pin numbers for 4017, on the overlay pattern. Both have been corrected on the accompanying drawings.

Top right: the modified board pattern incorporating the corrections and modifications. Immediate right: The modified board with overlay pattern. Far right: How to modify an old board. Below: The circuit with the decoupling components added.

Alternatively, we can fit a decoupling network, consisting of a 1k resistor and a 1000uF capacitor. A modified board pattern (79d5m) with overlay is illustrated, and will take care of units yet to be built.

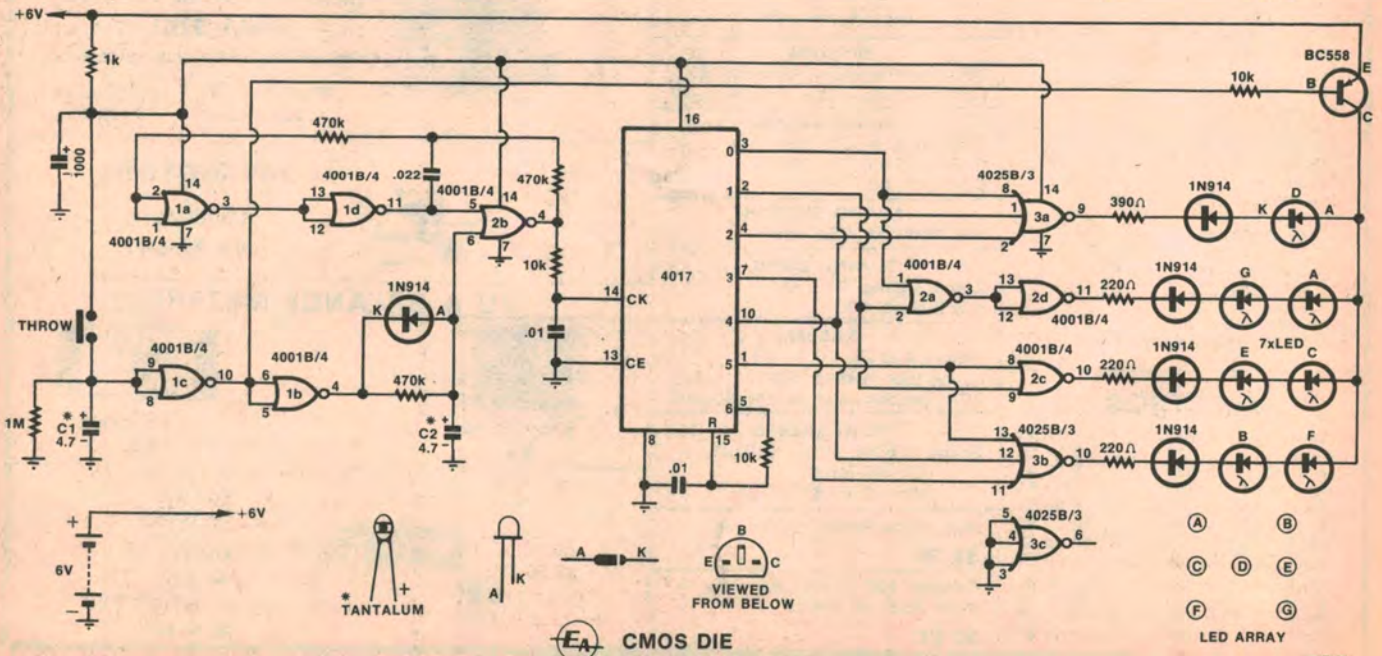
The high-number bias appears to be due to pulses from the display section coupling into the counting section, via the common battery impedance. The reader who reported this suggested sacrificing the "rolling dice" effect by removing the diode, 470k resistor, and C2 network. This approach is completely effective.
