UPDATES

"Packet on the Mac"

Refer to the above article on page 8 of the October 1992 issue. The following corrections need to be made:

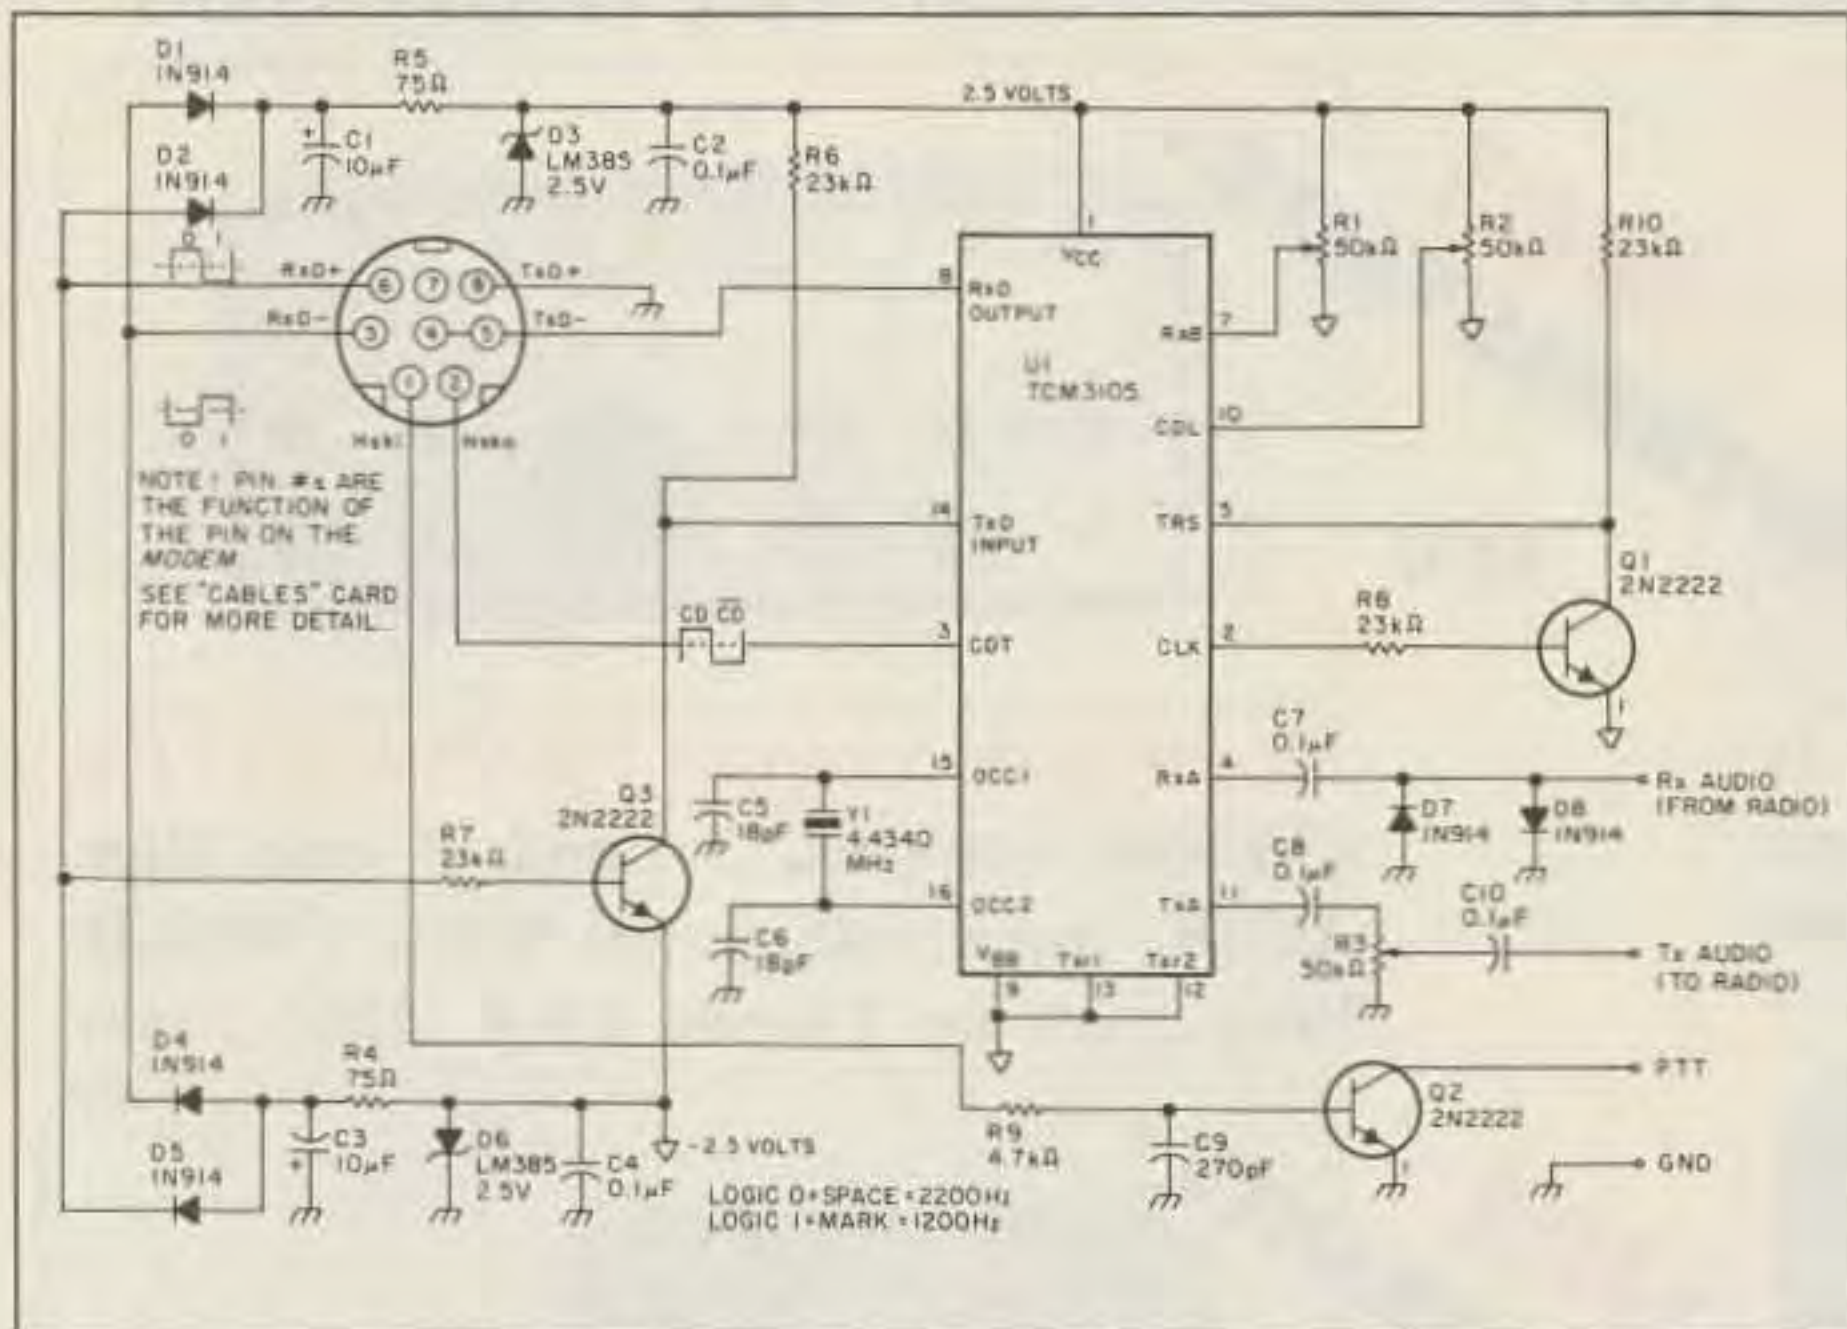
Figure 1. The corrected schematic diagram of the PacketMac Modem. Changes are to the TxD and RxD wiring, pin numbers on the connector and the -2.5 volt connections. Note, however that everything except the loopback test will work as originally wired.

2) The bit asserted sense of the TxD+ and TxD- lines are the same as their name, not the opposite as stated in the article.

Note however, that the modem will still work fine for packet as originally wired

since the NRZI encoding asserts a bit by changing state, it does not matter if the state starts high or low. The only indication that a reversal exists is that the characters received during a loopback test are the "inverts" of what was sent.

The modem can be fixed by simply

swapping the wires on the mini DIN-8 Macintosh cable where it attaches to the TxD+ and TxD- pads on the modem. You could also change the modem by swapping the wires going to the RxD+ and RxD- pads.

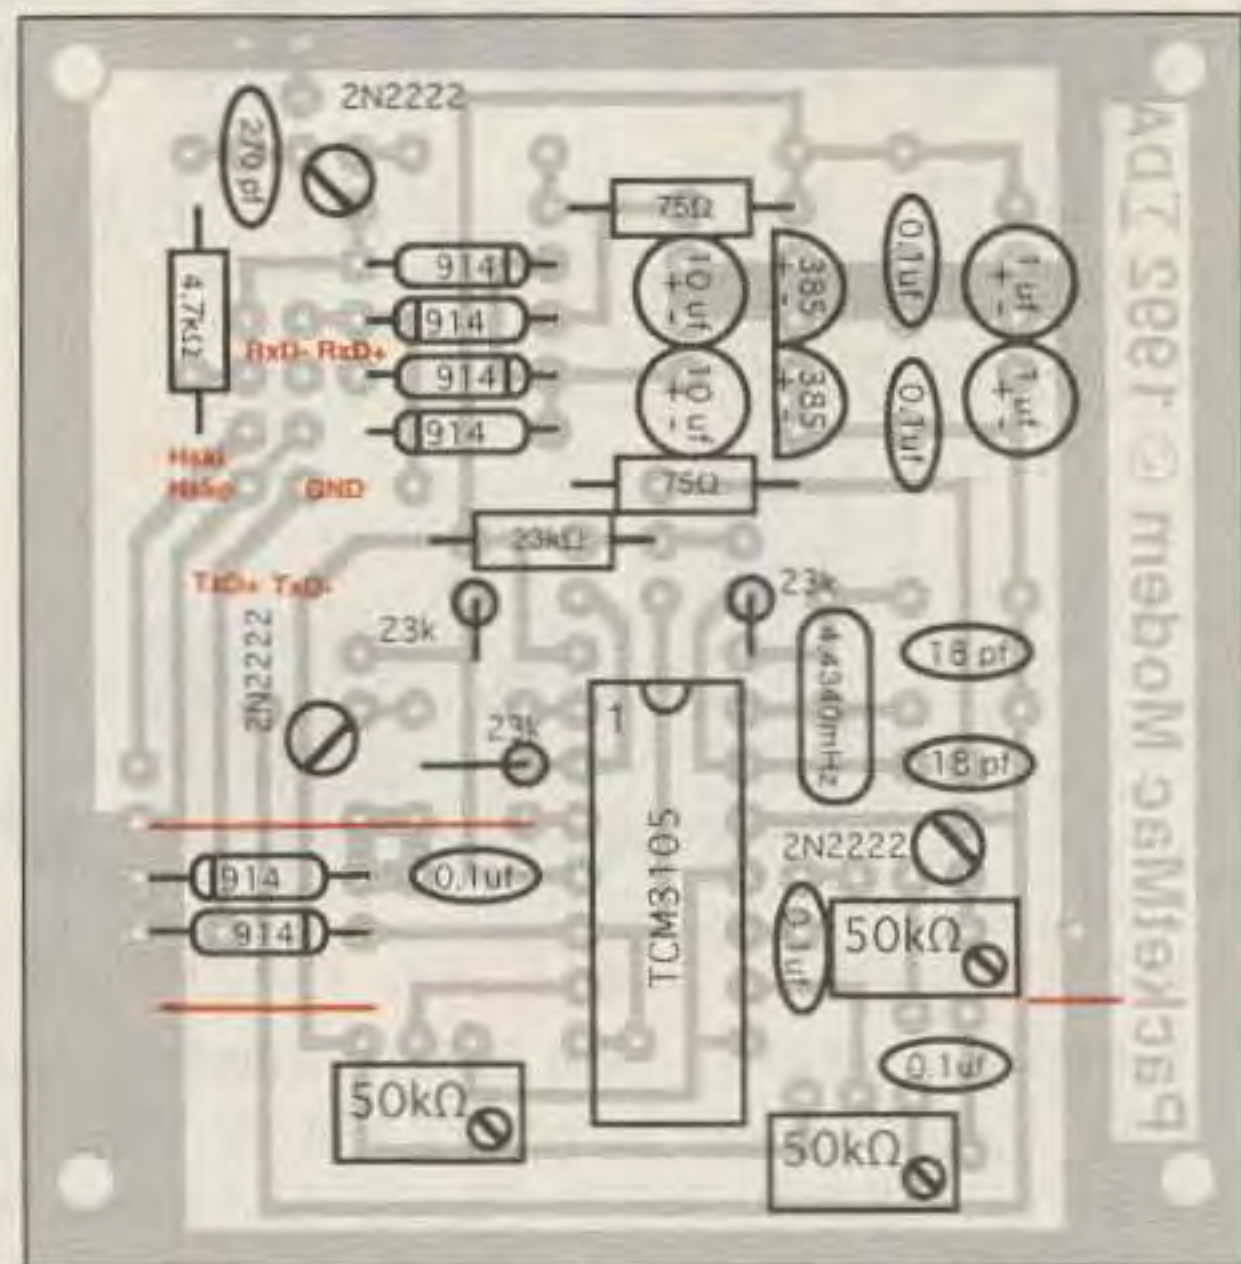
1) The jumpers were not shown on the parts placement diagram for the modem. See the corrected diagram in Figure 2.

Figure 2. The corrected parts placement diagram of the PacketMac Modem showing the jumper wires as well as the new pad assignments (shown in red). Using these new pad assignments, just follow the wiring hookup chart in Figure 4 in the original article for the proper connections.
