# NOTES AND ERRATA

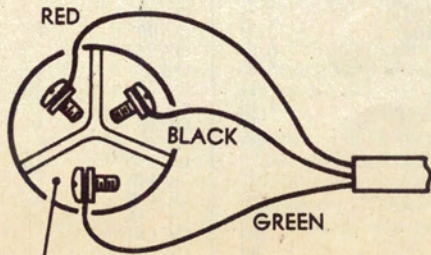
**POWER PLUG  
(LOOKING AT SCREWS)**

**LOW COST STEREO SYSTEM:** (January 1972, File No 1 / SA / 38). Several readers have commented on the diagram on page 39, querying the connection of the

active and neutral leads to the three pin plug. Contrary to what some readers apparently believe, there is strictly no regulation requiring that the active, neutral, or earthing conductors be connected to a plug or socket in any specific order. All that exists is a recommendation that the pins be wired in the order earth, active, neutral, in a clockwise direction, when viewed from the front of the socket. In practice, this convention will have been followed in the vast majority of installations. Since the wiring we showed does not conform to it, the black and red leads should be transposed, as shown.
