MUSIC VISION CORRECTIONS

An error appeared in the parts placement diagram (Fig. 10) of the article, "Music Vision" (Electronics Now, November 1995). The label for resistor R59 was incorrectly placed; It appeared as an unlabeled jumper located below R60. In addition, the solder-side of the PC board was reversed in the X-ray view, Fig. 10. The corrected version is shown below.—Editor

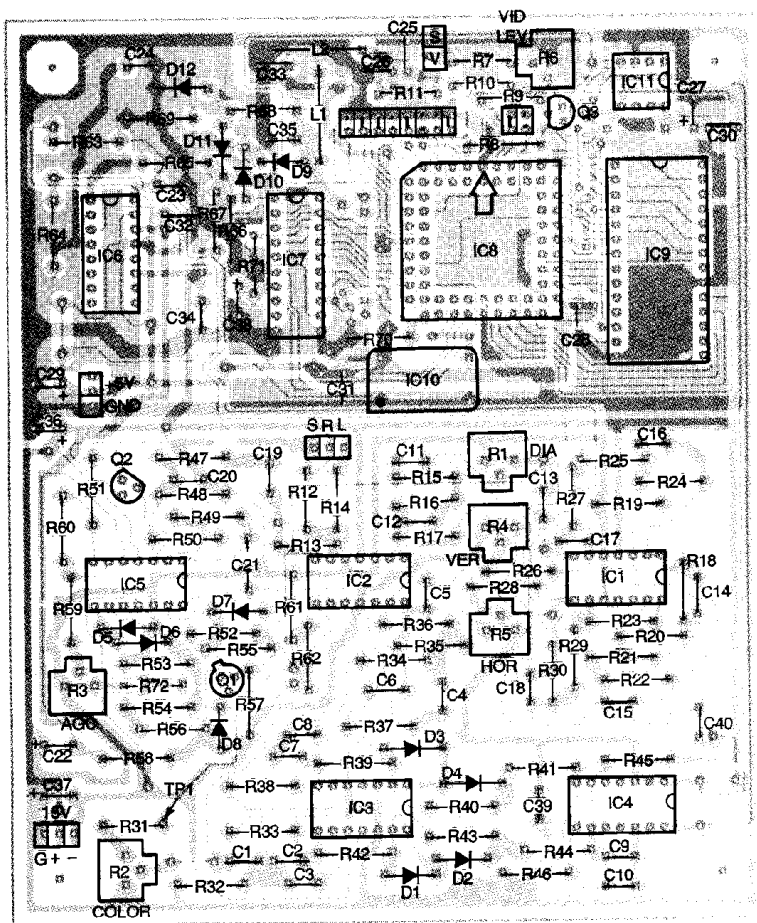
CORRECTED DIAGRAM for Music Vision article.
