Pin 1 Revisited

Jim Brown
Audio Systems Group, Inc.

RaneNote 165
© 2003 Syn-Aud-Con

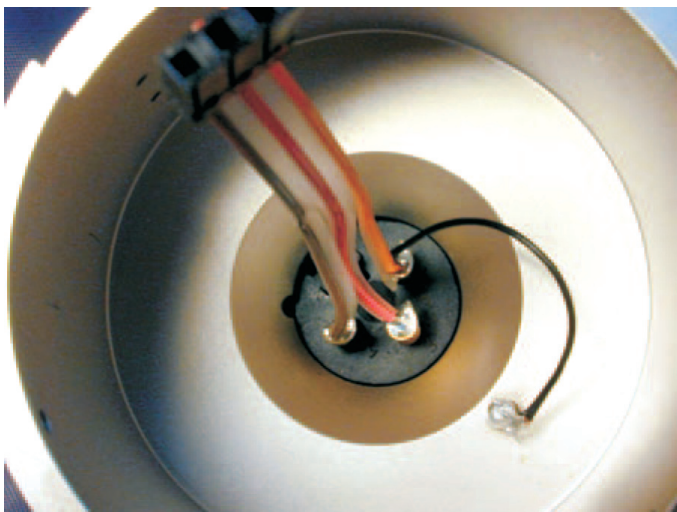
Here's the inside of a rather expensive condenser mic (Figure 1), the manufacturer of which has long insisted that the shields of mic cables must be connected to the shell in order to prevent RF interference. A quick look at the photo tells us why — this mic has a screaming pin 1 problem at VHF frequencies!

The black wire takes pin 1 to the body of the mic, and the orange wire takes pin 1 up to the circuit board. At audio frequencies, that works just fine. But at 56 MHz (the frequency of TV channel 2), the inductive reactance of the black wire is about 4Ω . If you try to use this mic in downtown Chicago with a properly wired mic cable, the shield current induced by Channel 2, Channel 5, and a bunch of FM broadcast stations causes enough voltage drop in the black wire (which the orange wire adds to the audio circuitry) that both the video and FM signals are clearly heard! Rick Chinn's review of this mic several years ago for a magazine noted RF interference from TV stations, the closest of which were 13 miles away!

Figure 1 (left) and Figure 2 (above). Impedance-to-ground is frequency dependent. A good connection in the audio band can be a bad connection in the RF band.

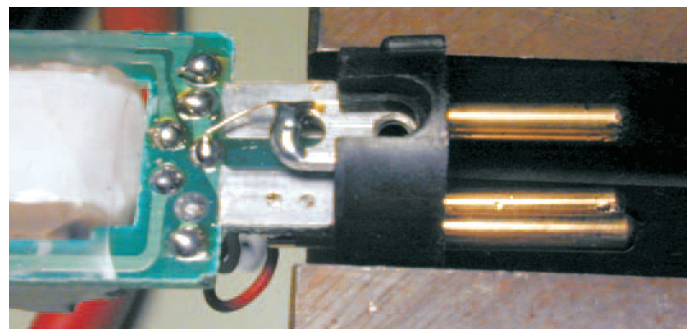
This mic has a pin 1 problem too (Figure 2), although not as severe — it takes about 6 dB more RF to cause audible interference. Here, the shield goes to the chassis through the tiny wire connecting pin 1 to the broad tab holding the connector's retaining screw. The combined length of that path is on the order of 1 cm, which results in about 2Ω of inductive reactance at 60 MHz. Again, circuit common is connected to pin 1 and sees the drop across the inductance. I was first alerted to the problem in this mic when I noticed that tightening the screw reduced the interference by about 3 dB!

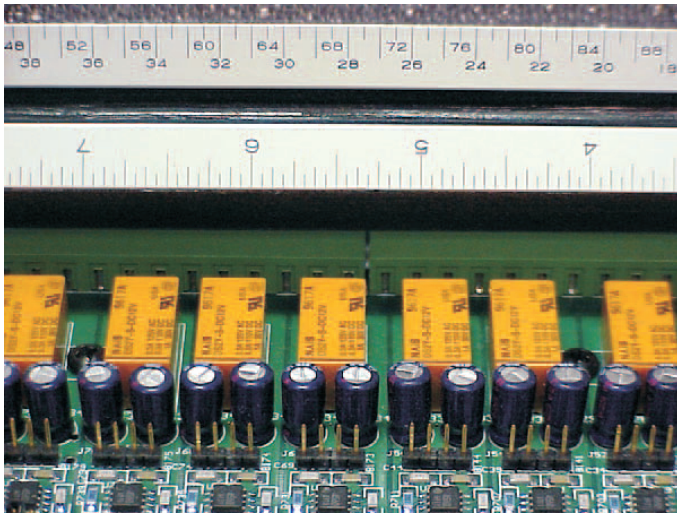
Figure 3. Internal conductors (including PCB traces) that connect to pin 1 can act as antennas. Radio frequencies flowing on the cable shields are re-radiated inside of the unit. In reverse, radio frequencies generated inside of the unit (DSP clock, etc.) can exit the unit via pin 1 and contaminate surrounding equipment.

Figure 3 shows the rear panel connections to a DSP unit that has a bit of a noise problem. Looking behind the panel, we see the circuit traces go to the chassis via the two black screws at approximately the 4" and 7" points on the ruler that has been laid on top to show dimensions. All the incoming shields are bused together and go to the screws. These long leads (typically 2-4" with all the zigs and zags) are like open doors to radio frequency signals — any current flowing on the shields radiates inside through antenna action, and noise inside the box is coupled out onto the shields, which also act as antennas.

The pin 1 problem works in reverse too — any RF noise currents (digital clock noise, for example) flowing in that common impedance create a voltage drop that is coupled out to the shield. The shield, acts as an antenna and noise is radiated to nearby equipment and wiring. It's not at all uncommon to see shield paths inside equipment 3-5 inches long! At 100 MHz, a 5" long wire is about 60 Ω ! At 1 GHz, it's about 600 Ω .

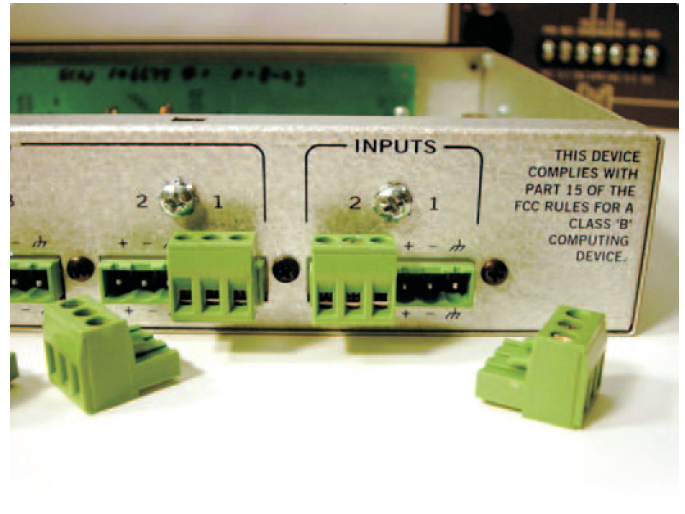
Figure 4. A direct connection to the chassis is the best broadband grounding solution. This enabled the device shown to get a class "B" rating (more stringent).

There are better ways to do this. Some manufacturers (Figure 4 shows a Rane product) provide a chassis screw next to pluggable strip connectors for proper termination of the shield. Inside, the signal leads go directly to RF filter networks.

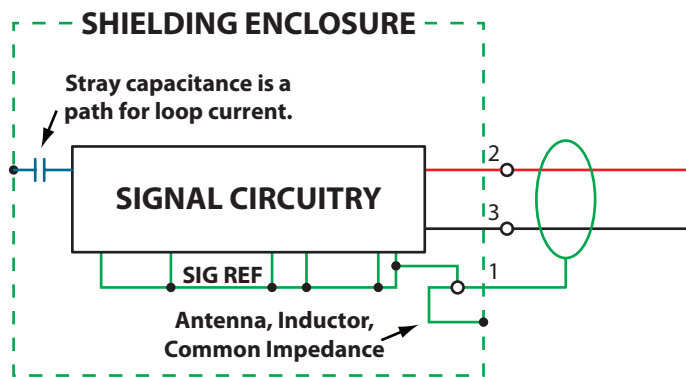
Figure 5. This is the classic RF pin 1 problem in a mic. The cable shield goes to the enclosure, but through a wire long enough to have significant inductive reactance at VHF. The drop across the inductance is coupled to the signal zero reference, where it is added to the signal.

Since the 1930’s, engineers have known that audio frequency noise coupling will be minimized with single point (star) grounding, while radio frequency noise coupling is minimized with multi-point (mesh) grounding. The solution is simple — the shield of a balanced audio cable is connected to the shielding enclosure at the driving source, and to the shielding enclosure at the receiving end through a capacitor. It was easy to do this in the 40’s, when RF signals higher than 30 MHz were rarely encountered. It’s much tougher now, when the interference sources are strong RF signals from UHF cell phones and high power TV transmitters. Again, it’s series inductance that makes life difficult, this time the inductance of the capacitor’s wire leads. See Figures 5 and 6.

A simple circuit study shows why. Figure 7 shows a cable using the new connectors used with the mic shown in Figure 5. The concentric capacitor ties the shield to the mic shell with an inductance that is much lower than the wire inside the mic.

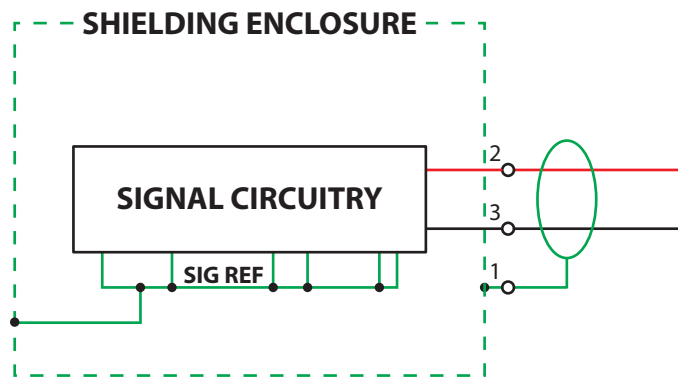
Figure 6. A circuit configuration that avoids a pin 1 problem. The shield goes directly to the shielding enclosure. Signal reference common also goes to the shielding enclosure, but there is no common impedance.

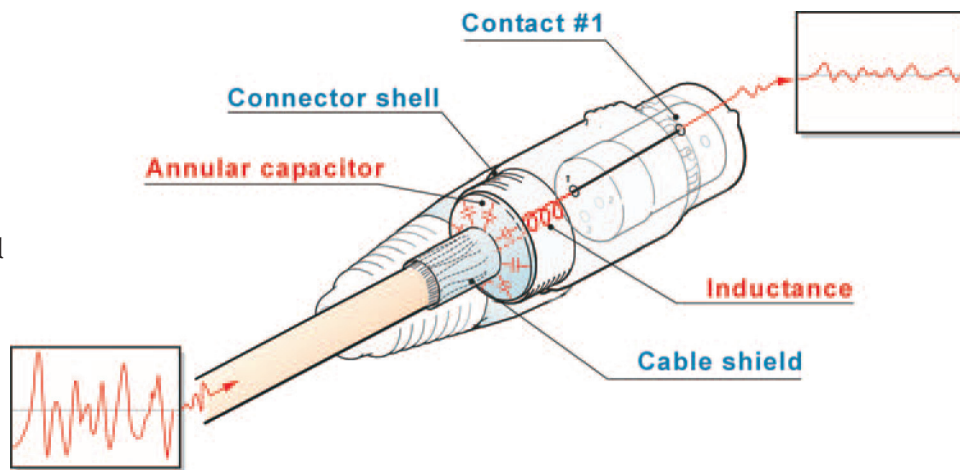
Figure 8. This drawing was produced by Neutrik for my AES paper. A pictorial view of the new EMC connector, courtesy Neutrik.

It took a while for these ideas to germinate, but before long, engineers at Neutrik had begun work on a practical implementation (Figure 8), and by early 2002 had developed engineering prototypes. British consultant John Woodgate tested them in his lab, and I tested them both in my lab and in the field. The results met my expectations, and yielded an unexpected bonus — they solved RF pin 1 problems, even when pin 1 was connected at both ends!

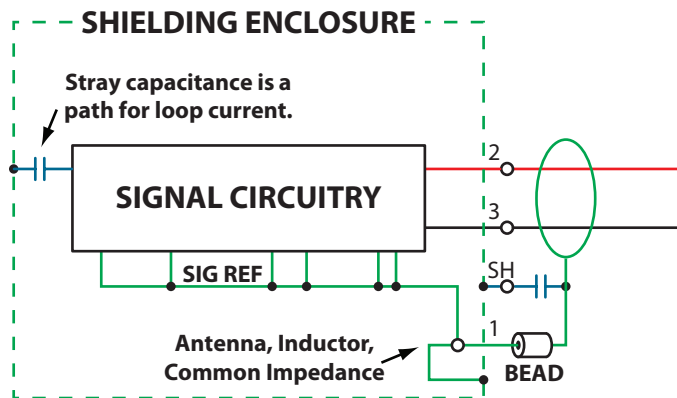
Figure 7. The new EMC connector as it would be used at both ends of a mic cable. The shield has a DC connection to pin 1 with a ferrite bead around it. The concentric capacitor also connects it to the shell. The ferrite bead increases in series impedance through pin 1 at RF, while the capacitor makes a very low impedance connection of the shield to the equipment (or mic) enclosure.

Not only that, but the ferrite bead around pin 1 inside the new connector adds series impedance to the path through pin 1, effectively disconnecting the shield from the pin 1 problem. Shield current thus divides, most of it taking the low impedance path through the capacitance to the shell, with very little flowing through pin 1. In effect, the new connector bypasses the problem!
