VINTAGE RADIO

Fault finding – there's always something different

Vintage radio receivers can develop some very unusual faults. Here's what it took to bring two old receivers back to life again.

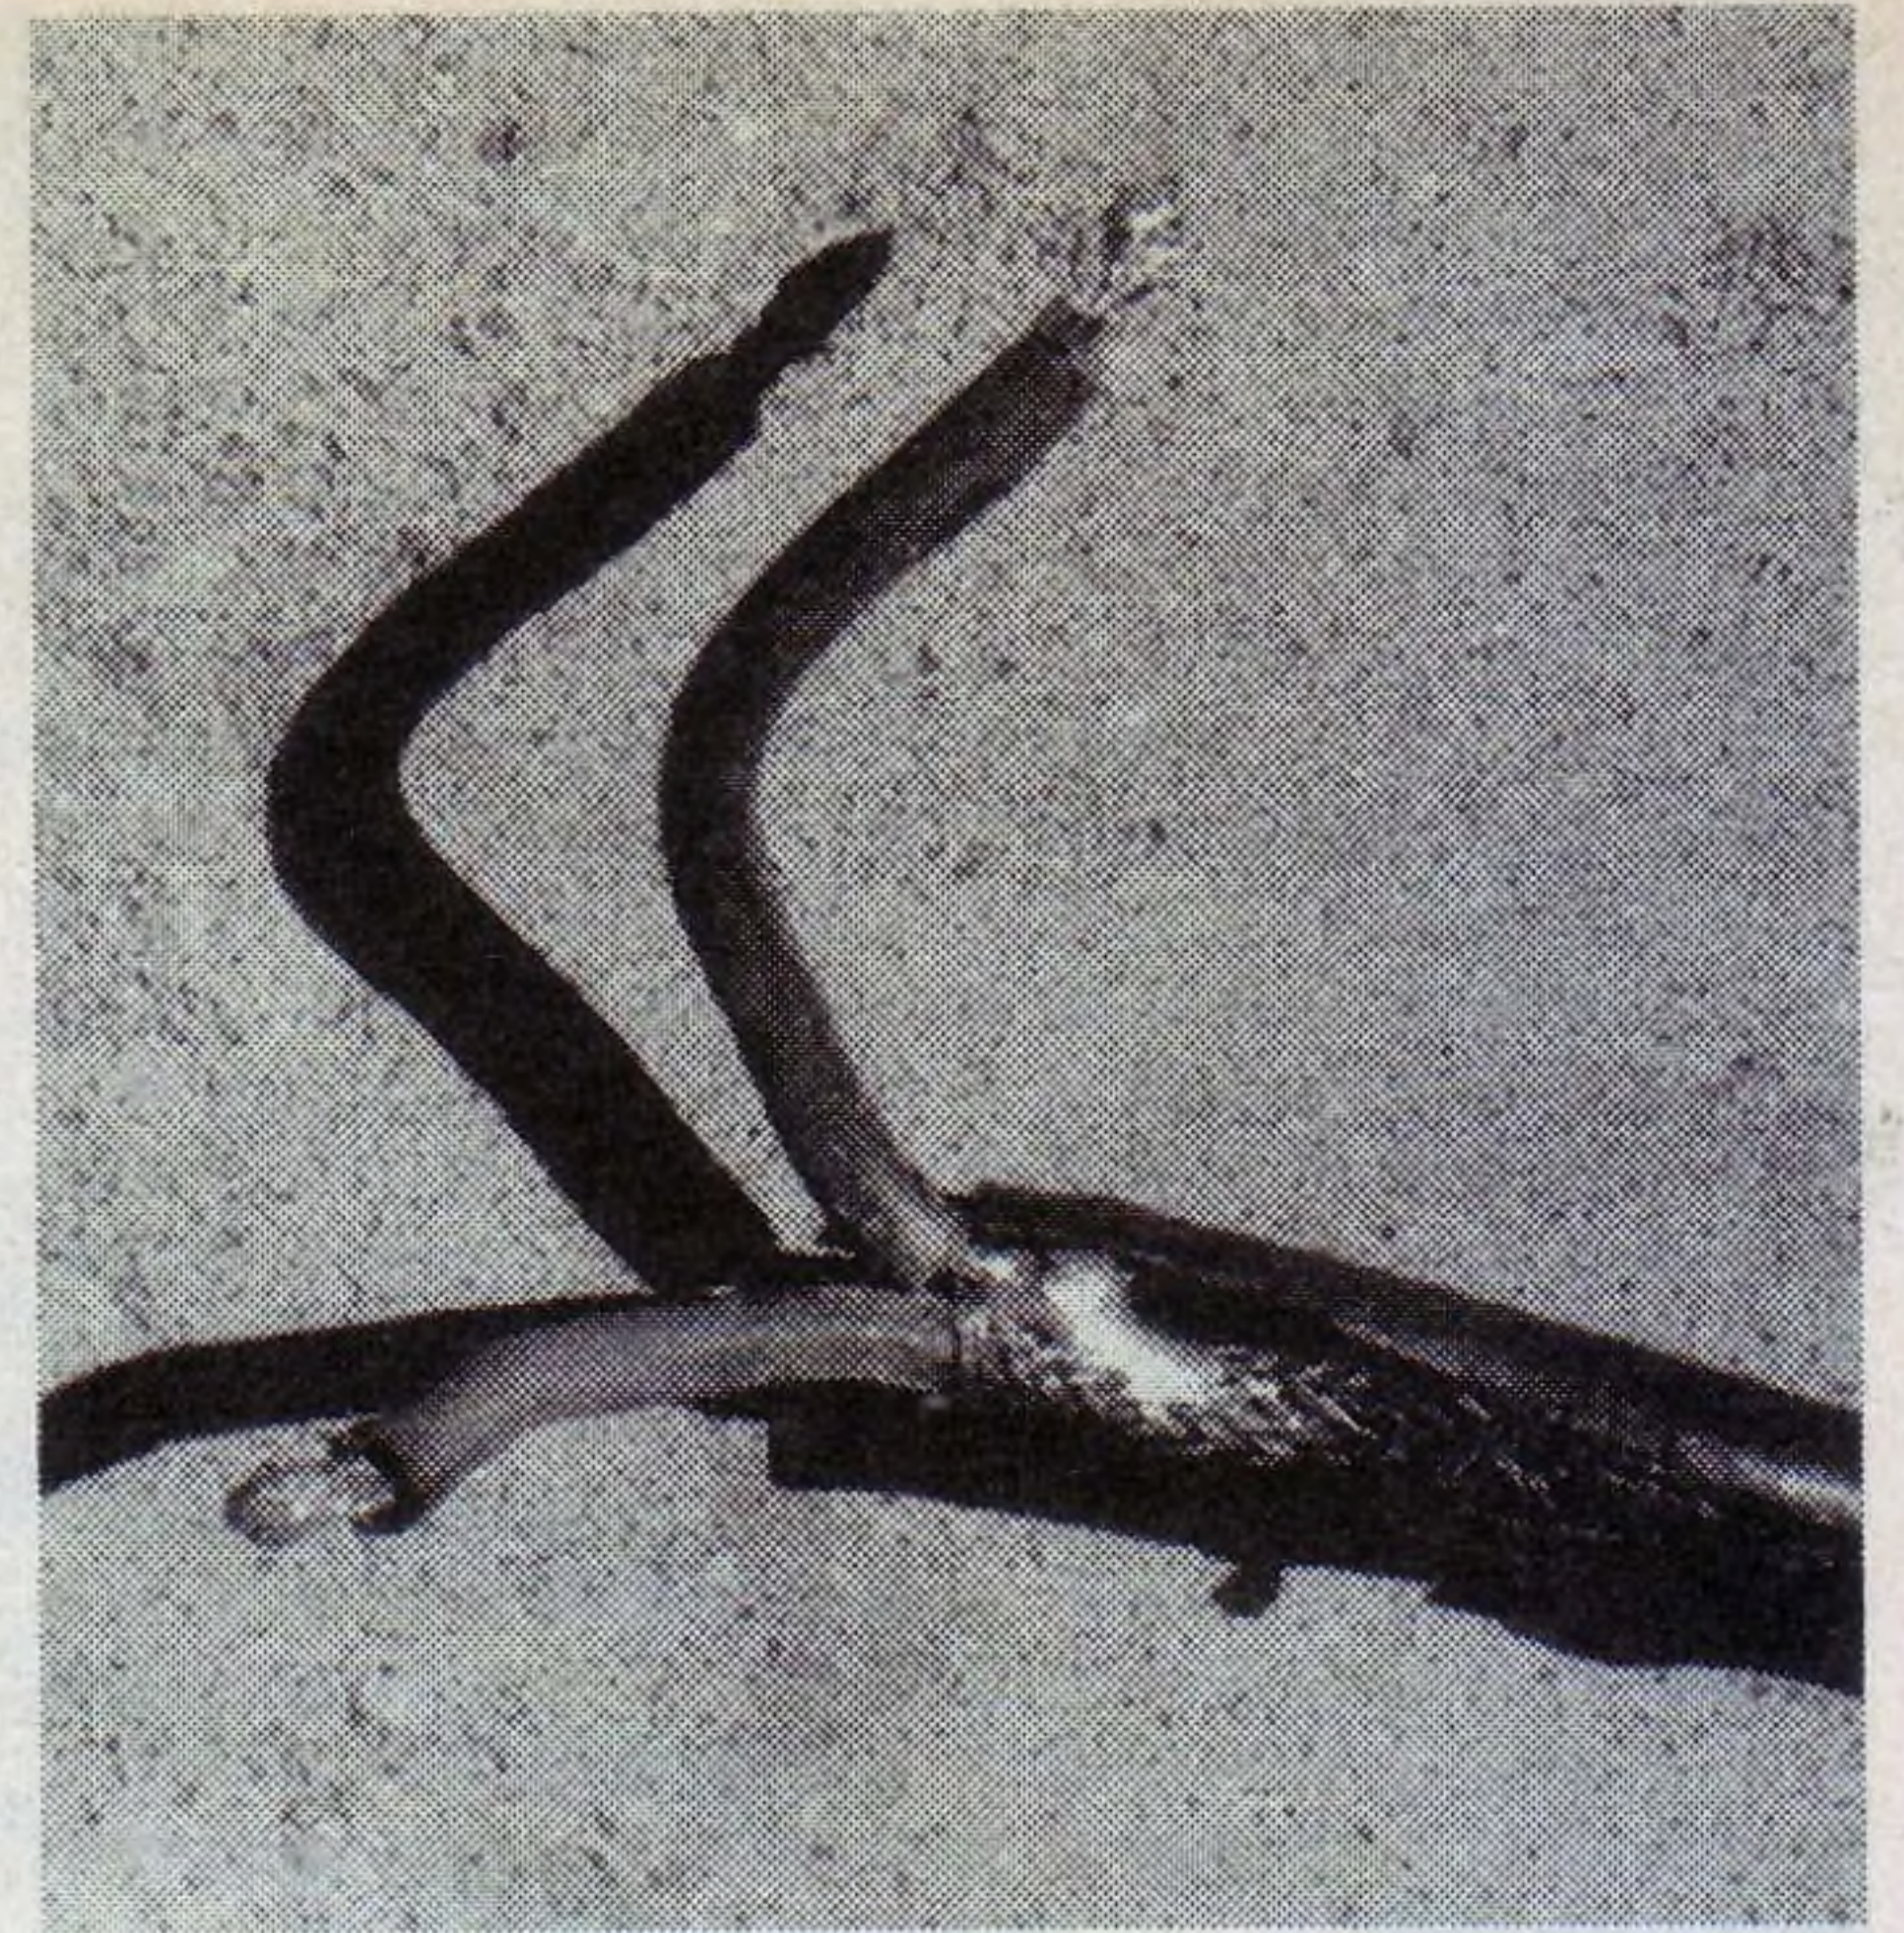
This photo shows the troublesome shielded wire in the old HMV radio. The short circuit was at the solder joint where the heat of the soldering iron had damaged the rubber insulation of the inner lead. This problem has been encountered before in other old receivers, so it was not an isolated incident.

A quick investigation revealed a similar fault in this unit – the inner wire from the pick-up socket was found to be shorting where a wire had been soldered to the shielding to make an earth connection. Apparently, the heat of the soldering iron had damaged the rubber insulation between

the inner wire and the shield, which eventually shorted and muted the receiver.

The shielded lead probably gave no trouble until it was disturbed and that most likely happened when the capacitors were replaced. After replacing the shielded cable, one would expect everything to work OK but there were still problems!
