Salvaging An Autotransformer

BY JULIAN SIENKIEWICZ

On the project bench or under your Christmas tree, this troubleshooting device from the vacuum-tube era is just as important today.

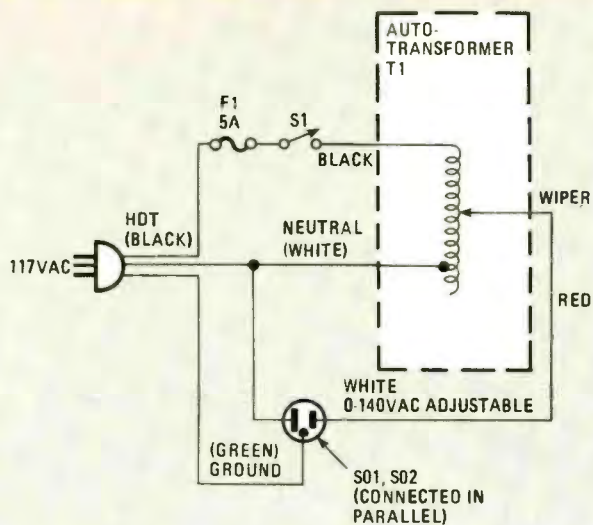
Fig. 1. Here is the wiring diagram for the modified autotransformer. The original fuse holder was reused. The power switch and two-terminal outlet were discarded. Colored insulated wires (black-hot, red-variable AC, and white-neutral) were attached to the short leads on the stripped autotransformer to assist in goof-proofing the final wiring.

cord and clamped it to the electrical box. The wires from the autotransformer were passed into the box to begin the wiring of the box. In Fig. 1, as in all electrical circuits, the white wires are ground and connect to the silvered screw terminals on the AC outlet. The black wire (it's electrically hot) from the autotransformer goes to the fuse. The red wire from the wiper terminal is also hot and connects to the brass-screw terminal on the outlet.

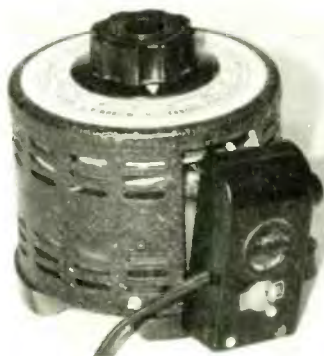
Here's the autotransformer ripe for repair. With a little effort, it turned out to be a worthwhile test-bench tool.

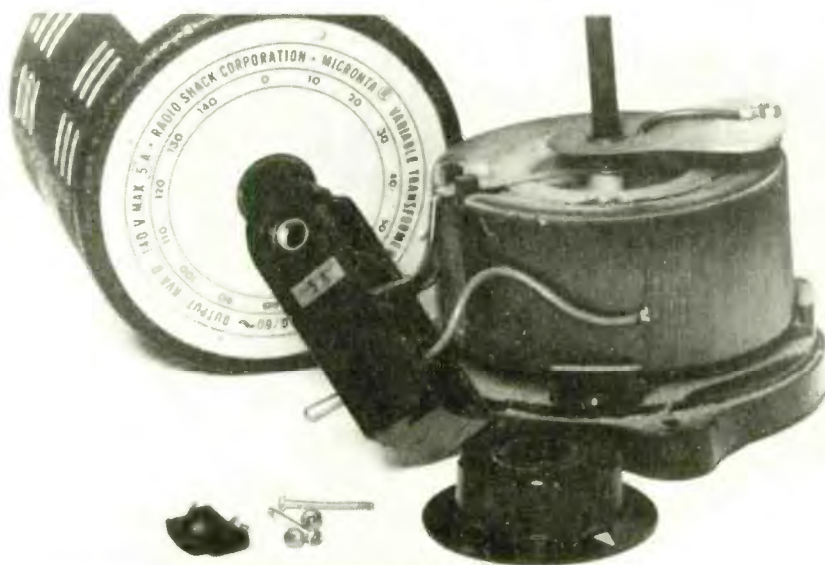
The autotransformer is a one-coil device wound on a cylindrical iron form with the AC line connected across the bottom of the coil and to a tap on a copper turn about 85% of the distance from the first tap. A sliding contact selects one of the coils to pick off an AC voltage. The plastic piece hanging from the leads of the winding was discarded because it was damaged and the single outlet was neither polarized nor of the three-terminal type.

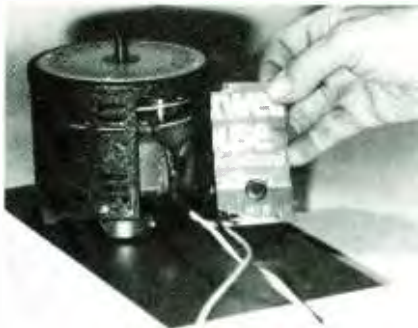
A piece of a two-pound coffee can was used to close up the hole left in the autotransformer's safety shield. The can had an almost perfect curve and indented ribs for reinforcement. A hole was drilled through it. Once the shield was complete, it was sprayed with a flat black paint. After drying, a grommet was installed.

fuse holder and AC outlet, and passed the line cord to the outside, was broken beyond repair. That was not a total loss, because I was not satisfied with the two-terminal AC outlet used in the original unit. I wanted a three-terminal outlet, and a strong contact surface in the outlet to grab the prongs of the AC plug. So I discarded the plastic piece and covered the opening in the cylindrical housing with a piece of sheet metal cut from a 2-pound coffee can. The price of the can was certainly right. The section I had cut from it had almost the same radius as the metal shield, and its indented ribs (common to coffee cans) made it very rigid. I drilled a hole through it and inserted a grommet in it to protect the insulation of the wires to be passed through it. The metal was painted black before installation, and, when finished, the fabricated cover looked as if it was installed by the manufacturer.

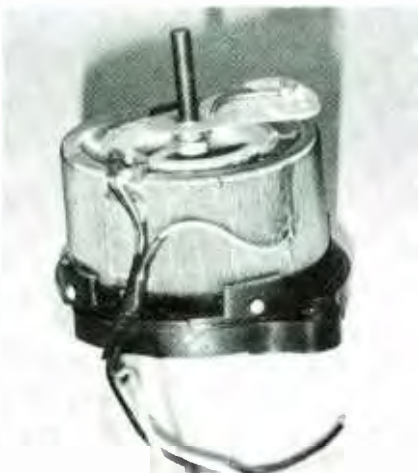
The leads of the cylindrical winding were too short. Colored leads (a red, a black, and a white) were added to make wiring easy and goof-proof. The splices were soldered, and black plastic tape was used to insulate the splices.

The interconnecting leads from the autotransformer were too short to reach an external electrical box, so they were extended using color-coded stranded wire. The splices were soldered and electrically insulated with black plastic tape.

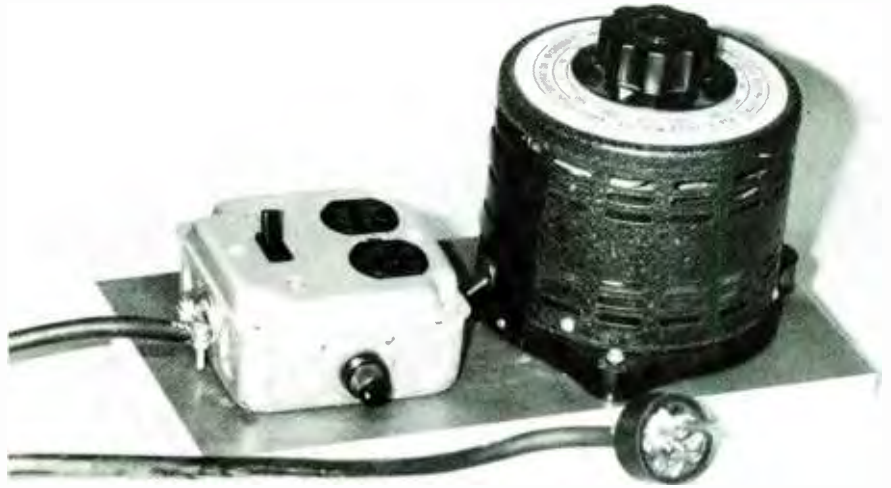
Here's the autotransformer mounted on the board with the electrical box mounted and wired. Note that the fuse holder is easy to reach for fuse replacement.

Electrical Work. The autotransformer was secured to the board with wood screws. A 4-in. square electrical box and a face plate for one duplex outlet with toggle switch, was installed on the board. I installed a new three-wire power

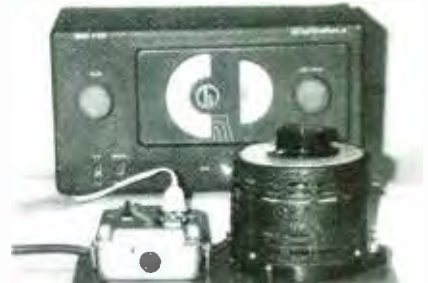
More than just a Christmas-tree bulb saver, the autotransformer is used here to uncover a failing part in an old relic—a Hallicrafters SX-38B shortwave receiver.

The first task I designated to the autotransformer was to discover a fault in an antique tube-design Hallicrafters SX-38-B shortwave receiver. The receiver operation was intermittent, but the trouble never lasted long enough to locate the fault. Voltage was applied and I cranked the autotransformer up to 127-volts AC, when the fault occurred and held. The problem was then traced to a defective wax-paper capacitor.
