# VINTAGE RADIO

## AWA Radiola Model 137 the “Fisk” recreated

Rob took an old radio chassis he inherited from his grandfather, fixed it and built a cabinet for it. The style is 1930s Art Deco, but with a less ornate and much smaller cabinet than the original. He had to repair or replace quite a few of the original components, and figure out how to get it working with few circuit details to go on. The result is a new-looking radio with the style and the sound of the 30s.

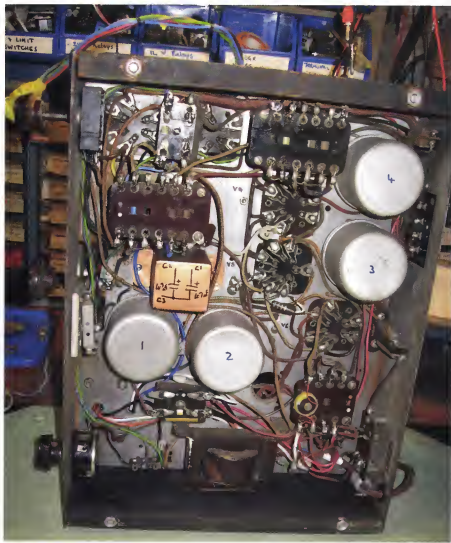
The underside of the chassis is quite neat. The silver cans marked 1-4 contain the coupling transformers, while the two copper boxes on the underside and top (left of the dial) of the chassis contain electrolytic capacitors.

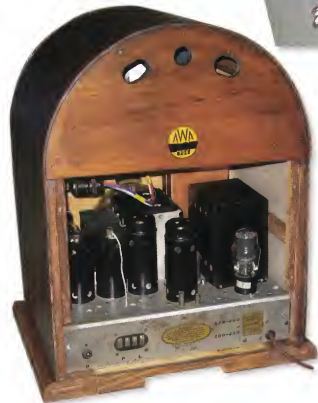
◀ The new case is custom-built in an Art Deco style, and is much smaller than the original console cabinet (shown at right). The rear of the new case was affixed with an old AWA employee badge and a replica logo was made for the front.

The base is made from recycled Australian cedar, as are the vertical pieces on either side, while the main part of the face is veneered in teak. The top arch is stained plywood. The badge in the middle of the speaker is a replica AWA Fisk Radiola.

I cut and shaped brass into a rounded rectangular shape for the dial feature. I had "Model 137" engraved under the dial opening. On the rear, I fastened an AWA employee badge that I found in a box of old badges.
