# ELLIS ON ANTIQUE RADIO

## A little housekeeping is worth a lot of troubleshooting!

□ DURING THE LAST COUPLE OF months, we've been working on the restoration of a Zenith 7S232 BC-SW set. The set is a large table-model radio with some very interesting features, including a tuning dial of unusual and beautiful design. Called a "shutter-dial," it contains a mechanical arrangement to automatically display the correct set of calibrations for the band that is in use. The radio also features flywheel-aided vernier tuning, a magic-eye tuning device, and individual indicator scales for the tone control, volume control, and bandswitch.

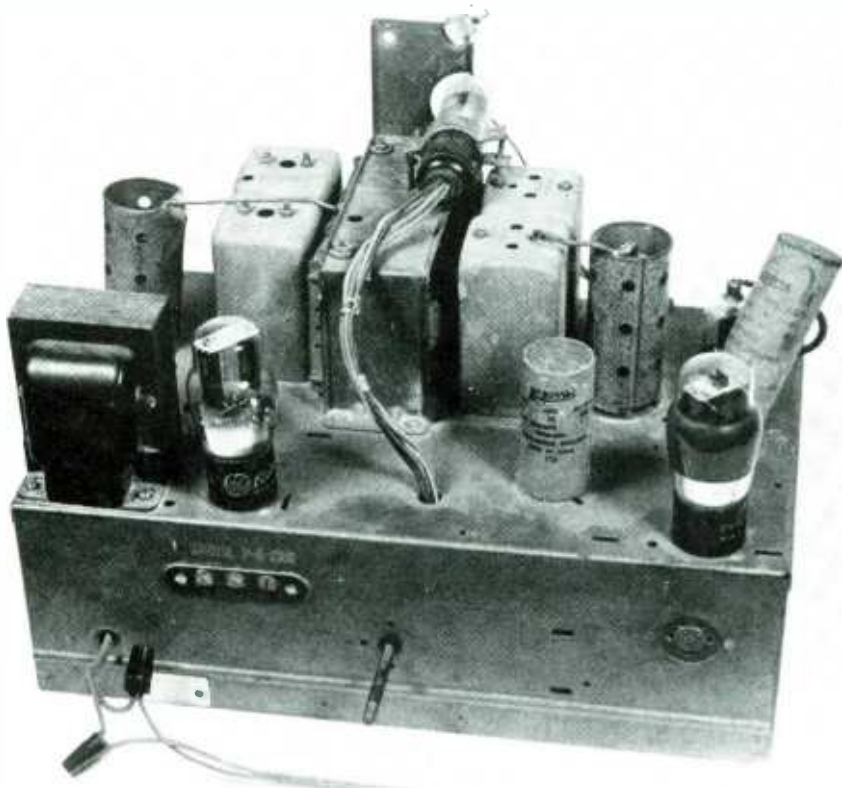
Looking at the top of the chassis, I could see that both tube shield cans were improperly mounted on their bases and very loose. One of the shields had been crudely pinched at the top to give the grid lead enough clearance to extend much farther down into the can. That had been done so that the original glass ("G" style) 6A8 tube could be

Here is how the set looked when as this month's restoration work was started. Note the stretched grid wire and pinched shield can on the tube behind the power transformer.

Luckily, I happened to have a good "G"-type 6A8 in my tube collection. With that substituted for the metal version, there was no longer any need for the shield-can top to be pinched in. Straightening out the dent was fairly easy and left only a few visible ripples. As it turned out, though, I didn't have to use the repaired can because I also happened to have an identical—and perfect—replacement in my junkbox.

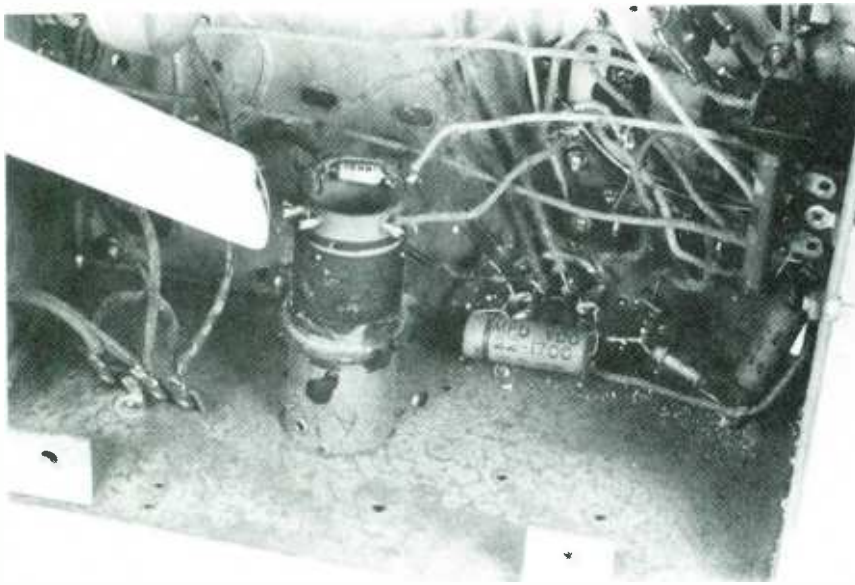
Using a vacuum cleaner helped remove spider webs and other accumulated debris from the tight spaces underneath the chassis. Once that was done, it was time to get down to the serious troubleshooting.

Conditions under the chassis were just about what you might expect of a radio that was probably stored in a basement or garage for about thirty years, and my first official act was to get out the vacuum cleaner to remove the dust, debris, and cobwebs. In areas that were especially dirty, the vacuum worked better after the debris was first loosened with a soft brush.

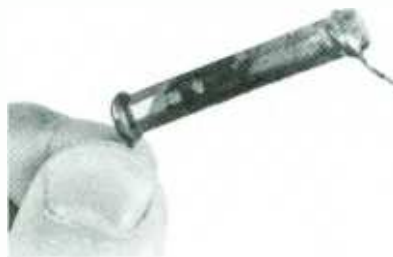
The overheated burned resistor was replaced with a new one of the proper value. Finding problems like that up front eases troubleshooting later.

As I scrutinized all of the components for signs of overheating or other failure, my eye was almost immediately drawn to a big orange resistor that proved to be the screen dropping resistor for the 6K7 IF amplifier. At some time in the past, the resistor had become so hot that much of its paint had burned off. The scorch marks on the chassis above the component also suggested severe overheating.

Without the set's schematic, I would never have known that the unit was supposed to be a 33K resistor. The color code was unreadable and—because of the overheating—the resistance had almost doubled (I measured it at 65K). I replaced that part with one of the proper value, making a mental note to check for overheating next time I turned on the set. Whatever circuit condition had caused the original overheating might still be a problem.

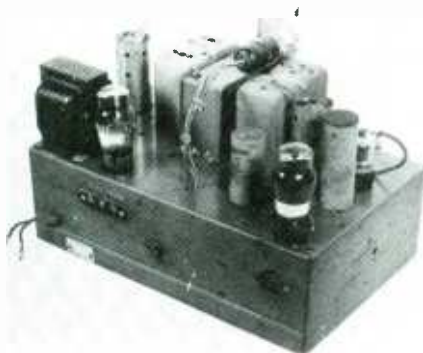
**Here's how the set appears as we conclude this month's restoration work. The installation of a proper, "G"-type tube in the shield can behind the power transformer gives the grid wire enough clearance without pinching the can top.**
