Vintage Radio

Philips 1953 portable 5-valve model 148C radio

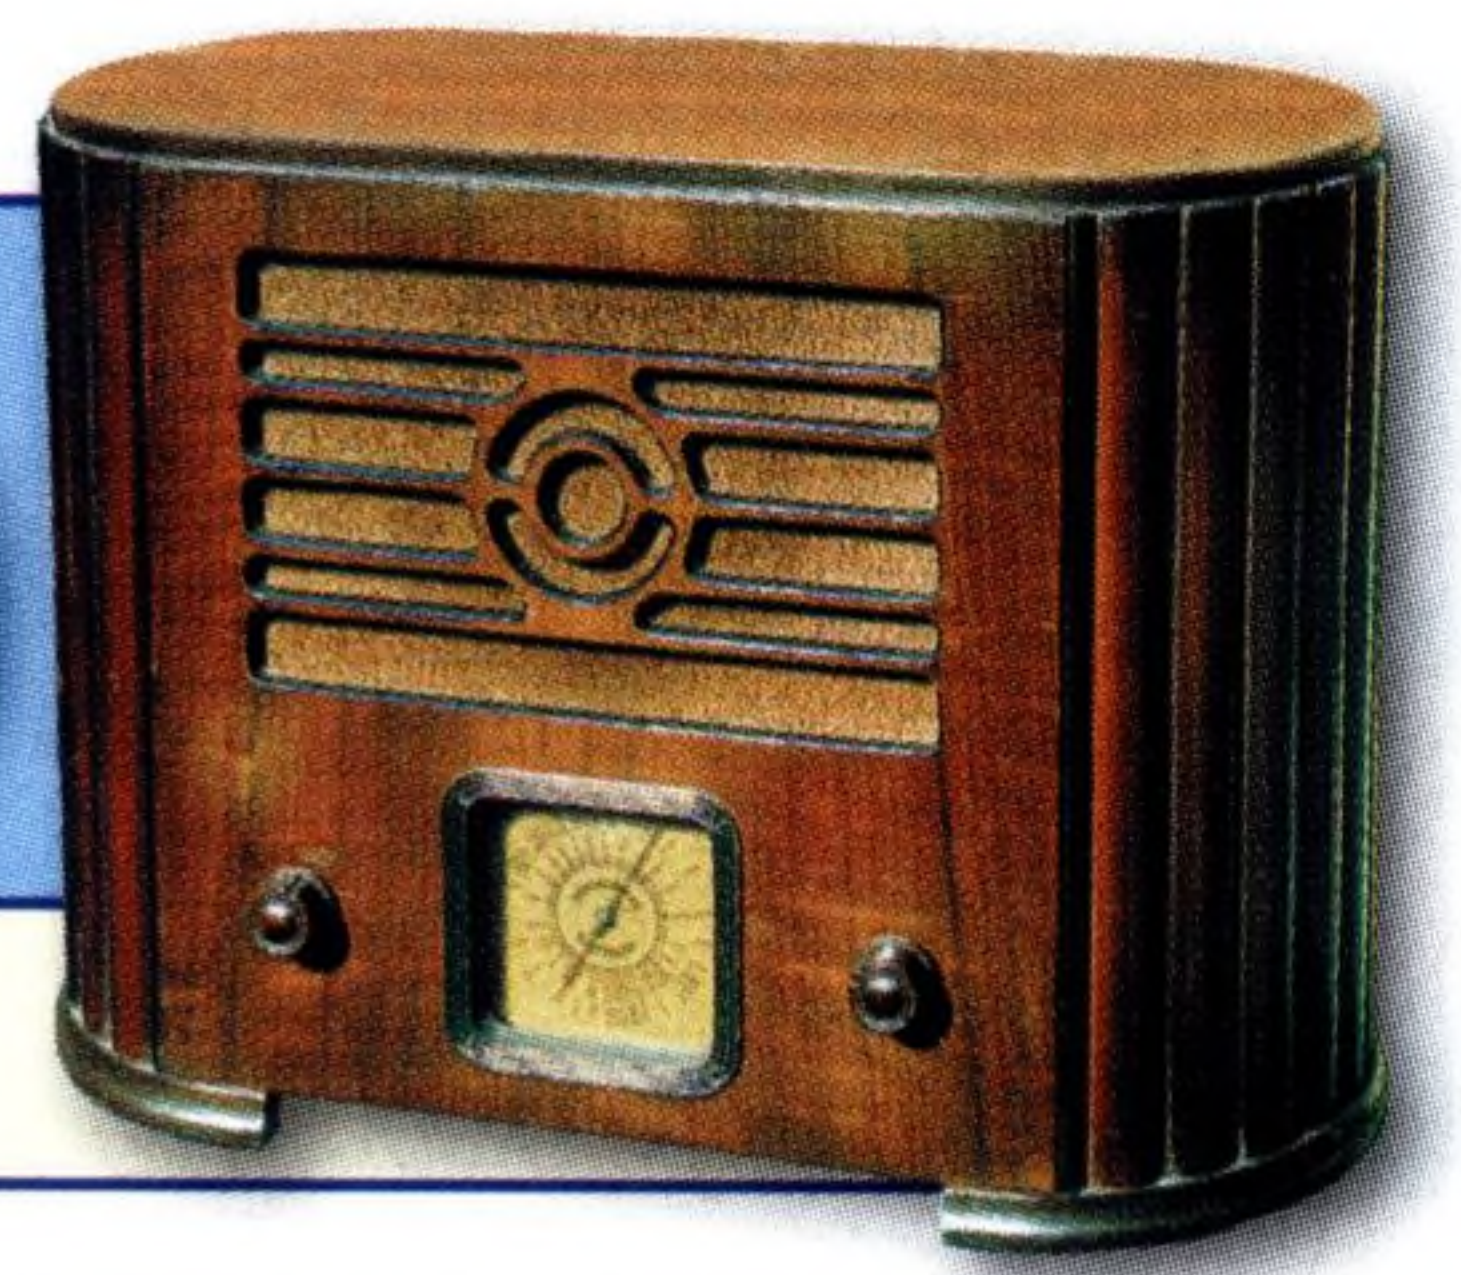
The Philips 148C was one of a series of portable radios produced by Philips under different brand names, including Mullard and Fleetwood. All had the same construction and broadly similar circuitry. Their common case was an interesting design, with all controls and the dial concealed by a shutter. Finally, the case panels were made from aluminium, a fairly exotic material in the later 1940s and 1950s.

Regardless of the lightness of aluminium, the weight of the Philips 148C is a substantial 6.3kg, even without batteries. In fact, it is only the outer panels which are made from aluminium while the end panels are of Bakelite. The chassis is steel and the internal construction is fairly conventional for the time.

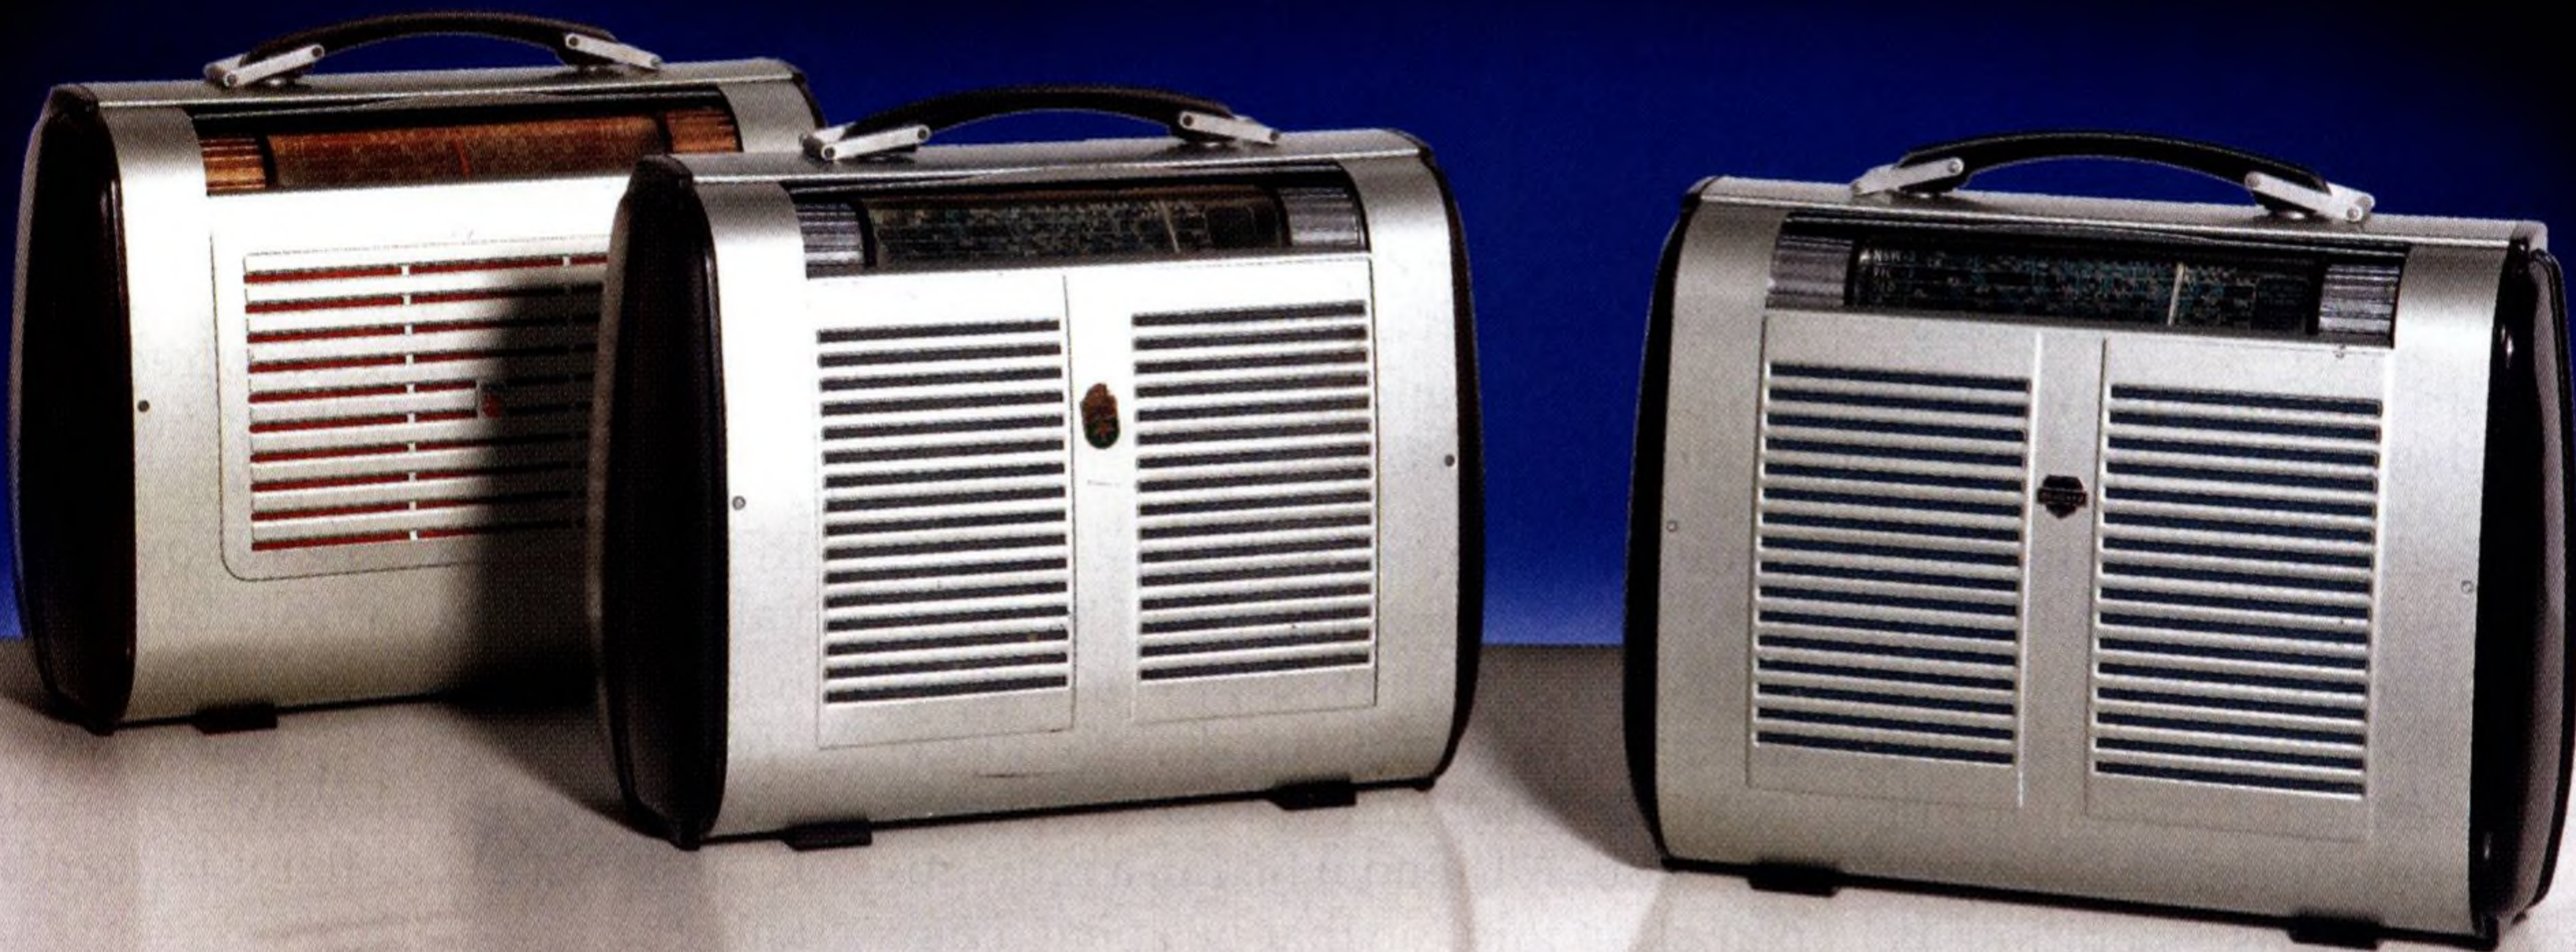
The aerial coils are wired in series and act with the first gang of the three gang tuning capacitor (C1) to provide RF input to the 1T4 RF preamplifier valve. A second tuned circuit involving (C2 and L5) feeds signal to the grid of the 1R5 mixer-oscillator valve. The 1R5 additionally receives tuned input from the local oscillator formed by C3 and L8.

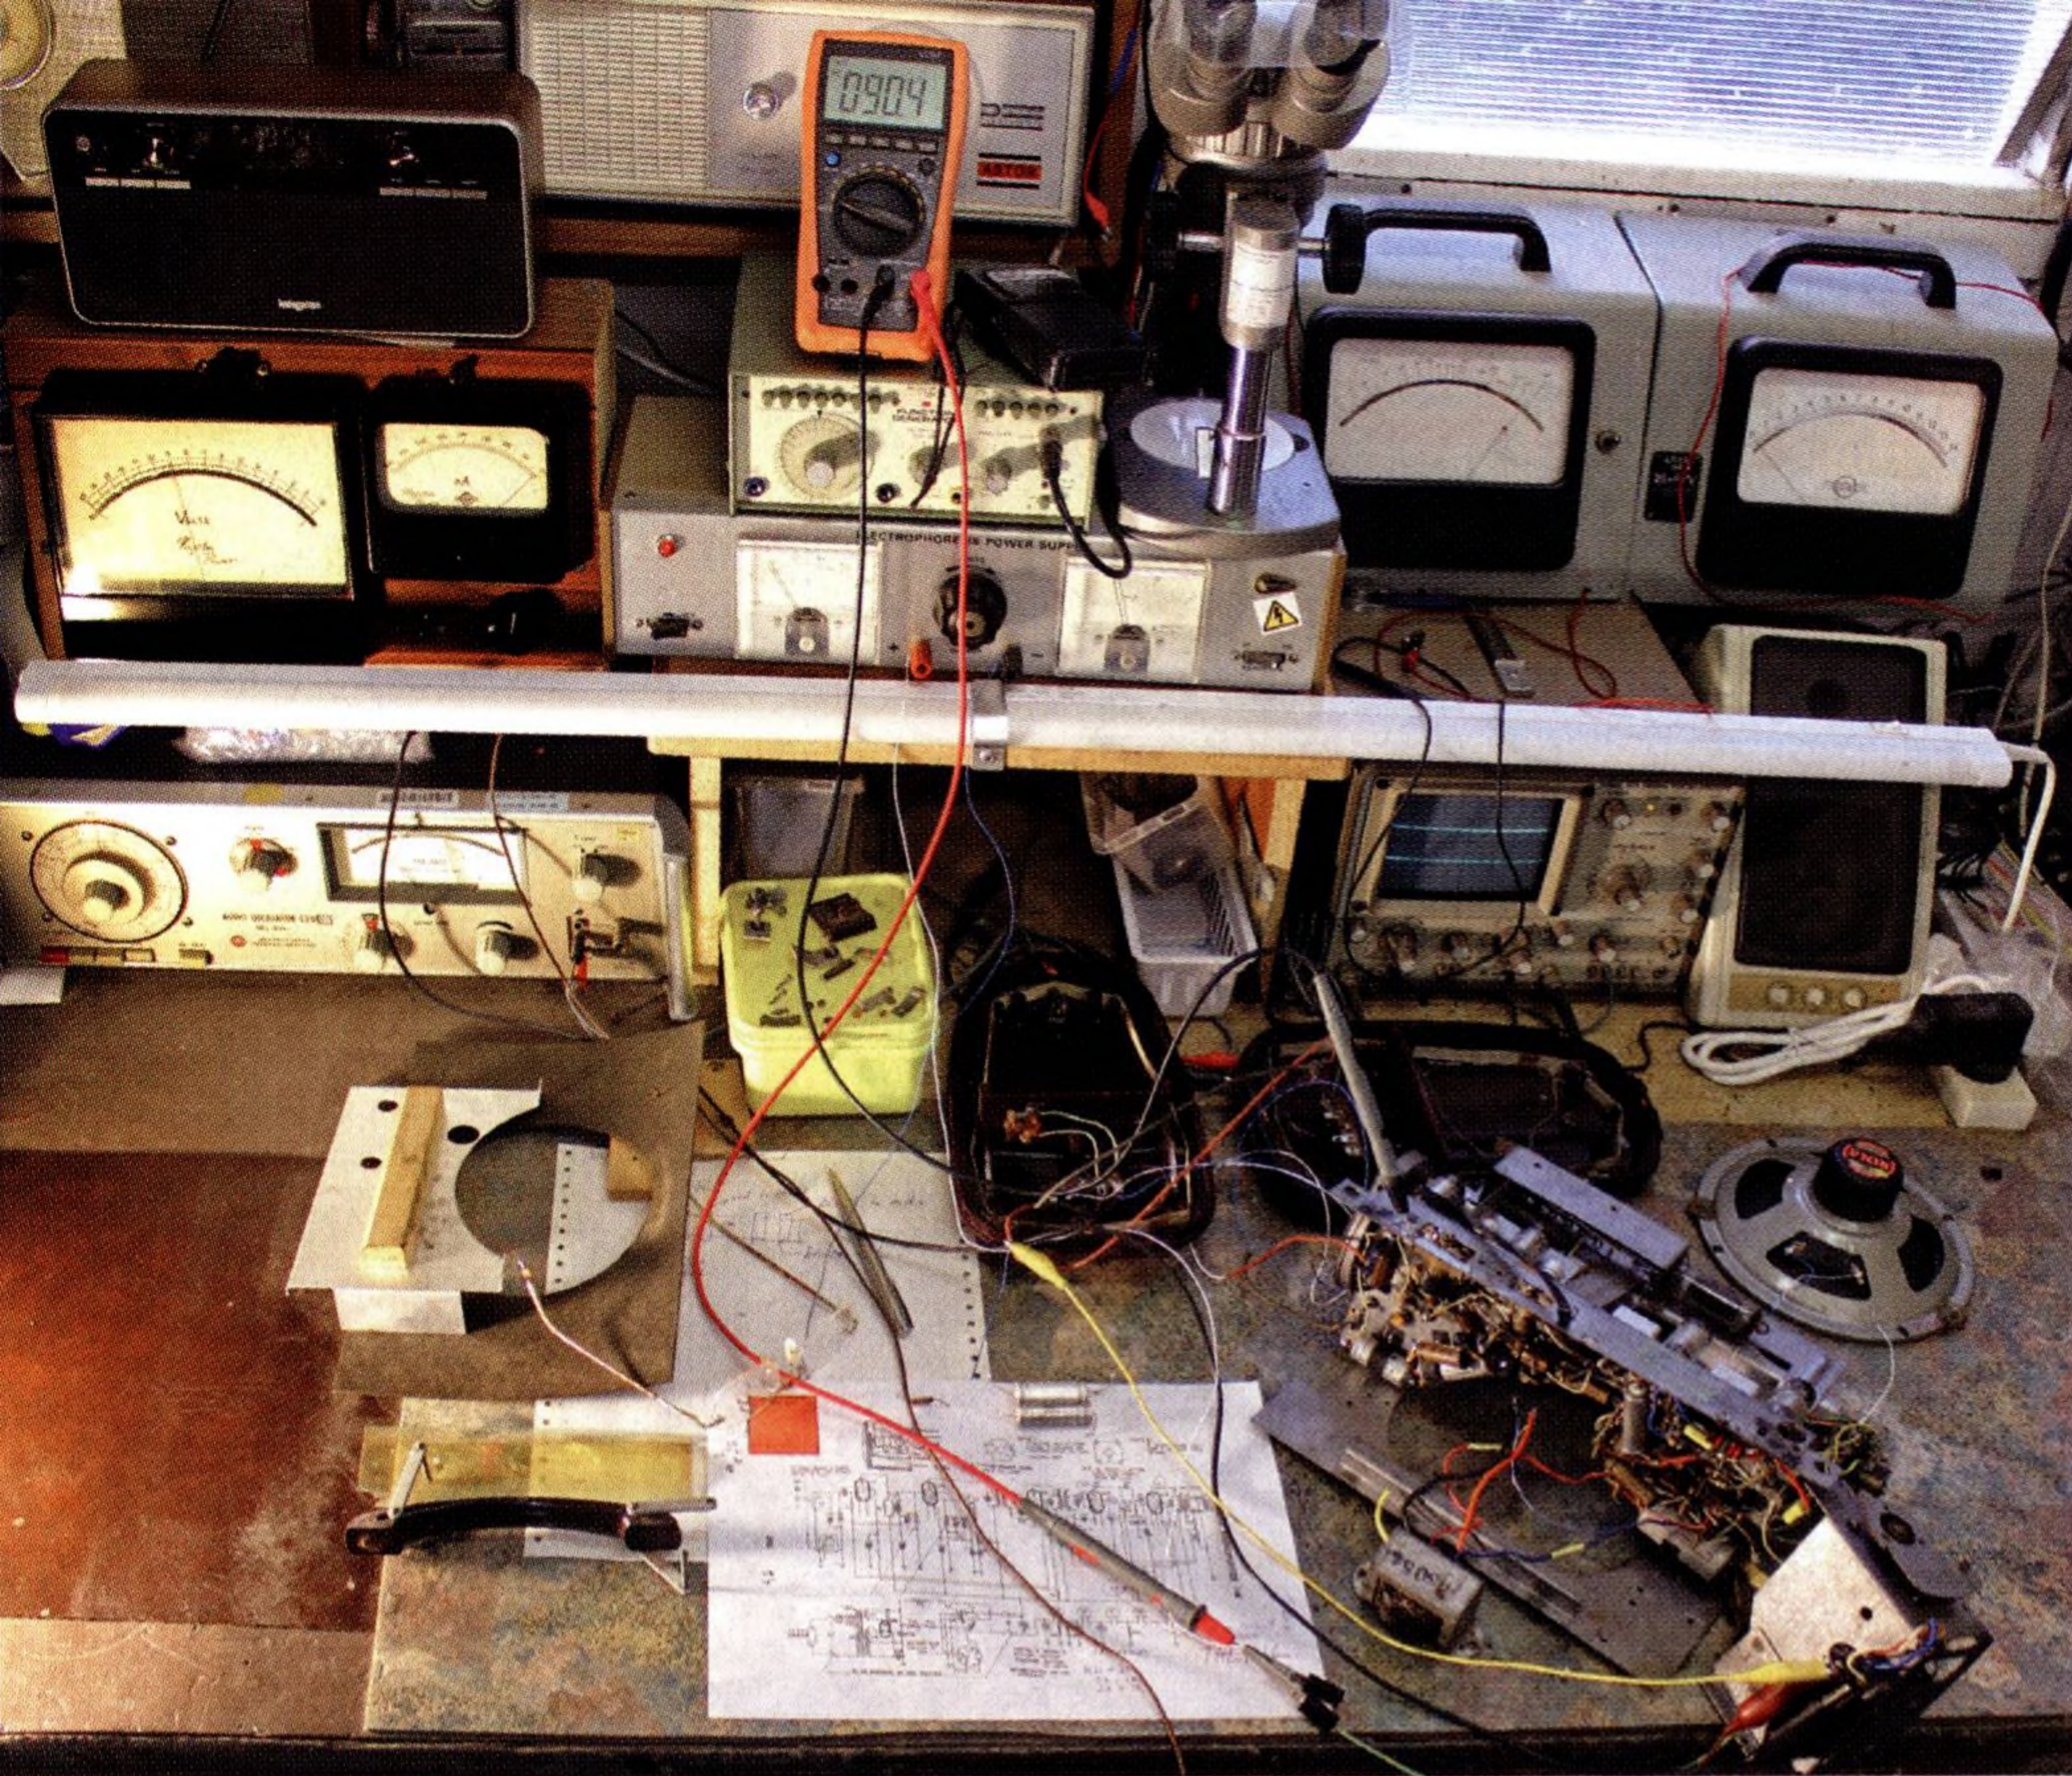
Opening the shutter on the front of the case reveals the two controls (one for volume and one for tuning), at opposite ends of the slide-rule dial.

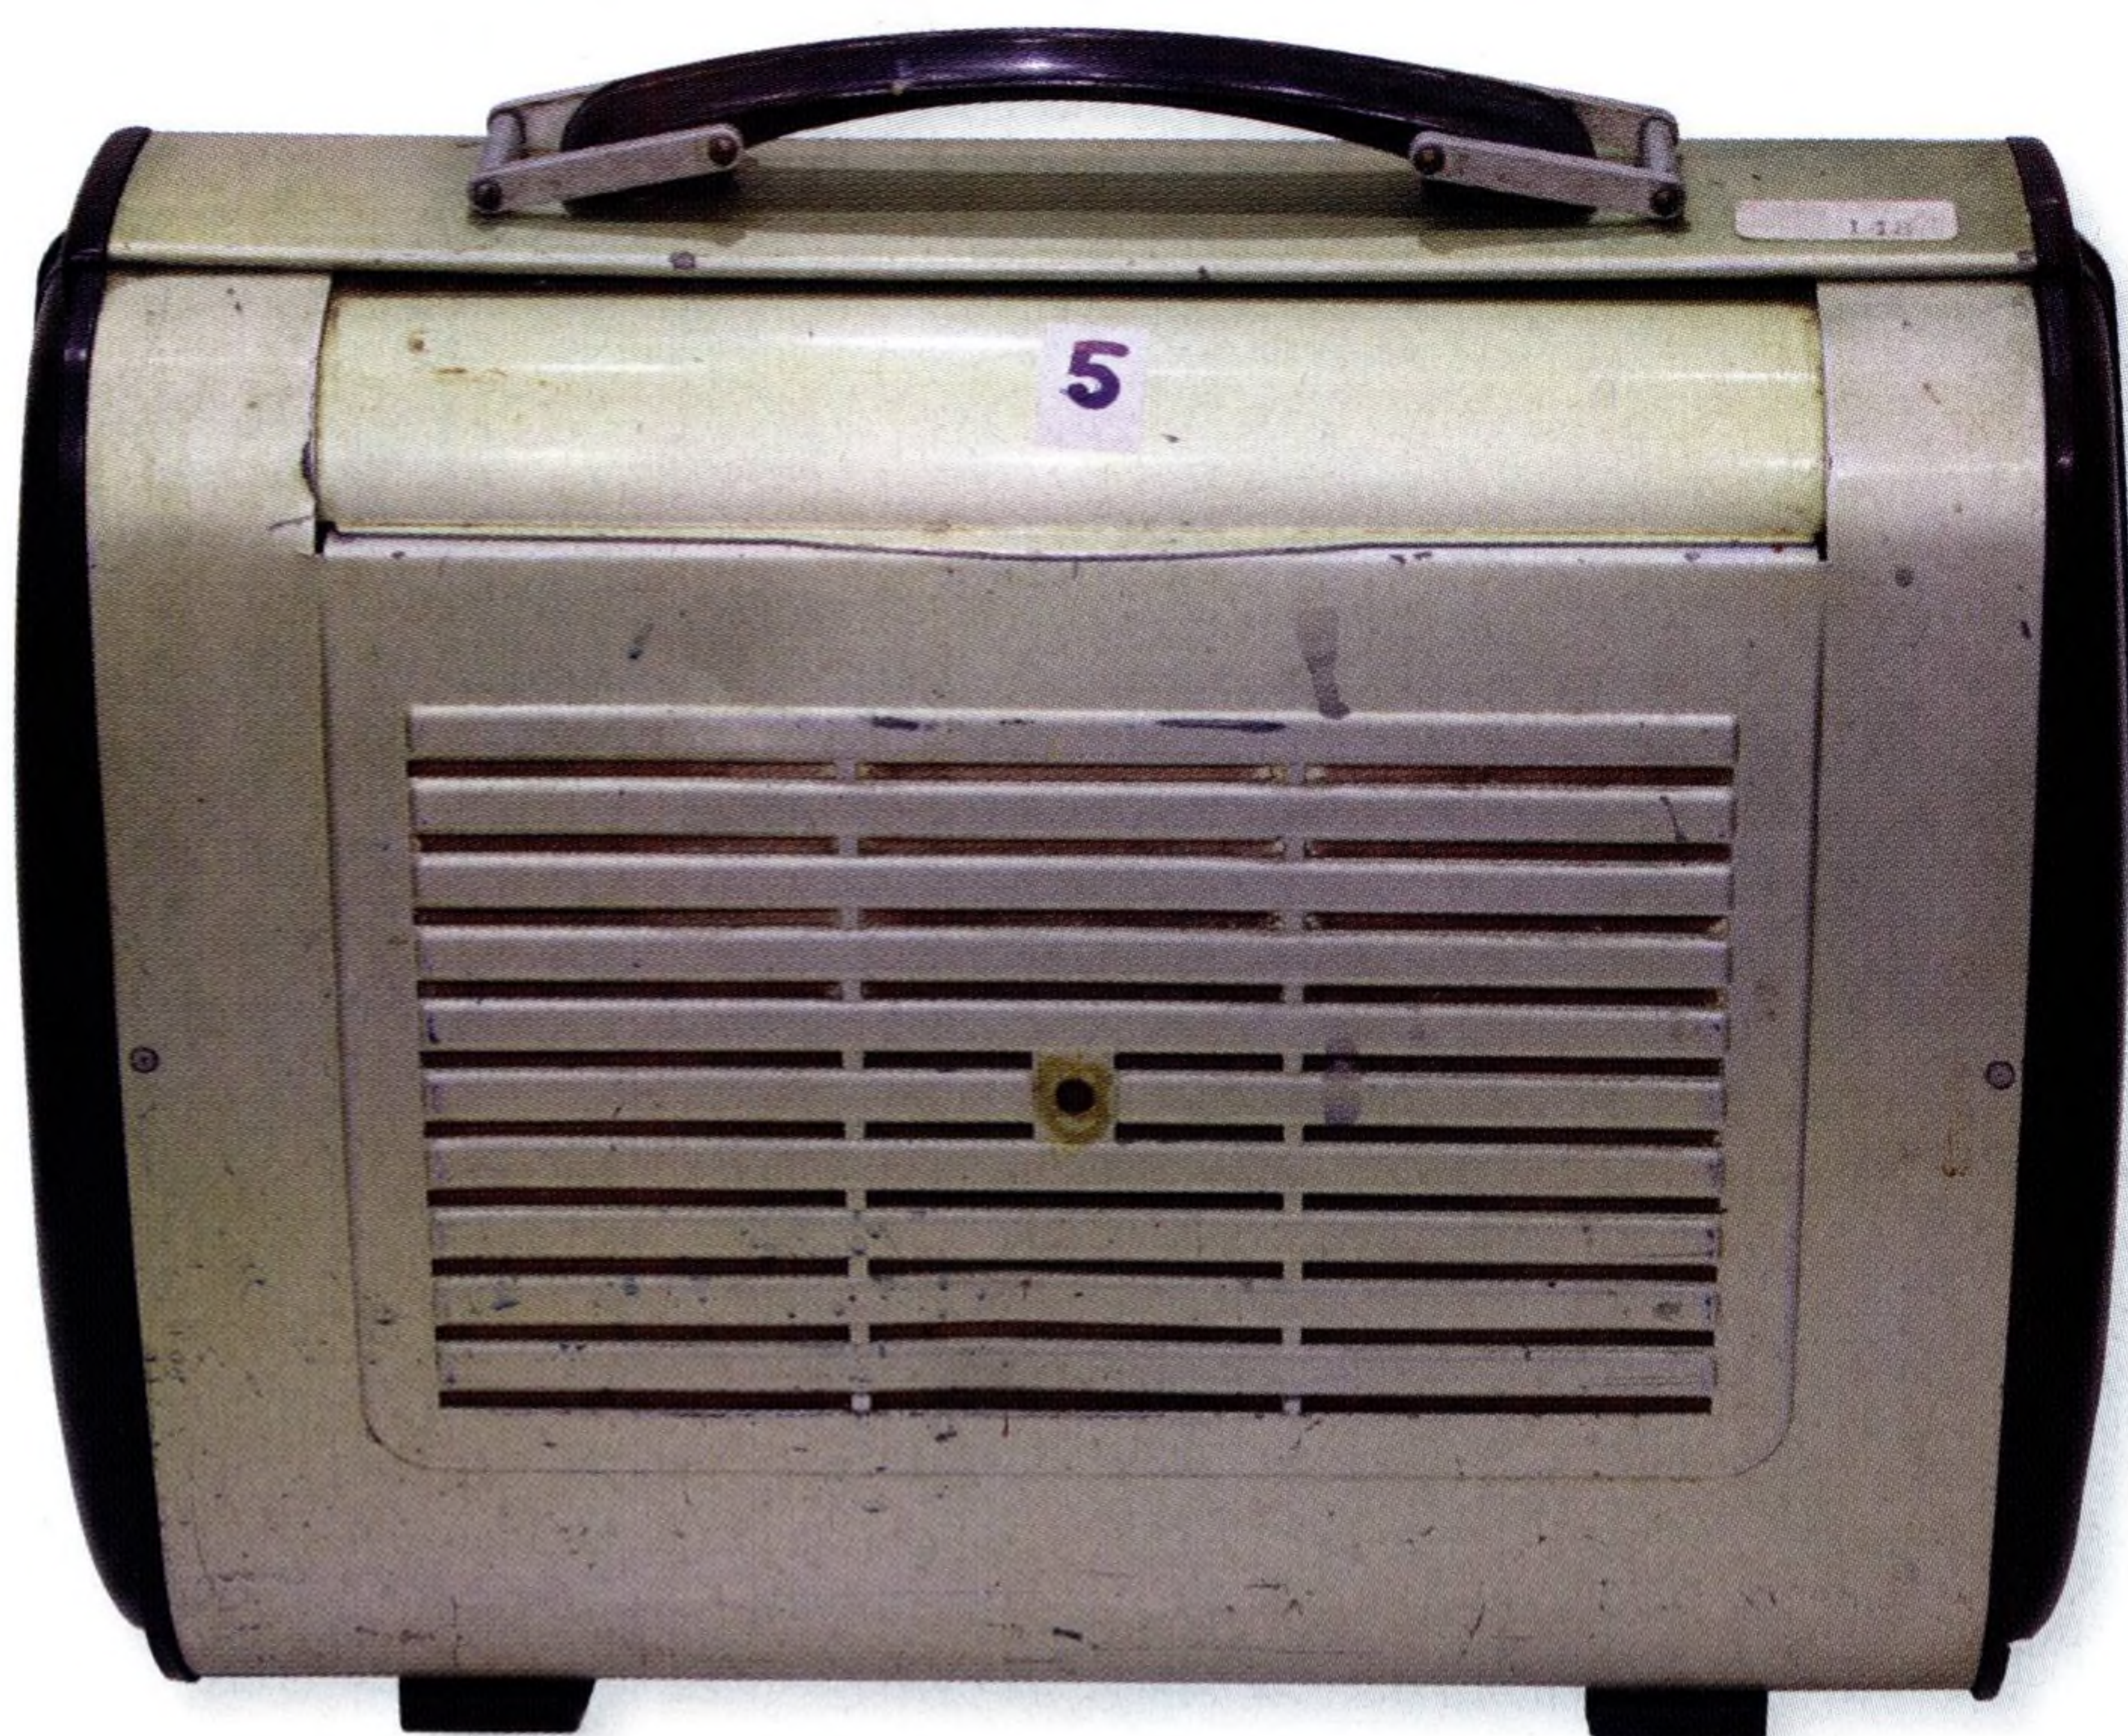
The unrestored aluminium case with the dial shutter closed and badge removed. The radio does not have an on/off switch, but instead is turned on by opening the shutter.

The anodised aluminium case had developed a patina of green and looked tired. After cleaning with a degreaser it was resprayed with an automotive chrome finish.

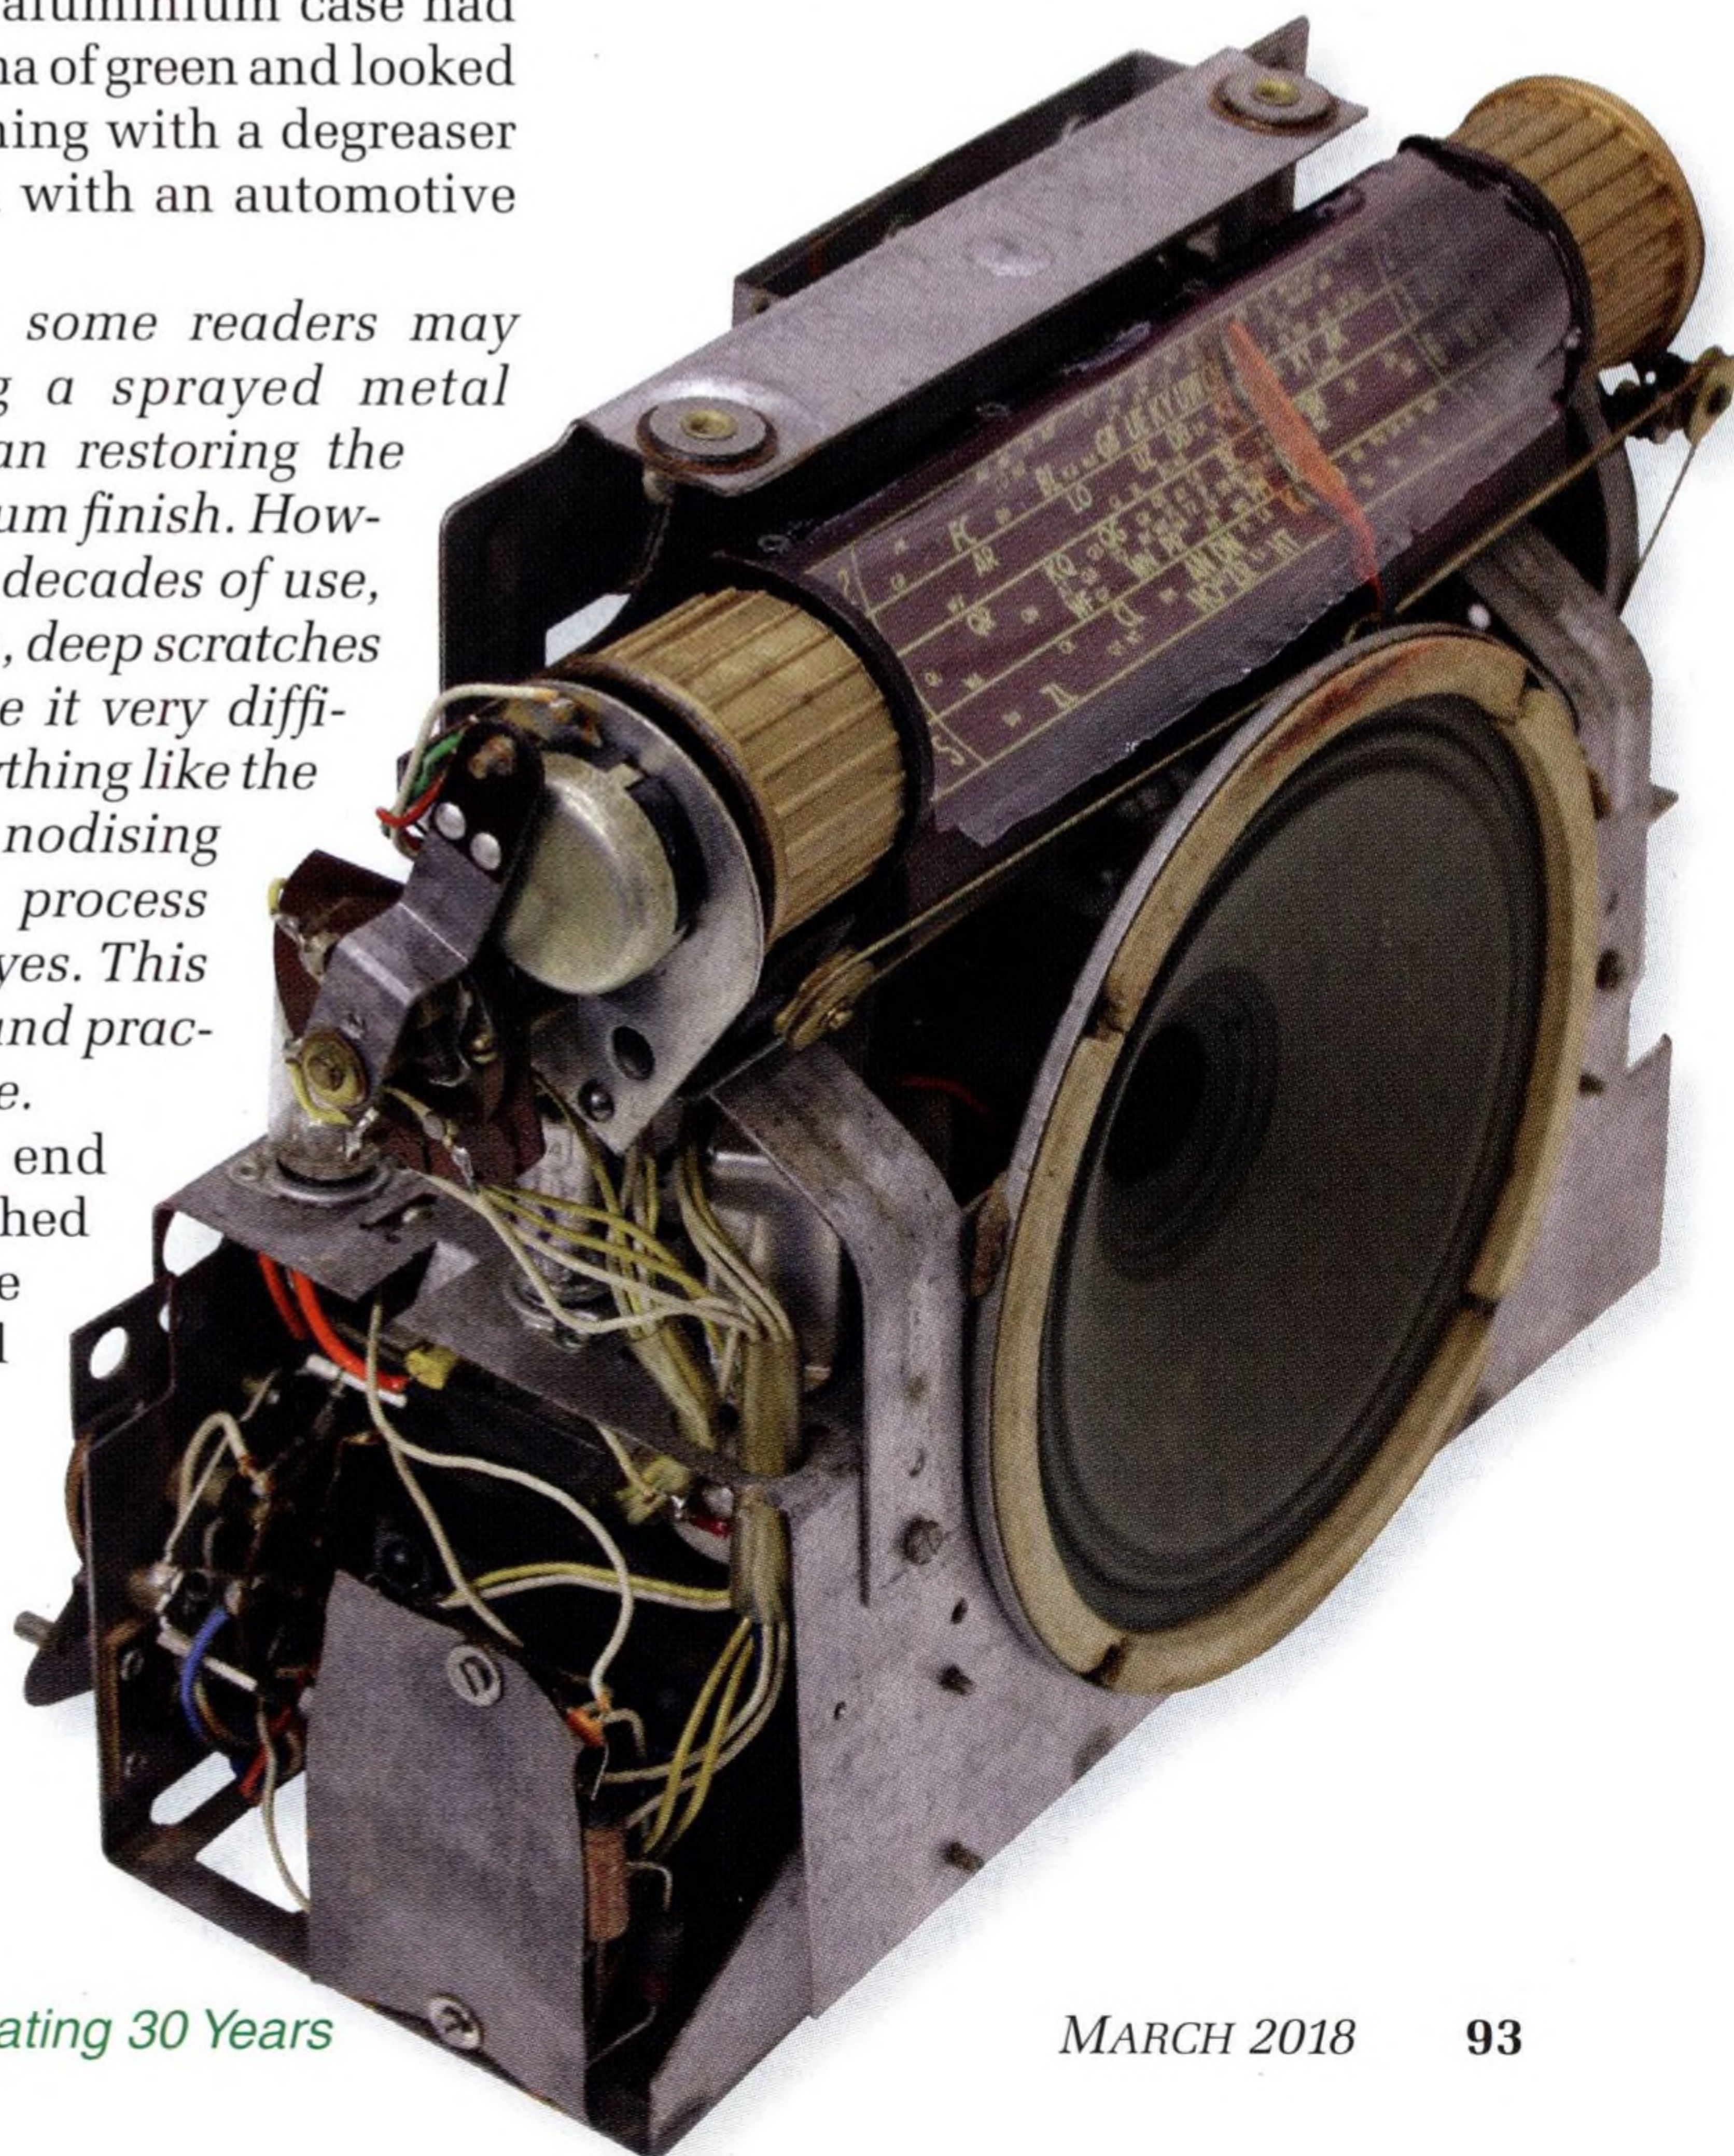
This end view shows part of the mains on/off switch which was operated by the shutter at the front of the case.

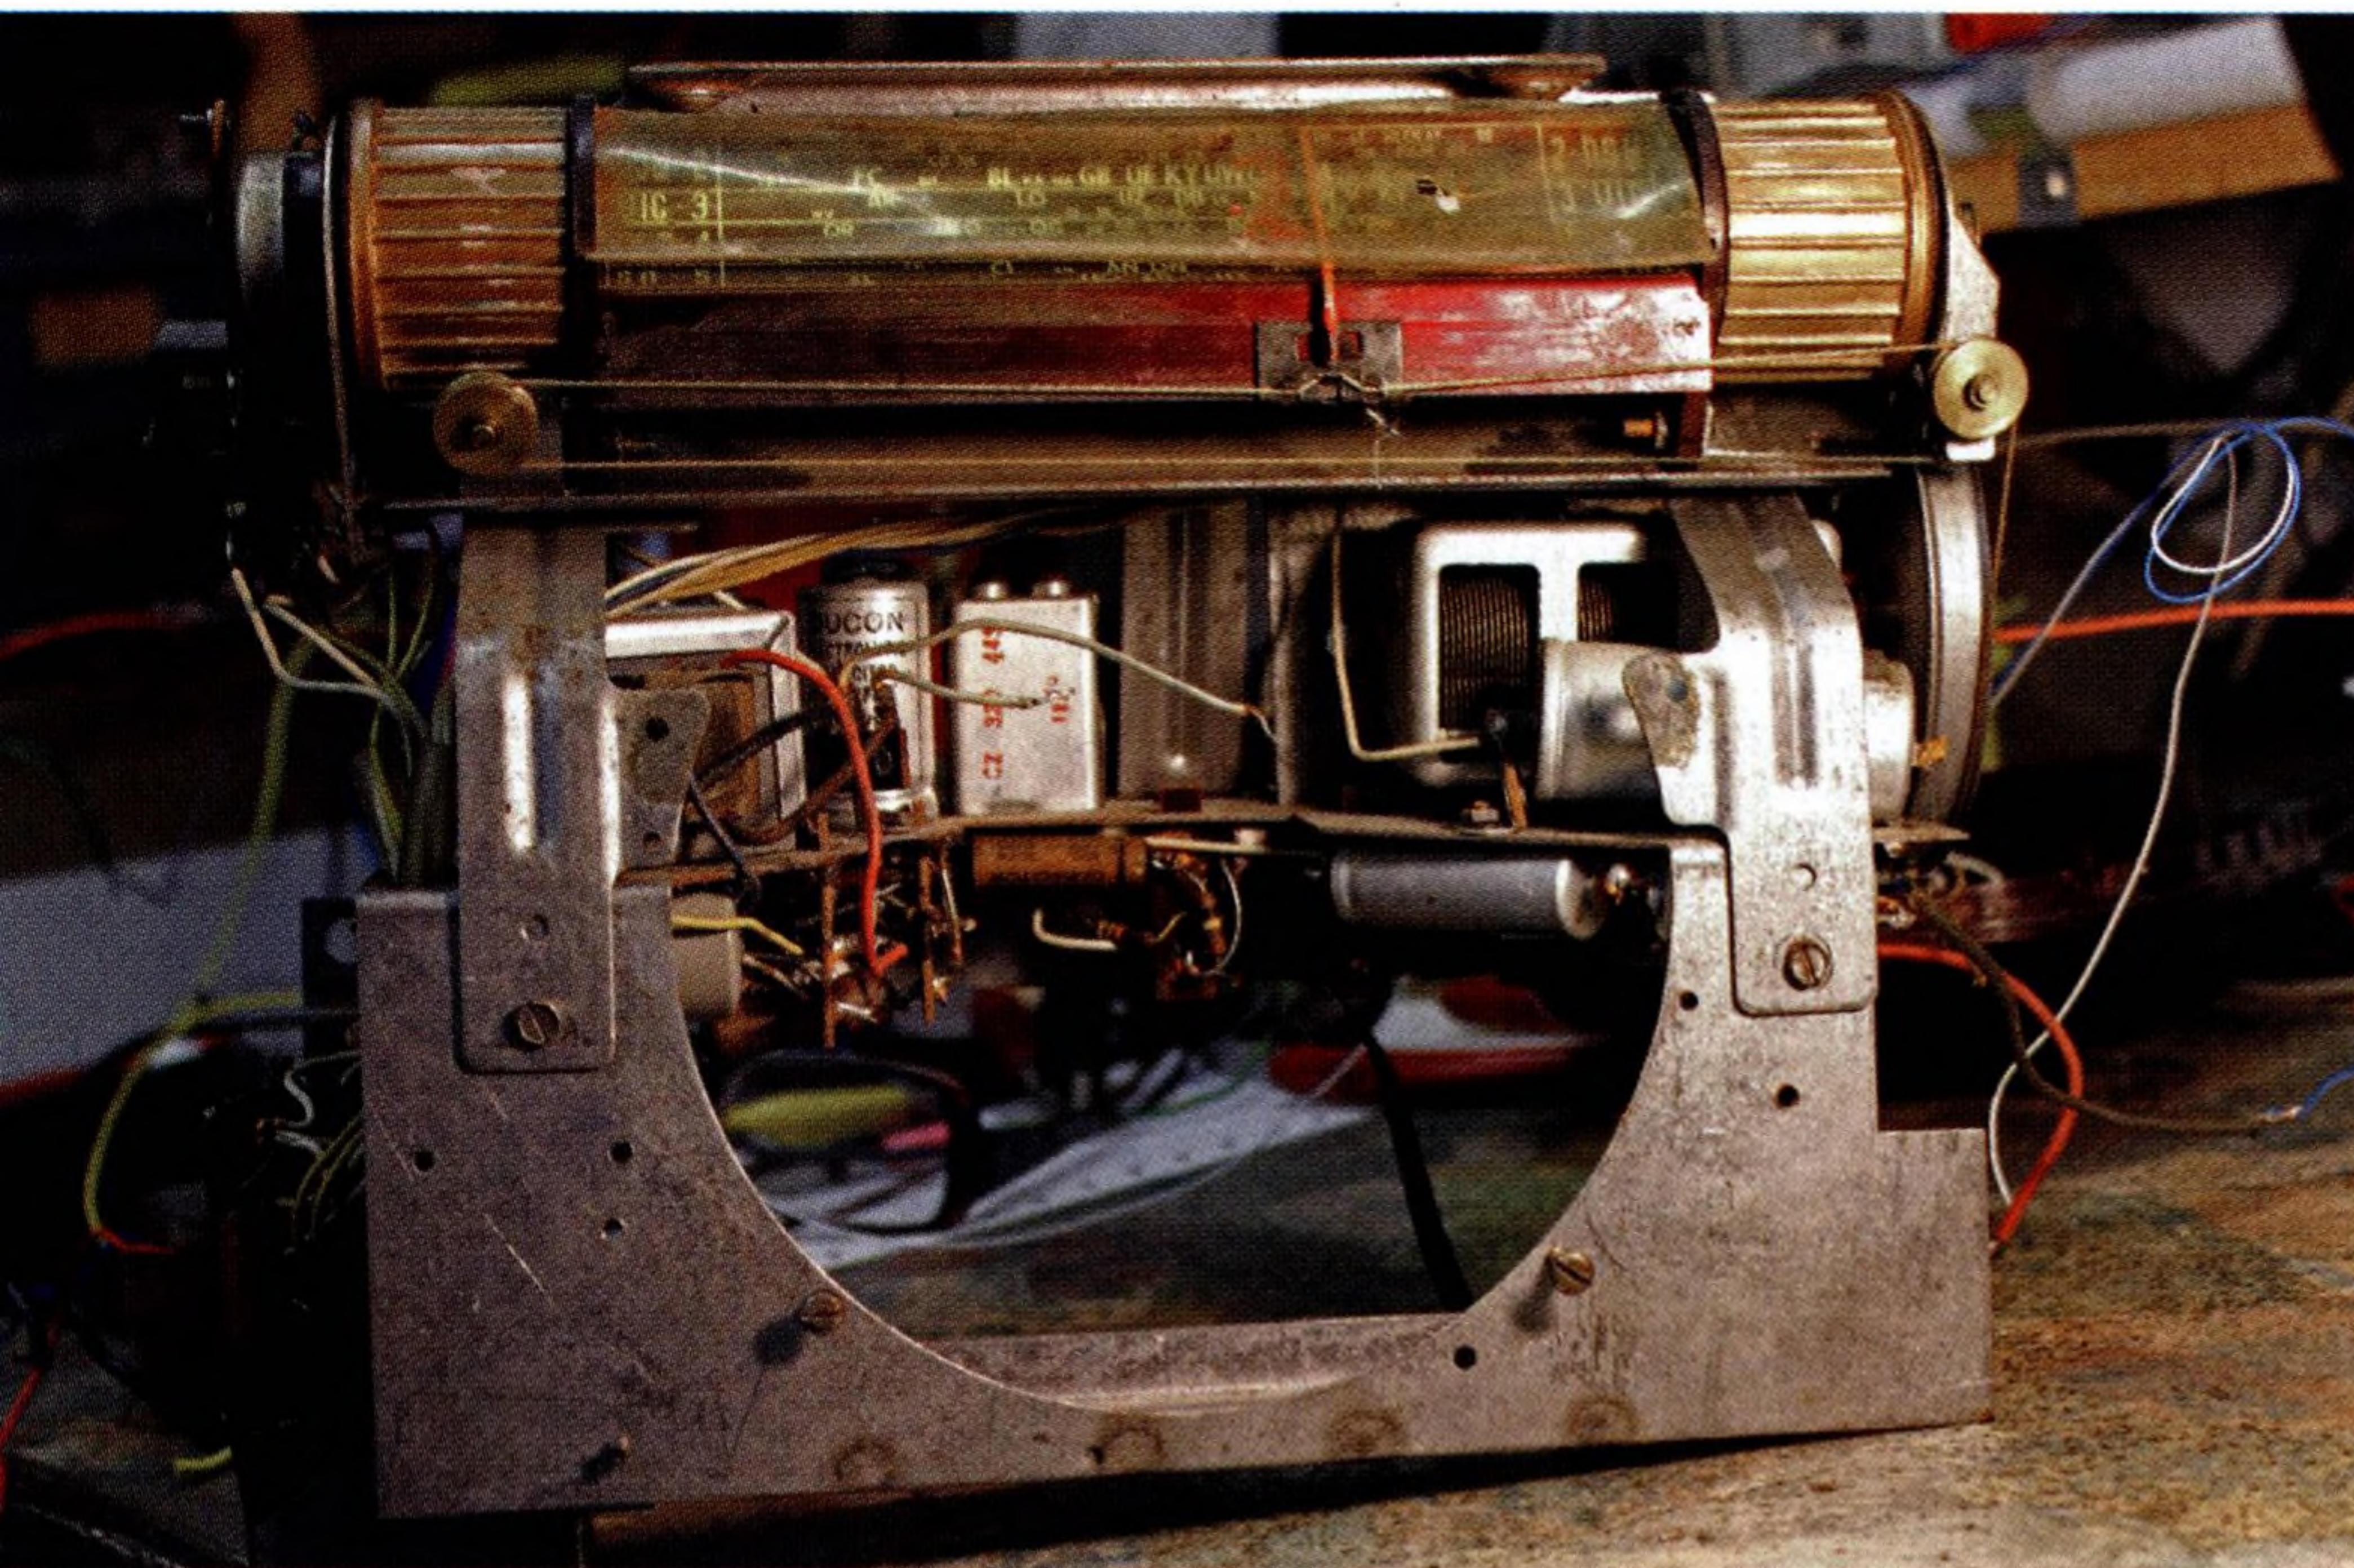
This view shows the front of the chassis with speaker removed. Interestingly, the tuning gang has brass plates, whereas most production tuning gangs at the time used aluminium plates.

The tuning capacitor is also relatively small, with brass plates (not aluminium). Even so, this is still a cluttered layout with difficult access to many components, as can be seen from the picture of the front of the chassis with the speaker removed.

cover with a hole (see picture of the front of the chassis before restoration) was replaced with acetate sheet, heat-moulded to shape.

Detaching the speaker also gave access to many components otherwise inaccessible (see the picture of the front of the chassis).

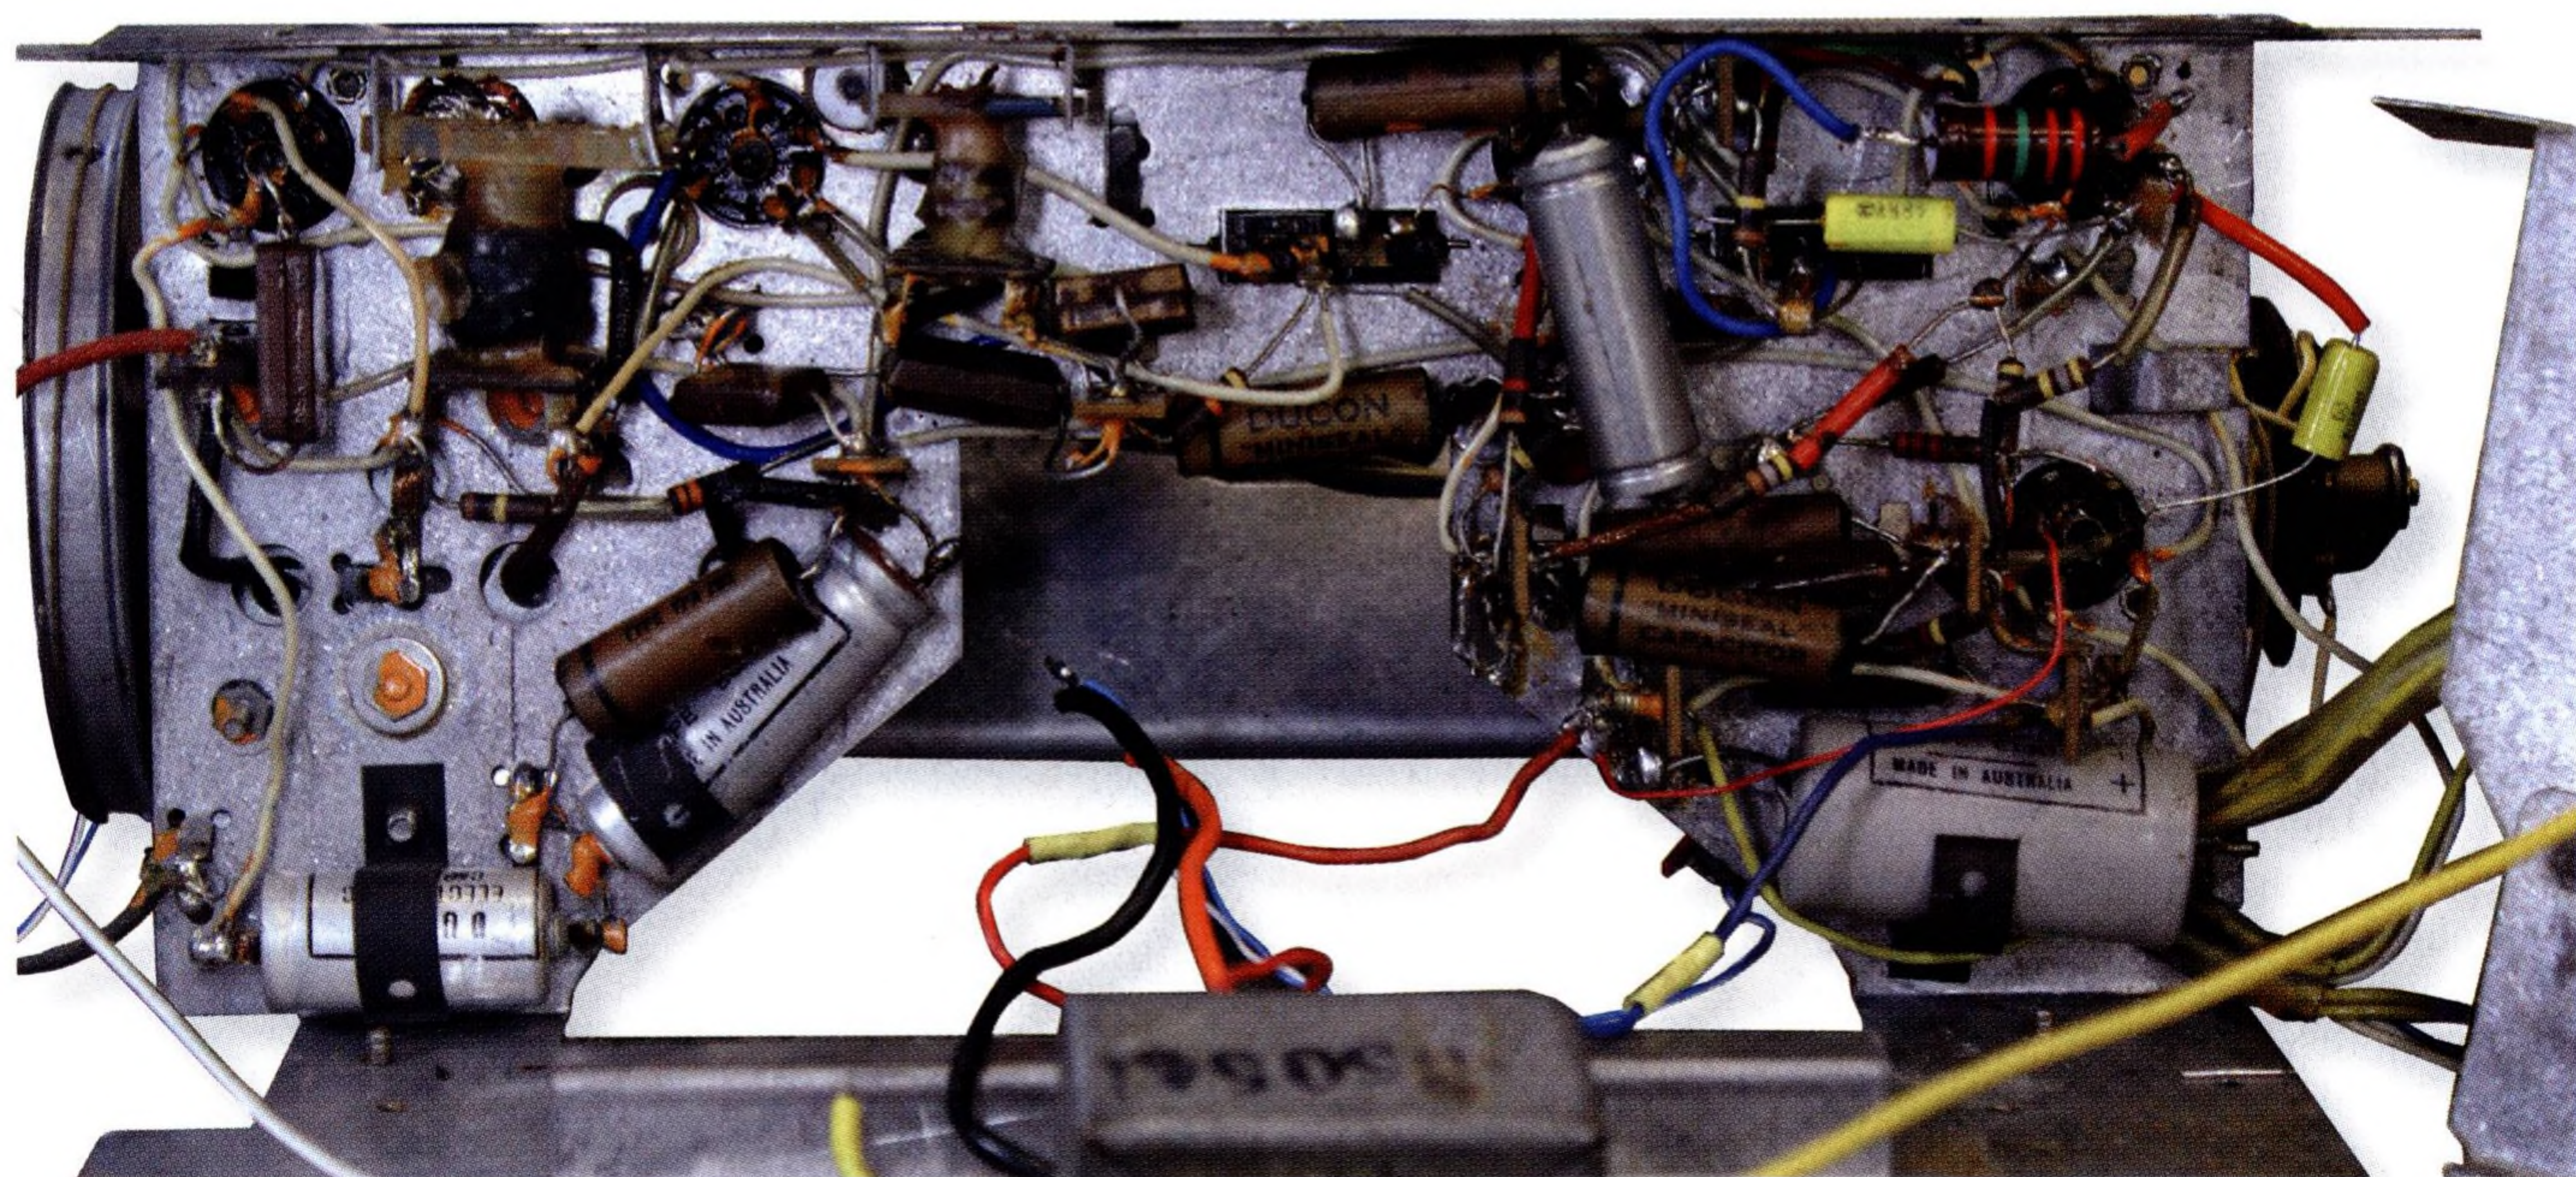
Even though the case was manufactured from aluminium panels, the chassis was made from plated steel and in other respects the construction was entirely conventional. Surprisingly, not many of the paper capacitors needed to be replaced.

The picture of the components under the chassis shows the radio after the correct pin connections were sorted out for the 3V4. But even then, the radio still did not work. The feed capacitor from the 1S5 to the 3V4 (C20) was replaced but there was no audio signal passing through.
