Vintage Radio

Philips 1953 portable 5-valve model 148C radio

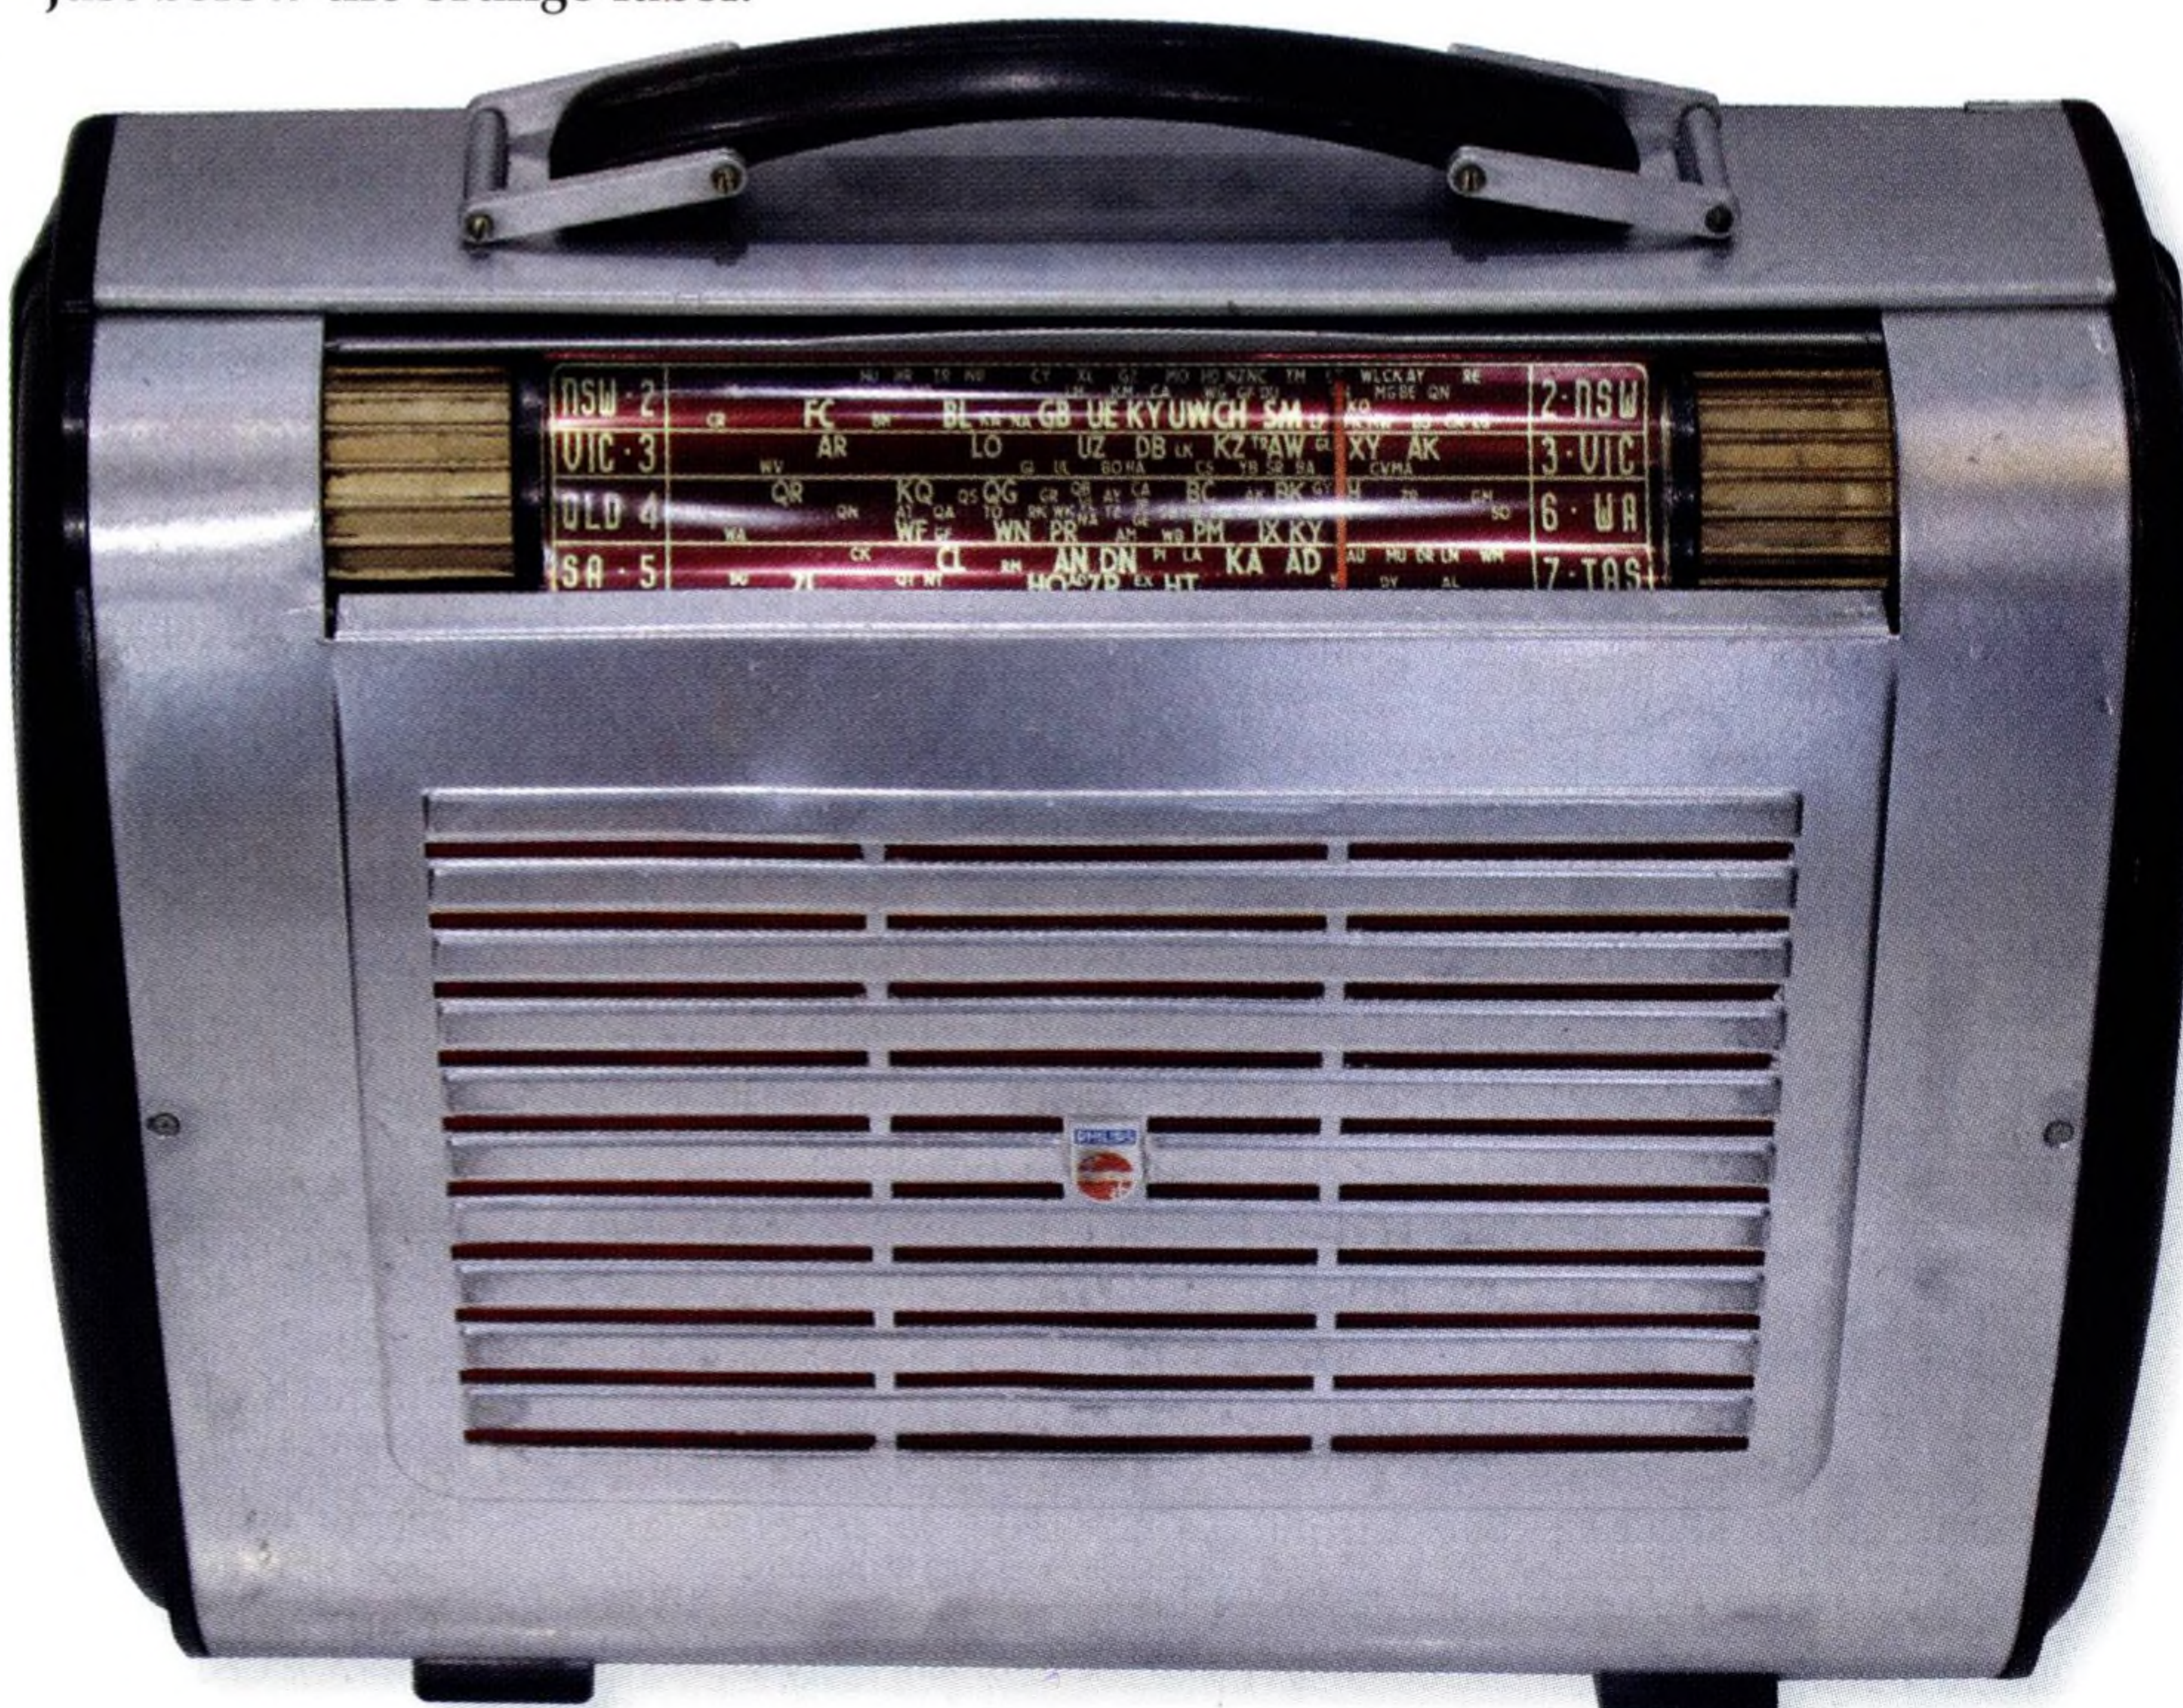
Not all of these portables made by Philips were equipped for mains operation as can be seen by the add-on section above involving the 6V4 full-wave rectifier just below the orange label.

After fixing the problems, the radio was run from the 230VAC mains using a proprietary plug inserted into the rear of the case. The power transformer and mains socket are awkwardly tacked on below the main chassis at the left-hand side and multiple wires lead up to the 6V4 rectifier and switching circuit mounted at the top.
