Antique Radio

THE SHUTTER-DIAL SET PLAYS

If you've been a regular reader of this column, you know that the last four issues of *Ellis on Antique Radio* have been devoted to the ongoing restoration of one of Zenith's more interesting receivers—a Model 7S232 "shutter dial" set. For those who have just joined us, the "shutter dial" is an ingenious mechanism for displaying only the frequency calibrations in use on a multi-band set.

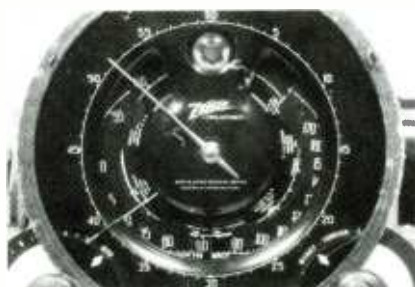
Close-up taken just before installation of the dial glass shows the action of the shutters. The broadcast-band shutter set is being swung out of the way to reveal short-wave band calibrations.

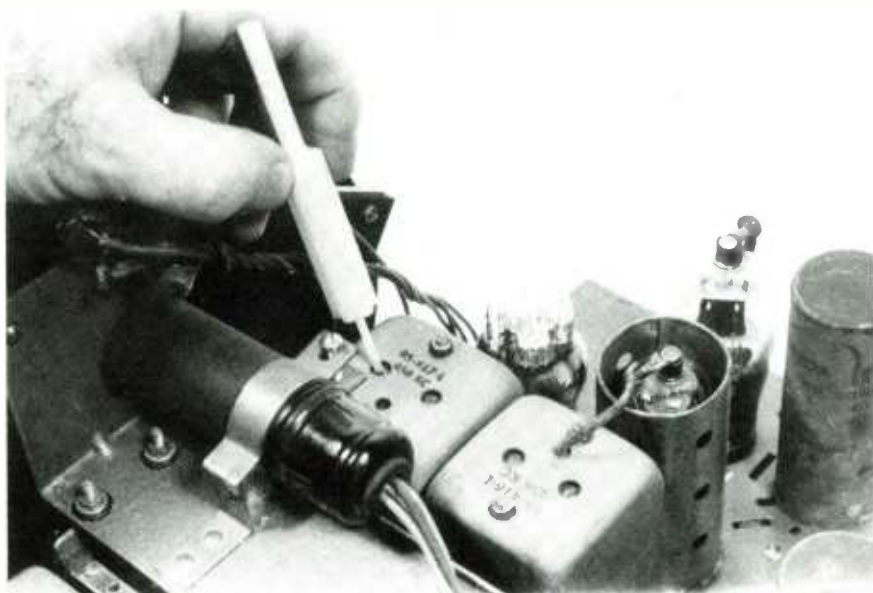
Tweaking the IF transformer trimmers helped a lot in restoring the set's sensitivity and "pep."

Realigning the IF, RF, and oscillator circuits per the manufacturer's published instructions finally brought the set back to life. Reception is now quite satisfactory on all bands, and the tuning indicator's response is very lively on both the broadcast and the shortwave bands.

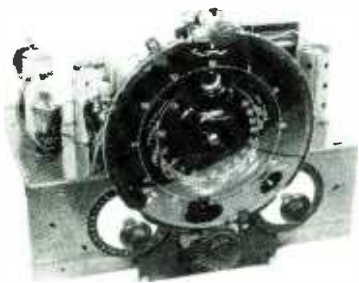
Completely restored chassis waiting for installation in cabinet.

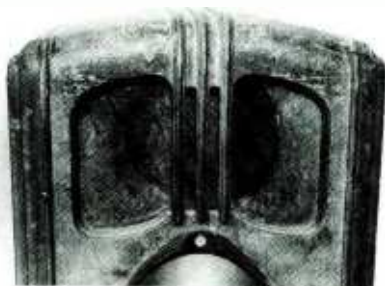
This close-up of the cabinet top shows the ravages of a furnace explosion. By next month, I hope to have cabinet looking beautiful again.

If you've been following this series from the beginning, you know that the shutter-dial set was the victim of a minor furnace explosion—which is why the last owner was willing to part with it. That's the reason for the charred speaker grille and the rather distressed condition of the finish.

However, once having gone through the trouble of restoring an interesting and unusual radio chassis, I obviously can't neglect the cabinet. Next month, I'll let you know how I made out.

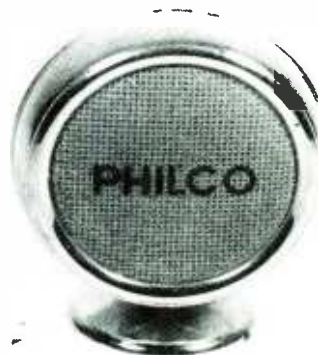
Here is another mysterious Philco device (see text). Write me if you can identify this thingumajig.

The small, highly-chromed device bears a prominent Philco logo and looks to all the world like a miniature speaker for an antique radio. (I've included a pencil in the photo for size reference.) A piece of ordinary rubber zip-cord comes through a grommet on the back panel, which also bears a slide switch labeled ON and OFF. Inside the mystery device is what appears to be an ordinary permanent magnet (PM) speaker heavily damped with a filler that looks like some form of cotton or glass wool.
