## Improving Supply To Test Car Sets

By HARRY S. LEEPER

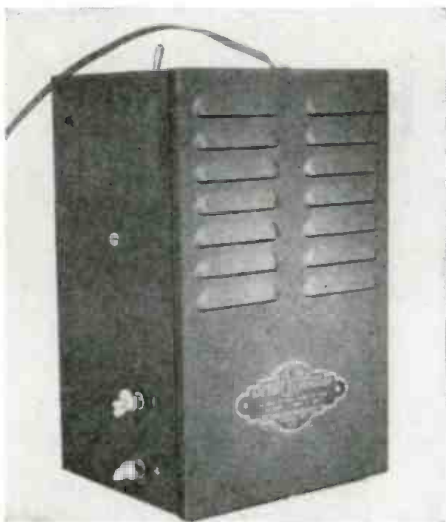
Photo 1—This is original battery eliminator.

An eliminator with a copper-oxide rectifier is shown, as originally purchased, in photos 1 and 2. The original wiring of the eliminator is shown in the schematic.

This eliminator is rated at 6 volts output with a 15-ampere load. With the original arrangement the voltage would be too high with the light load of most radios.

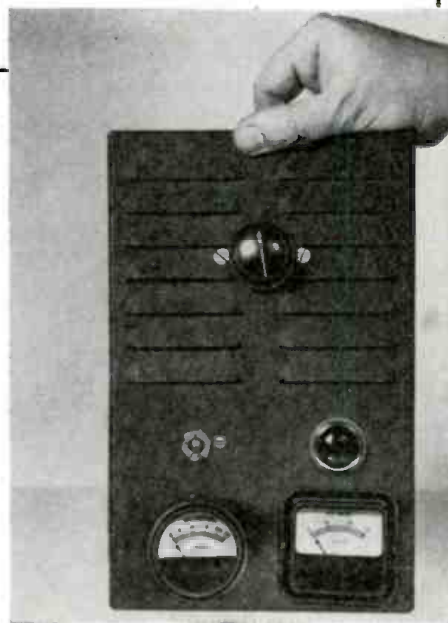
Photo 4—New components are on panel.

Photo 4 shows the panel with the parts assembled, while photo 5 is a rear view.

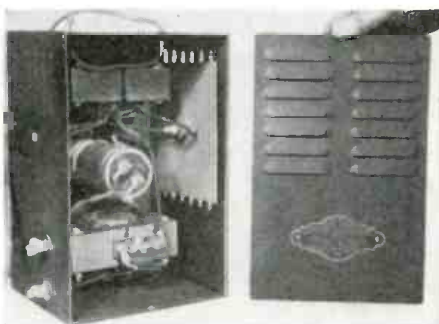
Photo 2—Rear view shows original parts.

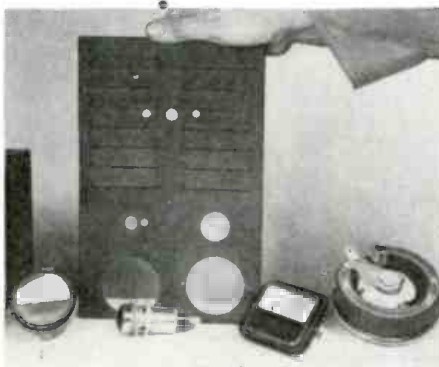
Photo 3—Drill holes in panel for new parts.

The parts are shown in photo 3, together with the top panel, which has been drilled and in which the required circular openings have been cut.

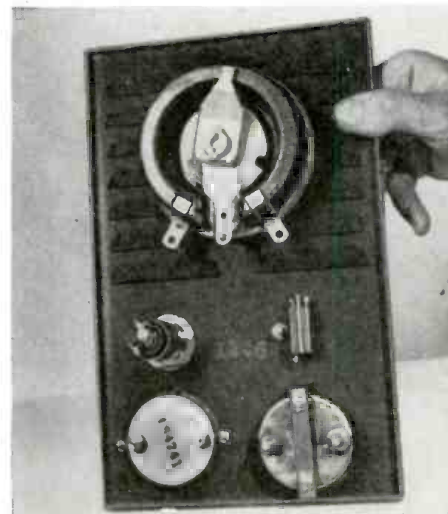
Photo 5—Rear view shows parts ready to wire.
