Model: KCY707 for PTS series

Classification: Service tip:

Where in some units IC802 is mounted parallel to the main chassis, the modification as shown should be done. For all others please just loosen the wire described on page 2.

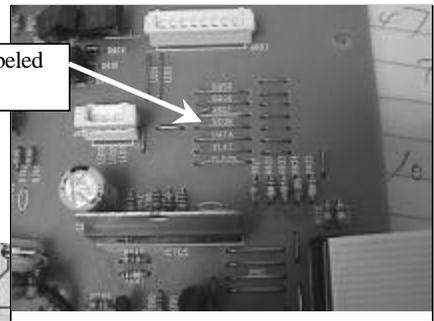
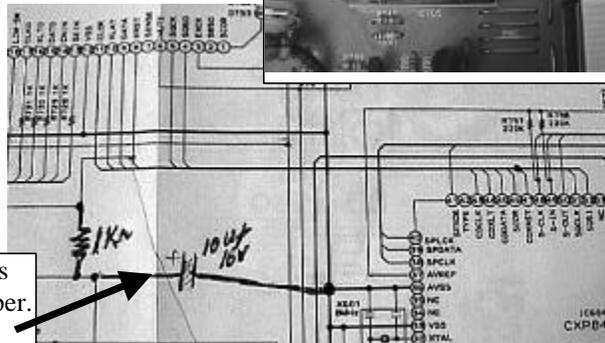
Front of unit

If IC802 is mounted parallel to the PCB layout modification given below would be appropriate.

Cut jumper wire labeled XRST

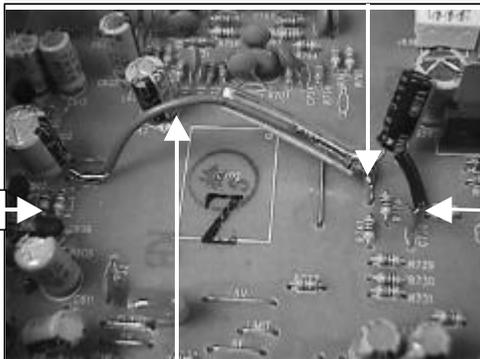
Negative side of capacitor is soldered on the rear side of C739 (ground) near R789.

Add 1k-ohm resistor and 10uf 16v capacitor as seen. + *Side of capacitor* is solder at the jumper. Capacitor is 10uf 16volt.

The lead wire in series with 1k-ohm 1/4watt resistor is then soldered to a jumper closer to R604 as seen. Place a plastic tube or heat shrink tube over the resistor. Note jumper location!

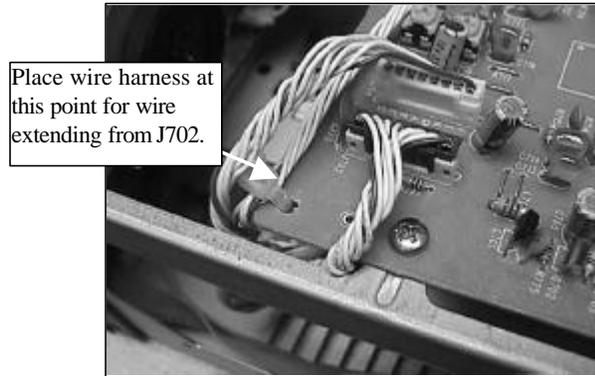
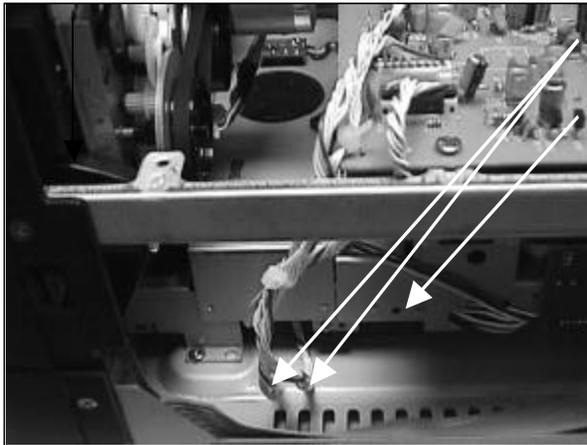
For unit having a smaller cut at this point (magazine home position sensor hole) compared to the rest sensor cutouts; please cut (shave) the top part of the plastic with shop utility knife until the hole matches the rest.

The two wires coming from J703 and J704 are connected to the PICKUP assembly. In some units these two feed wires are tied to the CD chassis and may cause some binding to the traverse gear mechanism system causing gear damage. To alleviate this problem, remove (cut) all wire ties and retie them as illustrated in picture. Give a 3/4inch play for wires connected to J703 and J704 compared to wire connected at J702. These two wires should rest flat and close to the bottom chassis of the unit without any abstraction.
