by LEO SIMPSON

What to do if your project won't work *-don't stomp on it*

Many readers build EA projects and are pleased with the results. But some projects don't work at switch-on and cause a lot of frustration. What is the answer?

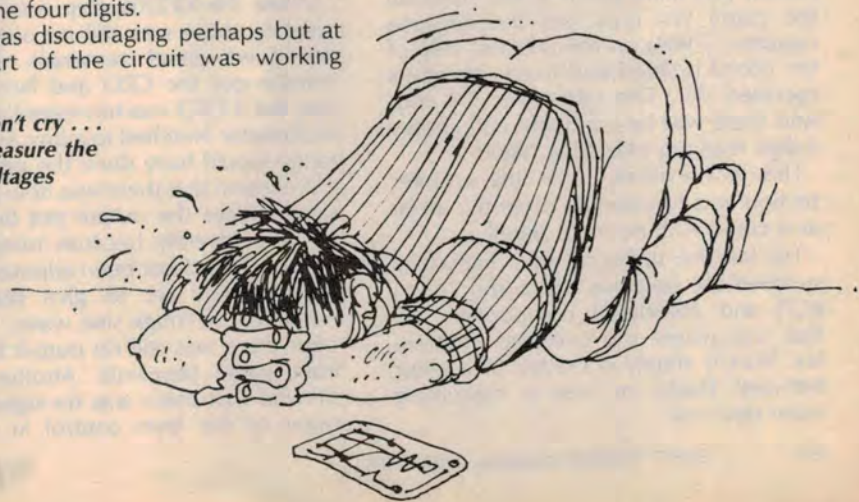
Next, the voltages at the outputs of the three-terminal regulators were checked. There are three such regulators in this circuit, one positive 5V and two negative 5V. Only the positive regulator was correct. The negative regulators were

Don't cry ...
measure the
voltages
