# New Life for a Pierson KE-93

*Part 2 of 3.*

*Part one of "New Life for a Pierson KE-93" discussed the power supplies that were sold as companions with the receiver during the 1957 era. All of the identified problems that I had discovered were also listed, and each will be discussed in the appropriate section as we proceed.*

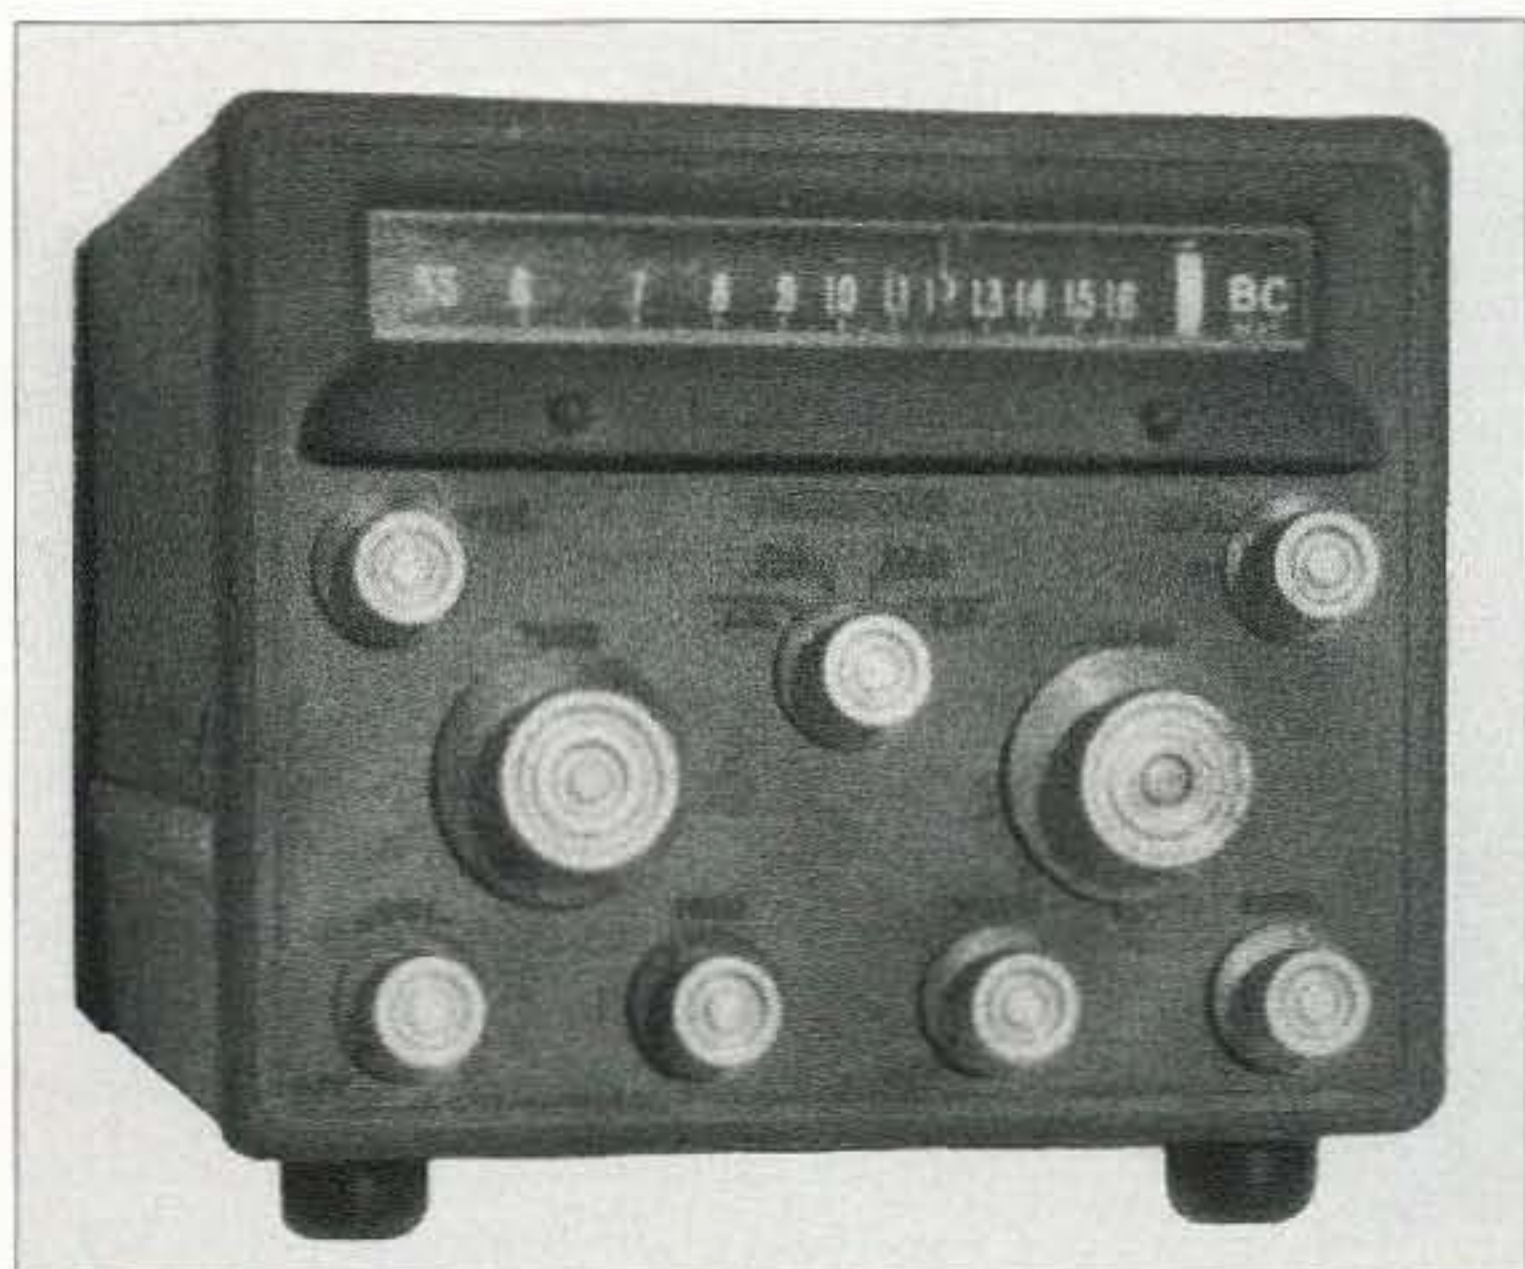
**Photo A.** Front panel view of the Pierson KE-93 communications receiver.

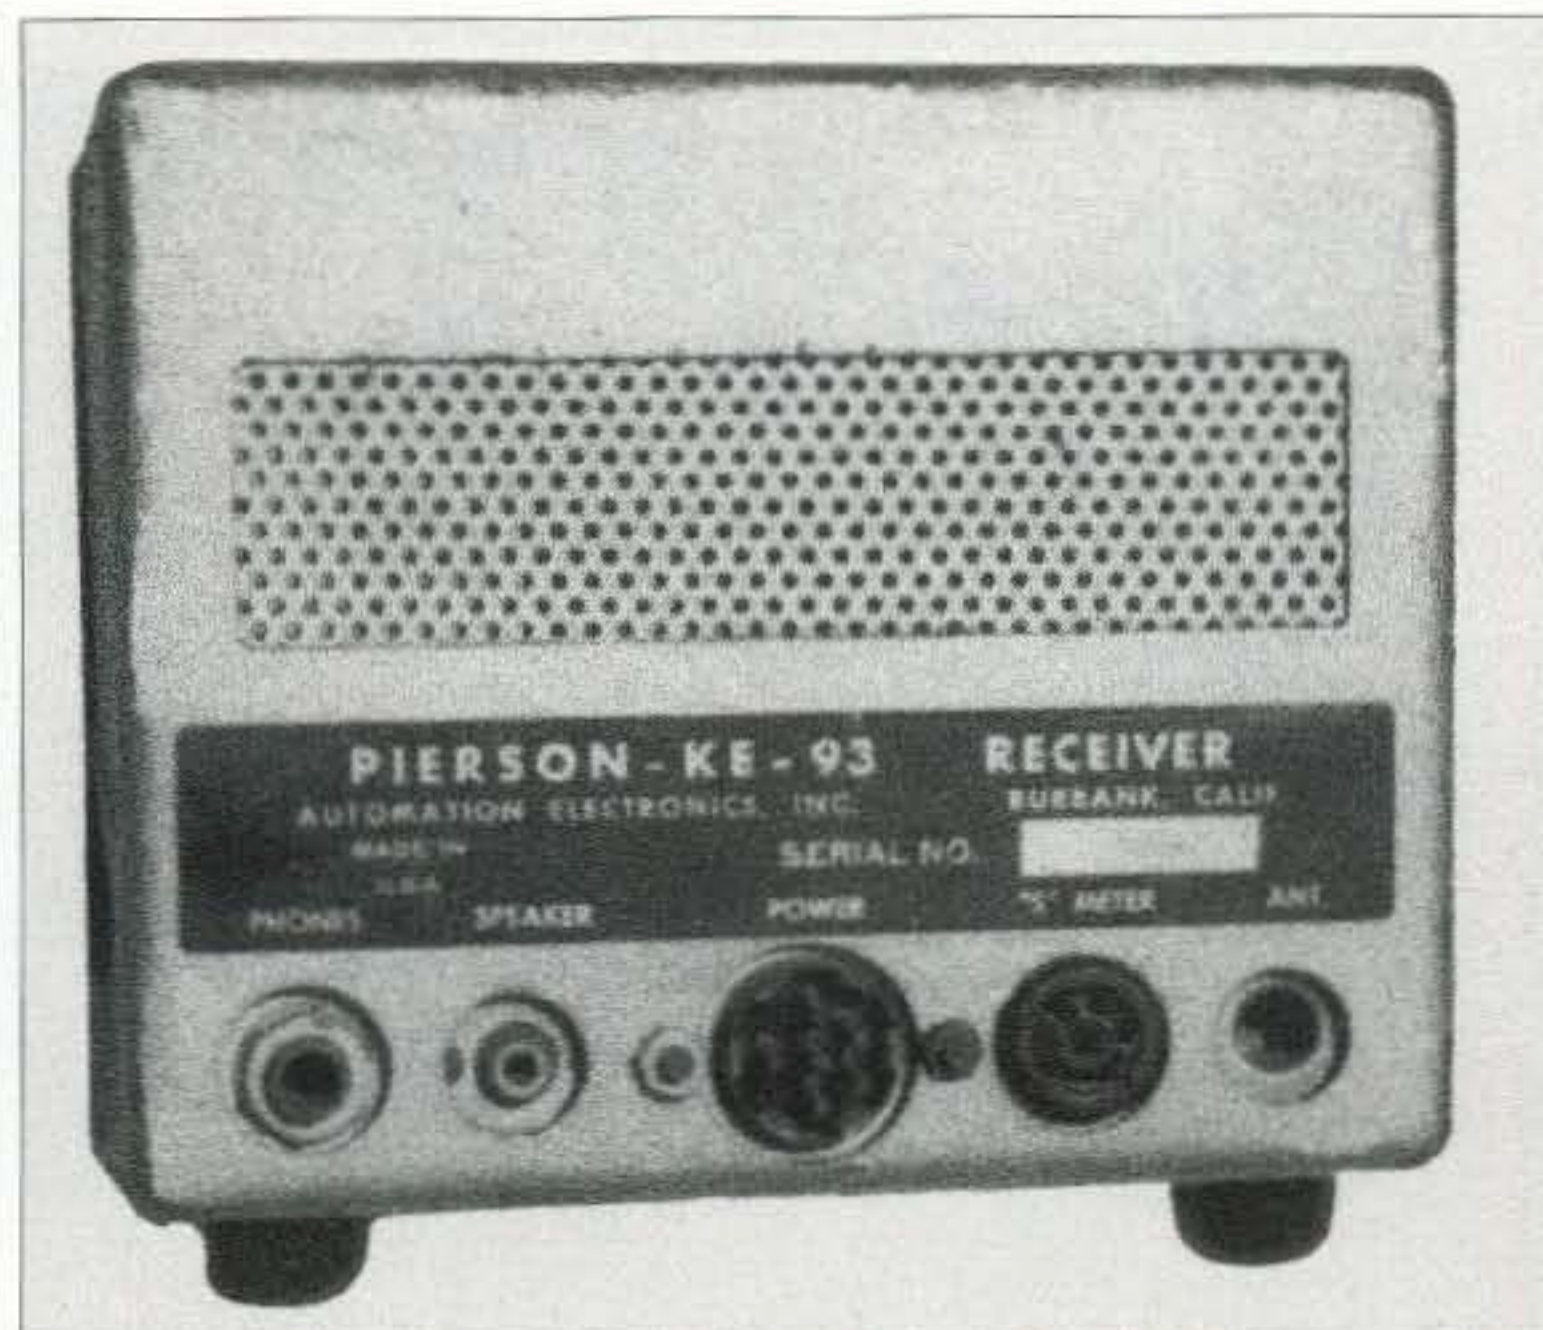
**Photo B.** Rear cabinet view of the receiver showing the connectors.
