COPING WITH TV's No. 2 BAD GUY

By ART MARGOLIS

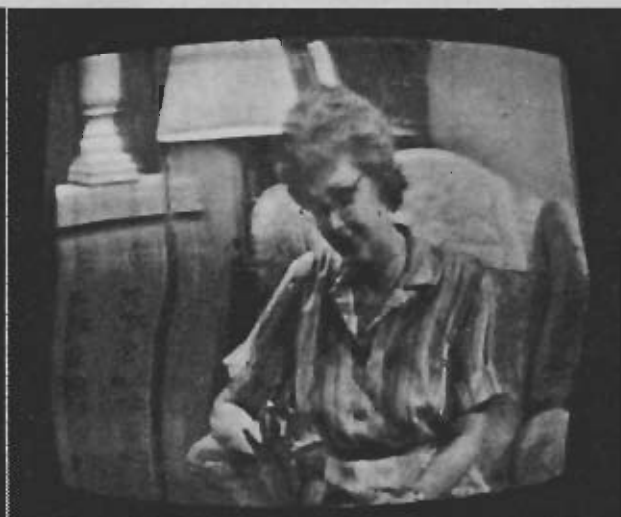
Fig. 4—Commonest TV filter-capacitor breakdown makes picture shrink, pull and develop hum bars.

Another case concerned a shrunken picture. All four sides had pulled in from the edges of the screen and the sides of the picture were not straight but curved. In addition, there was a loud hum in the sound.

Weak B+ will reduce the horizontal and vertical deflections and shrink the picture. Unadulterated weak B+ will do this evenly—the sides of the picture remain straight and there is no distortion in the sound. When open filter capacitors lower the B+ voltage they also allow DC ripple into the B+ line. The ripple appears as bending in the picture and hum in the sound.

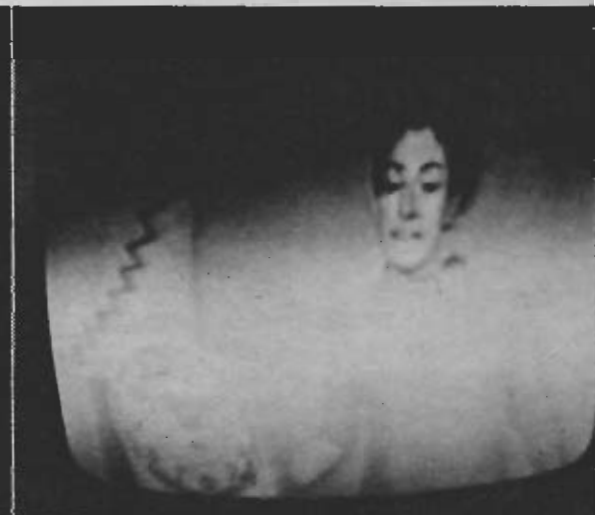
Fig. 6—Banding is across screen for filter short in vertical output (up and down if in horizontal).

I once took a service call from a boxing promoter. His trouble looked something like 60-cycle hum except that it was turned 90° and appeared as a vertical band (Fig. 6 shows the reverse effect, with a faulty filter in the vertical output). As he demonstrated his problem to me the promoter gave the set a sharp left hook to its side. The trouble
