## Repairing moving-coil loudspeakers

## VINTAGE RADIO

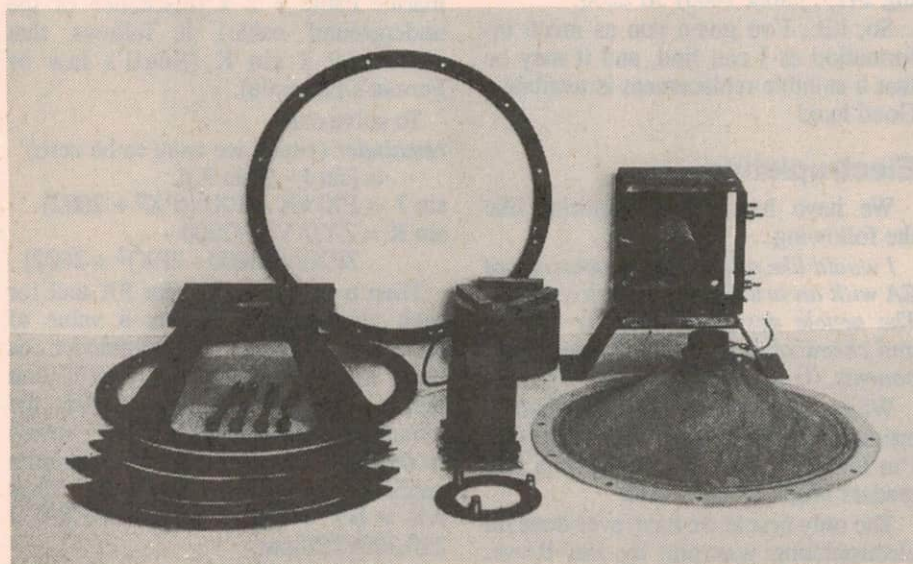
**Fig.1: The component parts of a 1930 Kolster Brandes speaker. The construction is typical of early models, which are easily taken apart for repairs — unlike more modern models. This model has no hum-bucking coil or shading ring.**

It is an interesting exercise to study the changes in speaker construction methods over the years. In most cases, the older the speaker, the more readily it can be dismantled. Early models, typified by the Kolster Brandes unit in Fig.1, were assembled with nuts and bolts. As time went by, and especially after the demise of the electromagnetic speaker, more and more of the assembly was pressed, glued and welded — until with today's speakers, anything but simple cone repairing is practically impossible.

In the case of very old speakers, as in Fig.1, it is fastened to the rim by a clamping ring. In later speakers, the surround will be cemented under a cardboard or felt gasket. The cement may well be easily loosened, but otherwise lacquer thinners should be applied and left for a few minutes. Disconnect the flexible voice coil leads and the spider mounting and carefully lift the cone out.
