Vintage Radio

Those troublesome capacitors, Pt.1

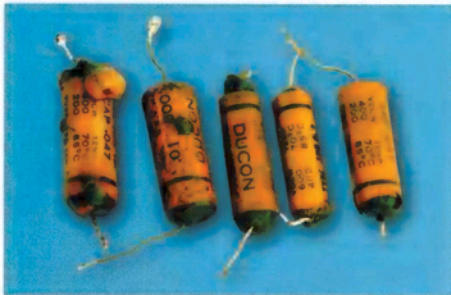
Capacitors that are deformed should be replaced. However, if a capacitor appears OK, it may still be used in many circuit locations even if it is leaky.

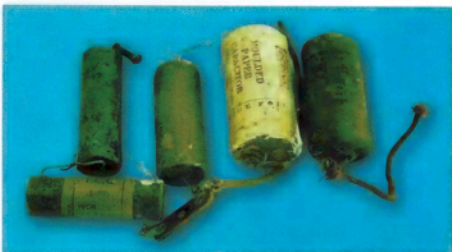
These old paper capacitors have obviously seen better days and have been replaced. If you want to maintain authenticity, you can often use the "shell" of an old capacitor to hide a modern replacement.

In addition, needlessly replacing all the original paper capacitors detracts from the set's authenticity – at least when it comes to appearance. There is an alternative though and that is to remove the innards of the paper capacitors and hide polyester capacitors inside the vacated cases. That way, the capacitors look authentic but now work reliably.

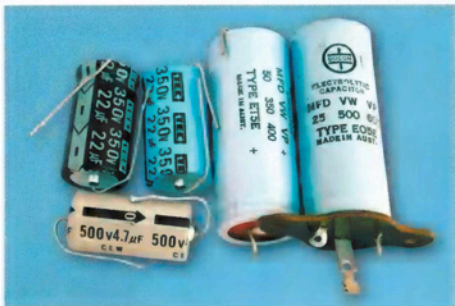
Electrolytic capacitors can also be unreliable and need to be carefully checked, both for leakage and for capacitance value. Again, you can hide modern units inside the "shells" of the originals to keep the appearance authentic.

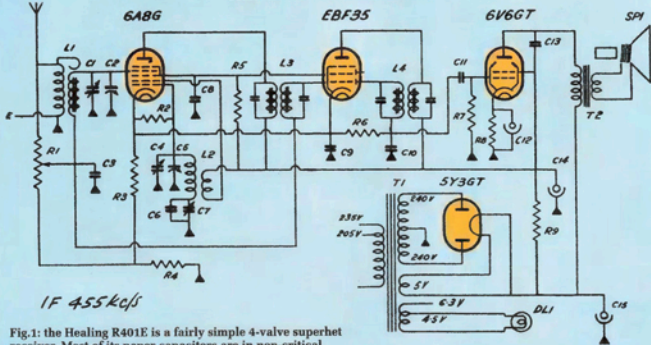
HEALING R401E/S401E.

Fig.1: the Healing R401E is a fairly simple 4-valve superhet receiver. Most of its paper capacitors are in non-critical locations when it comes to leakage.

The R401E has no AGC and only one audio stage, so that greatly simplifies matters. Generally, bypass capacitors (such as a screen bypass) can have a leakage resistance of 10 times the value of the screen dropping resistor and the performance of the set will be little affected (if noticeable at all).

20 times, with a minimum of around 2M Ω . In this case, screen bypass capacitor C8 could have a leakage of 20 times the value of R5 (20k Ω) which is 0.4M Ω but as just stated, I would replace it if it were below 2M Ω just to be on the safe side.

Note that C8's voltage rating is 400V, although the operating voltage is around 116V. However, the voltage across this capacitor could be as high as 330V just after switch-on, as the 5Y3GT is operating and supplying peak DC voltage well before the other valves start drawing any current.

C3 is used as an RF bypass and is connected to potentiometer R1 which has a resistance of 50k Ω . Even with R1's moving arm at the centre of its travel, the maximum resistance to earth is around 14k Ω and so the maximum voltage across C3 is only about 35V. As a result, C3 isn't highly

C9 is the cathode bypass for both of the radio frequency (RF) valves (6A8G & EBF35). This capacitor is in parallel with R3 which in turn is in series with R4 and R1 in parallel. As a result, the resistance from the cathodes of these two valves to earth is around 3k Ω and so the leakage across C9 could be as low as 60k Ω without causing problems.

By contrast, C10 is a mica capacitor and it must have very low leakage – i.e. greater than 20M Ω internal resistance. In practice, mica capacitors generally have extremely low leakage (high resistance) and rarely need replacing.

Next, we come to the critical audio coupler – capacitor C11. Resistor R7 has a value of 1M Ω , so as a rule of thumb, I would expect C11 to have greater than 20M Ω of resistance or I would replace it. There's not much voltage across this capacitor though, so it's quite unstressed in this circuit.

In this set, a 20M Ω leakage across C11 is probably acceptable as the valve is not being pushed hard. However, I would still replace it if it were below 50M Ω leakage resistance. Note that although the maximum voltage across this capacitor is only 35V, it is rated at 600V!

R9 and output transformer T2's primary are connected in series across C13 and have a combined resistance of about 4.5kΩ. Once again, this capacitor could theoretically be quite leaky at around 20 times this value (ie, 90kΩ) without having any real affect on the set.

In summary, there's only one paper capacitor in this set that's under any real stress and that's screen bypass capacitor C8. The others all have quite an easy life and can have quite high leakage without upsetting the operation of the receiver. This means that you may not have to replace any paper capacitors when restoring this set (except for C8), which is contrary to what many people have believed in the past.

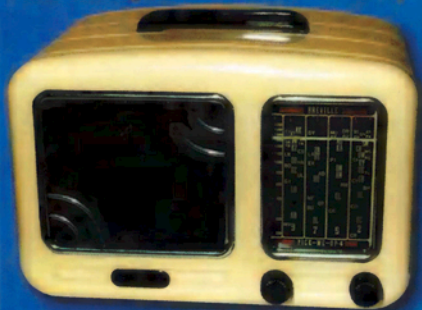
Photo Gallery: Breville 621 Pick-Me-Up-4

Introduced in 1947 by Breville Radio, Sydney, the 621 was housed in a painted metal cabinet fitted with a carrying handle. However, the set wasn't really a portable, being designed for mains-only operation. The valve line-up was as follows: EK2G frequency changer; 6G8-G reflexed IF/audio amplifier/AVC rectifier; 6V6-GT audio output; and 5Y3-GT rectifier. Photo: Historical Radio Society of Australia, Inc.
