HOW SMALL PCB DESIGN TEAMS CAN SOLVE HIGH-SPEED DESIGN CHALLENGES WITH DESIGN RULE CHECKING

MENTOR GRAPHICS

W H I T E P A P E R

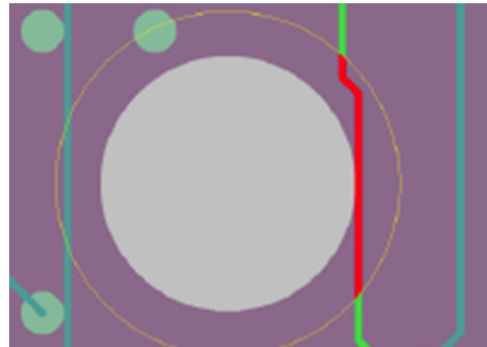
Figure 4: A trace routed near a large void on the reference plane can produce unwanted EMI.

Common instances of this radiation occurring are when a trace is routed too close to the edge of a board (Figure 3), and when a trace is routed too close to a large void on the reference plane (Figure 4).

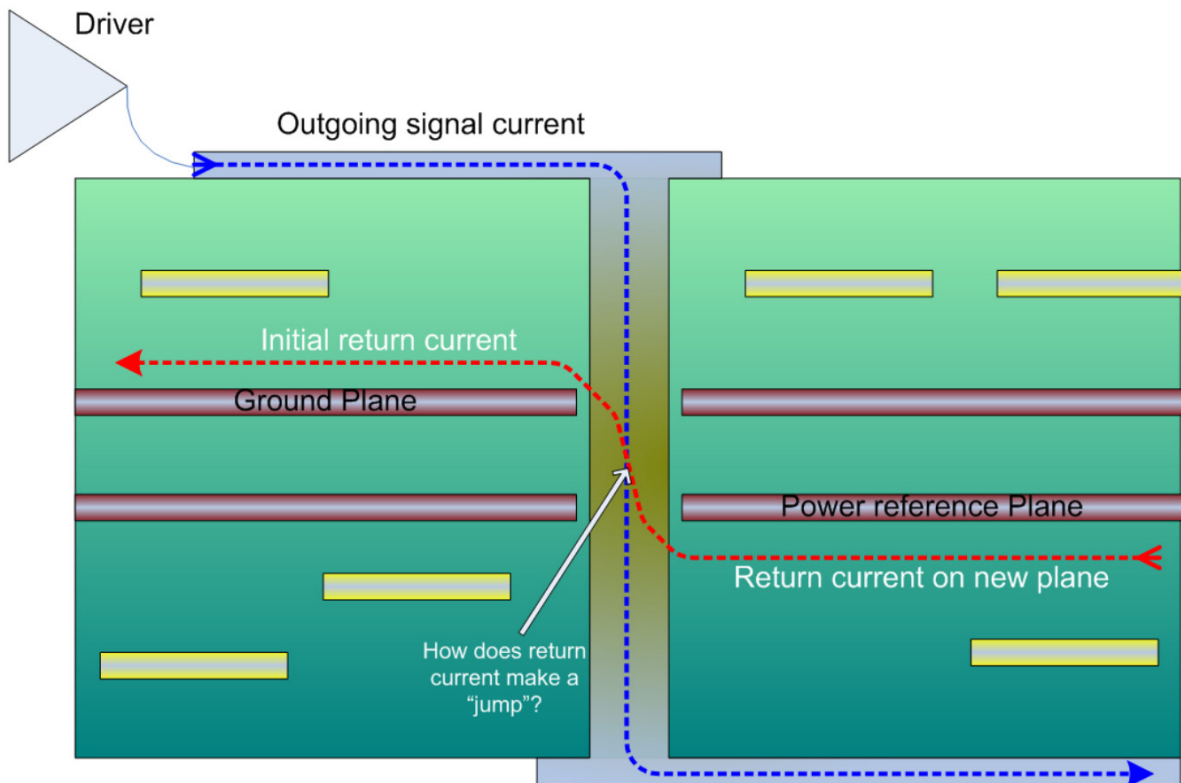
Figure 5: Unintended current flow, and unintended EMI, can result from a signal path that changes reference planes.

When a signal is routed from one layer to another layer through a via, it can result in the signal's return path changing, making the closed current path even more complicated. In Figure 5, the current flowing on the traces of different layers couples (or references) to different planes. The return current on these reference planes needs to be continuous as well; otherwise, the whole current loop is interrupted or broken, producing EMI issues.

- If the reference plane changes from power to ground, one or more stitching capacitors is required
- If the reference plane changes between grounds (or same-voltage planes), one or more stitching vias is required

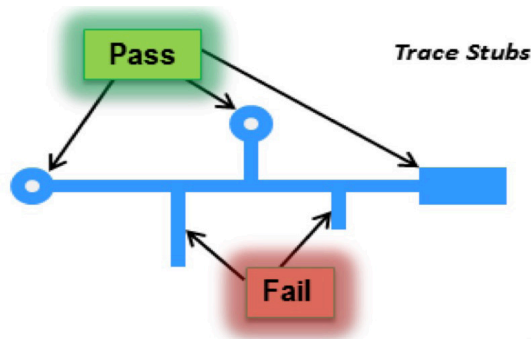
Figure 12: Examples of stubs that can be too long and cause SI issues.

In a PCB layout, a single net often connects multiple ICs. For example, an address bit on a memory interface can originate from the controller and connect to many different memory devices. The sections of copper that branch from the main trace and connect to the load are called stubs. If the stub is too long, it can cause unwanted signal reflections.

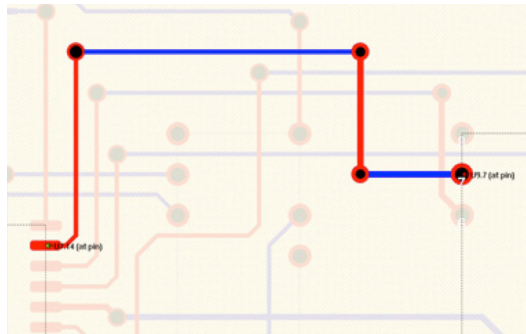
Figure 13: A trace with several vias should be further analyzed to avoid SI and EMI problems.

Often, a trace will need to switch layers in order to complete a route successfully. Each time the trace transitions to a different layer, the signal travels through a via. Vias can degrade a signal or cause unwanted reflections because they impose an impedance discontinuity and can attenuate the signal. Fast edge rates, along with a large number of vias on a trace, can result in large SI- and EMI-related concerns.

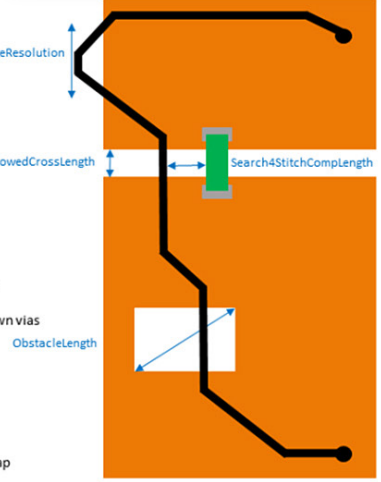
Check that signal traces have a solid reference beneath them. Signals require an adjacent solid reference plane to allow for continuous return current paths, thus reducing the risk of common-mode radiation.

ObstacleLength – Maximum allowable diagonal dimension of gap
PlaneEdgeResolution – Minimum trace segment length for reporting plane edge violation
AllowedCrossLength – Maximum allowable gap width
IgnoreViaConnections – Yes = Ignore antipad violations from signals connecting to their own vias
CoefAccountable – Minimum required percentage of return current through a plane for the plane to be included in the check
Search4StitchCompFlag – 1 = Do not search for stitching components, 2 = Perform search, 3 = Search but report violation
Search4StitchCompLength – Maximum allowable distance from gap for stitching components
ReqNumberOfStitchComp – Required number of stitching components in vicinity of the gap
UseViaAreaFills – Yes = Include vias and area fills in addition to traces

The Net Crossing Gap rule, as documented below in PADS HyperLynx DRC, helps identify one of the interrupted return-path cases (Figure 14).
