# FIFTEEN GREAT AMERICAN CRASHES

An excerpt from a study of 230 metal-rending impacts  
in which only two were killed.

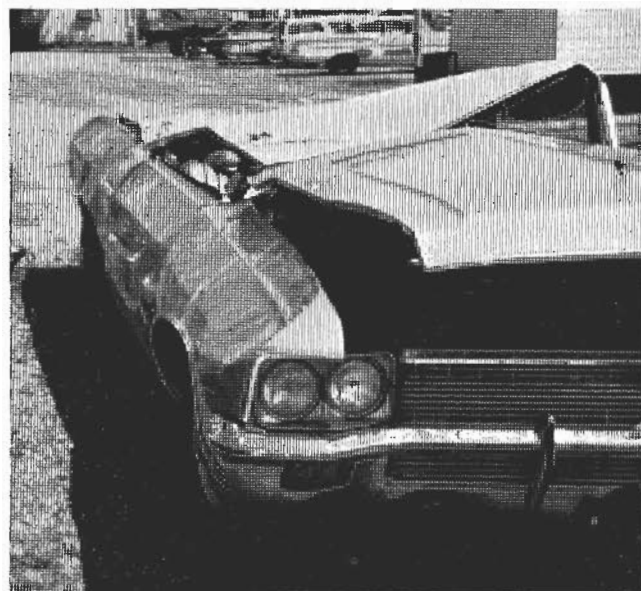
The untrained driver of this vehicle lost control of the car at 60 mph when she experienced a left rear tire blowout. The car left the roadway and rolled over two or three times. The roof deformation was 16 in. on the right side of the vehicle but all areas of the roof were deformed. The 29-year old, 123 lb. 5 ft. 7 in. female driver was using a lap and

shoulder belt and was hospitalized with the following injuries; cuts and scratches to the head, both hands, both feet, both knees were bruised and bruises from the lap belt were noted in the abdominal area. The left shoulder was bruised with muscle and tendon injuries and she complained of soreness in her back.

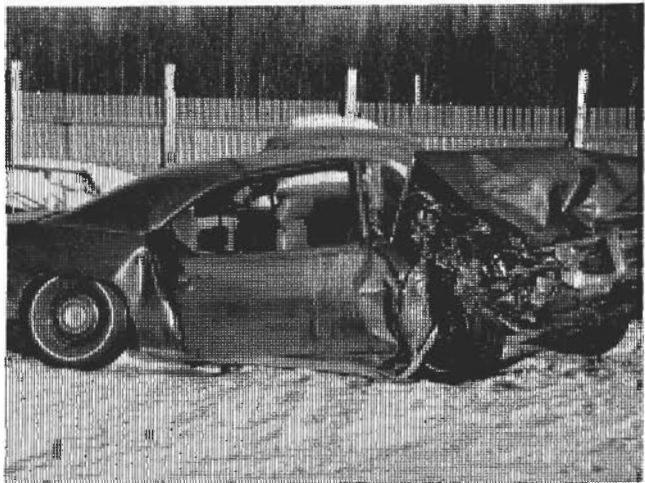
There were four occupants in this 1969 Firebird — all using some type of webbing restraint system. The vehicle was traveling at approximately 45 mph when a passenger car made an unexpected, quick turn across the path of the Firebird. The unrestrained driver of the other car was killed. The vehicle deformation of the Firebird was 65 in. The driver, who was a 21-year old, 175-lb. 6 ft. 1 in. male, was wearing a lap belt with a loose shoulder belt. He was hospitalized for three hours with sore ribs from the shoulder strap, a slight sprain on the right knee, and a sprain on the left knee

and left ankle. His right front passenger, an 18-year old female, who weighed 130 lb. and was 5 ft. 7 in. tall, was wearing a shoulder and lap belt with the shoulder strap adjusted loosely. She was hospitalized for four hours with lacerations to the top of the head, face, and hand. All of these injuries were related to the door glass or windshield. The right rear passenger, a 19-year old, 165-lb., 5 ft. 8 in. male, was wearing a lap belt. He had no injury. The left rear passenger, a 17-year old female, 130-lbs., 5 ft. 8 in. tall was also wearing a lap belt. She was hospitalized for internal injuries.

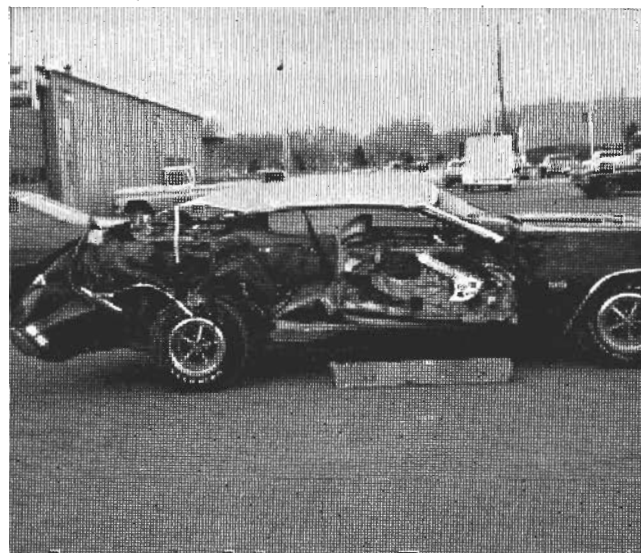
The vehicle in this case was attempting to pass a car traveling 50 mph, pulling a four-wheel farm trailer loaded with corn. The trailer began to whip and "fishtail" and was struck by the overtaking car causing 13 in. of deformation into the right side and the tearing away of some of the side structure. Only the two rear seat occupants, of the four occupants in the car, were injured. The driver, a person of small stature, was unrestrained

and probably protected from injury by the 185 lb., 6 ft. 3 in. right front passenger who was using both the lap and shoulder belt. The full restraint possibly prevented the ejection of both front seat occupants. Both rear occupants were unrestrained and ejected from the vehicle. The left rear occupant suffered abrasions to his back while the right rear occupant was hospitalized for four days for treatment of a leg fracture and lacerations. >>>

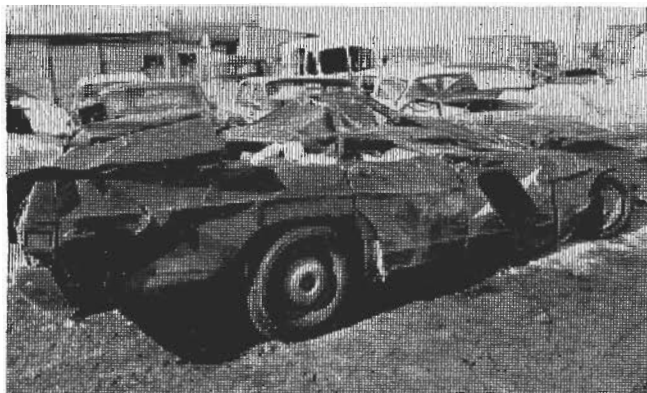
The driver in this case was returning from a skin-diving training session when he attempted to exit at an interstate roadway ramp at 70 mph plus. After leaving 146 ft. of locked-wheel skid marks on the pavement, the vehicle struck the guardrail. The combination of the exit ramp fill section and the vaulting effect of the guardrail caused the car to become airborne for approximately 70 ft. clearing a group of

small children playing along the side of the expressway. The car then rolled approximately 200 ft. end-over-end and side-over-side before coming to rest. The roof deformation was 27 in. The lap-shoulder belted driver, a 27-year old, 163-lb., 6 ft. male received the following injuries: abrasion to the left side of the head and right arm, fractures of the scapula and vertebral column, and a contused heart.

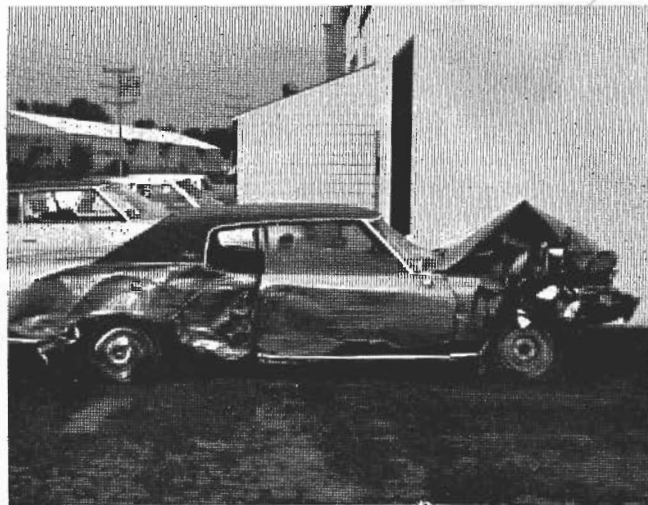
This 1971 Chevrolet left the road on a curve, struck a large mail box, struck a 20-in. dia. tree with the right front corner of the vehicle, continued on side-swiping three more 20-in. dia. trees with the right side of the vehicle before eventually coming to rest. Multiple impact collisions such as this accident can force an unrestrained occupant from the area where he has the

most designed protection and therefore, is apt to increase injuries as well as the possibility of ejection. The driver in this particular accident was wearing both a lap and shoulder belt and remained in the driver's seated position. The 40-year old, 245-lb., 5 ft. 10 in. male received bruises to the nose, the areas around both eyes and a minor laceration of the left hand.

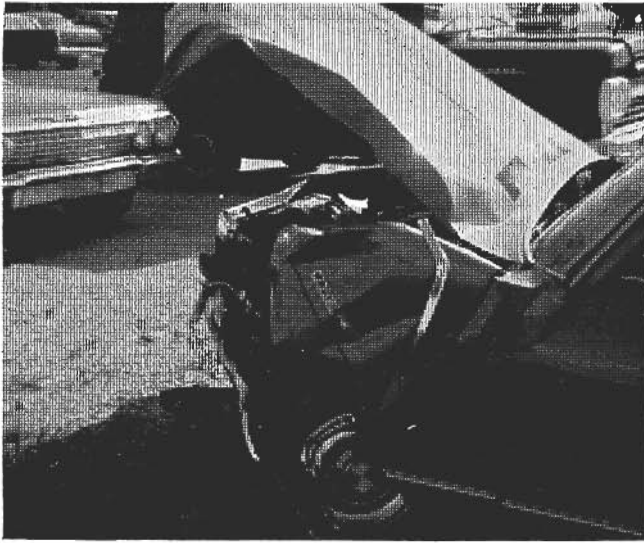
This 1969 Chevelle was forced off the roadway by an oncoming car while it was traveling at approximately 60 mph. The driver lost control of the vehicle on the shoulder material and struck a cypress tree approximately 6 ft. in diameter at an estimated speed of 40 mph. Vehicle deformation as 37 in. The 38-year old

driver, 165 lb. 5 ft. 9½ in. tall, was wearing a lap belt with a shoulder belt adjusted loosely. He required first aid for a one-inch cut over the right eye, a minor abrasion on the right cheek, a minor bruise on the right elbow, sore shoulder muscles on the left side, and minor bruises to both knees.

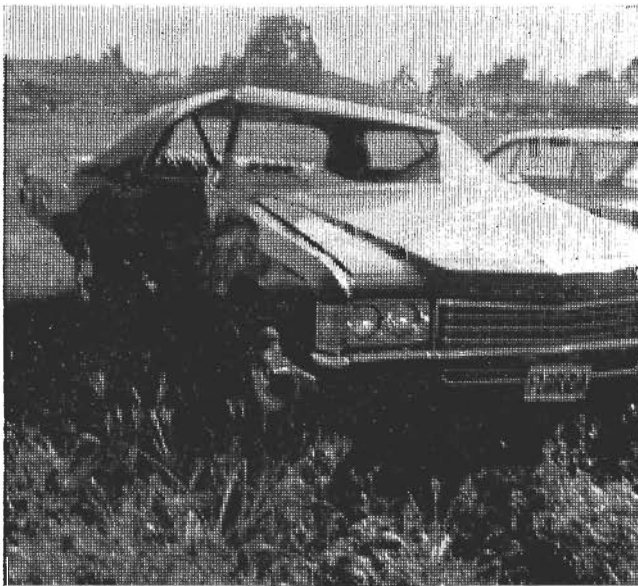
This 1971 Chevrolet four-door hardtop proceeded to cross an intersection after stopping at a stop sign and was struck in the right side by another passenger car traveling 60 mph. Exterior deformation was about 25 in. The driver was the only occupant in

this vehicle and he was wearing a lap and shoulder belt. He was 42 years old, 140 lbs., 5 ft. 8 in. tall. His injuries consisted of a minor laceration on the forehead requiring four stitches, bruises on the right shin, left knee, and finger of the left hand.

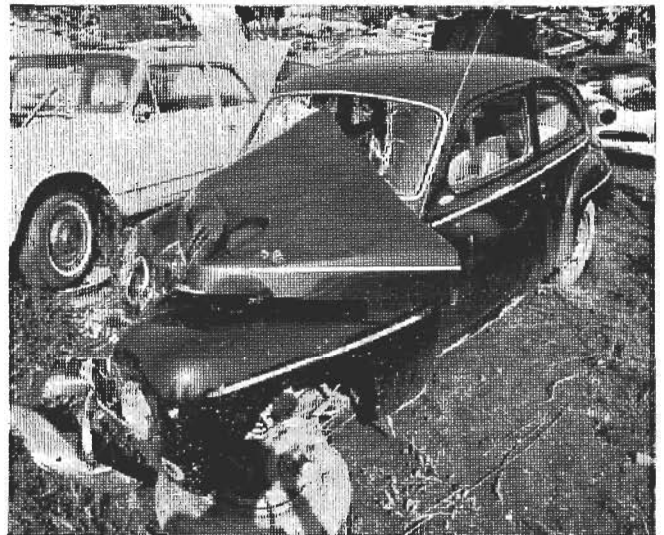
The driver of this European car survived a moderately severe frontal collision with the corner of a concrete wall, resulting in 24 in. of frontal deformation. The driver, age 23, 163 lbs., 5 ft. 11 in. male was wearing the three-point shoulder system tightly. His injuries consisted of a small laceration of the chin, a left clavicle bruise, left pneumothorax, abrasions on the right iliac crest, all probably related

to the restraint system, a small laceration on the left wrist and a comminuted fracture of the femur. His injuries are not typical of lap-shoulder belt usage and were intensified because the webbing (lap and shoulder belt are one continuous piece) separated at its routing on the left side of the seat during the collision. The chest and leg injuries may be related to this separation.
