ML 2C LOUDSPEAKER SYSTEM

SERVICE INFORMATION

SERIAL NO. L1COO1 TO L3C224

SERVICE BULLETIN

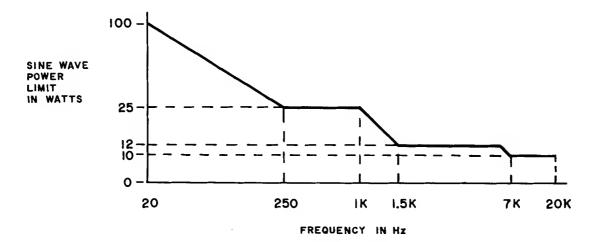
POWER HANDLING: Sine Wave steady state

Avoid operating the speaker system with sustained sine wave signals at power levels greater than the indicated limits. Permanent damage may result.

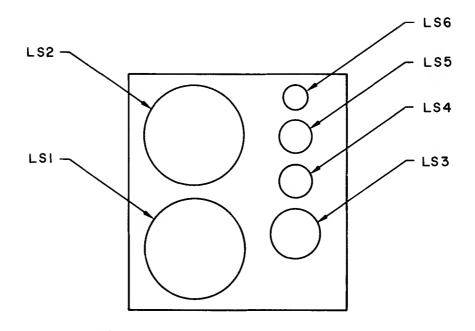
SPEAKER LOCATION

REMOVE REAR PANEL TO SERVICE CROSSOVER NETWORK

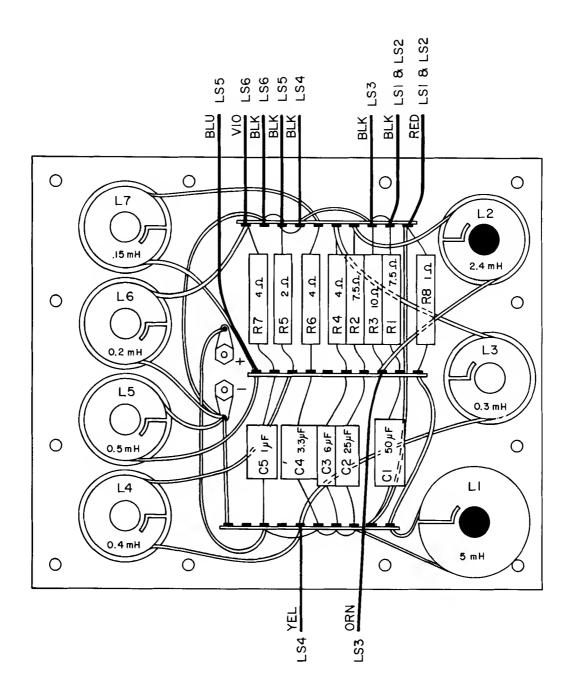
SYSTEM SCHEMATIC

1. In early units LS6 is 036-005 15 $\!\Omega$ impedance. LS6 can be replaced with 036-012 8 $\!\Omega$ impedance. Acoustic output will be the same.

CROSSOVER NETWORK

ASSEMBLY 044-222

The crossover network must be inspected when burned out speaker elements are replaced. The network must also be inspected if a speaker element produces sound with the battery test but does not play when connected in the system. The woofer must be removed to get to the crossover. Check for bad connections, broken wires, etc. Be sure to check the resistors mounted on the plate underneath the printed circuit board. A broken lead on these resistors can also be the cause of intermittent or partial failure of the system.

When a system has been driven excessively hard by a "clipped" amplifier for long periods of time, the dome mid-range may appear to have weak or no output. In addition to a burned out mid-range, the 7µF capacitor may also be damaged. This will be evident if a new mid-range has been installed and also appears to have weak or no output.

Step 2 Locate 10Ω , 10 watt resistor in series with the 8" loudspeaker. Remove and replace with 7.5Ω , 10 watt resistor.
