Replacement horn circuit for a car

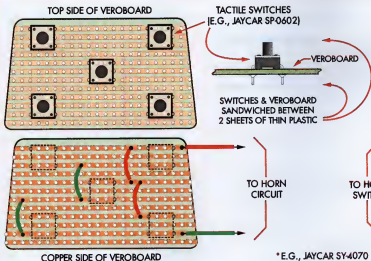
This circuit was devised to replace the horn contacts that were damaged after removing the steering wheel on a Mitsubishi Express van. It can be adapted to other models and the horn relay circuit could also be em-

Five tactile switches are installed on a section of Veroboard which is cut to shape to fit under the horn button. The tactile switches are wired to alternate tracks of the Veroboard and are all effectively connected in parallel so that as long as one of the

switches is closed, the relay will be energised and the horn will sound.

The Veroboard and switch assembly is sandwiched between two sheets of thin plastic which can be sourced from the lids of take-away food containers.
