## NOTES & ERRATA

**Project 662B, April '84.** The circuit diagram for this project, page 74, contained an error. The pushbuttons are labelled incorrectly. The correct positioning is detailed below. The pc board artwork shown in the original article is correct.

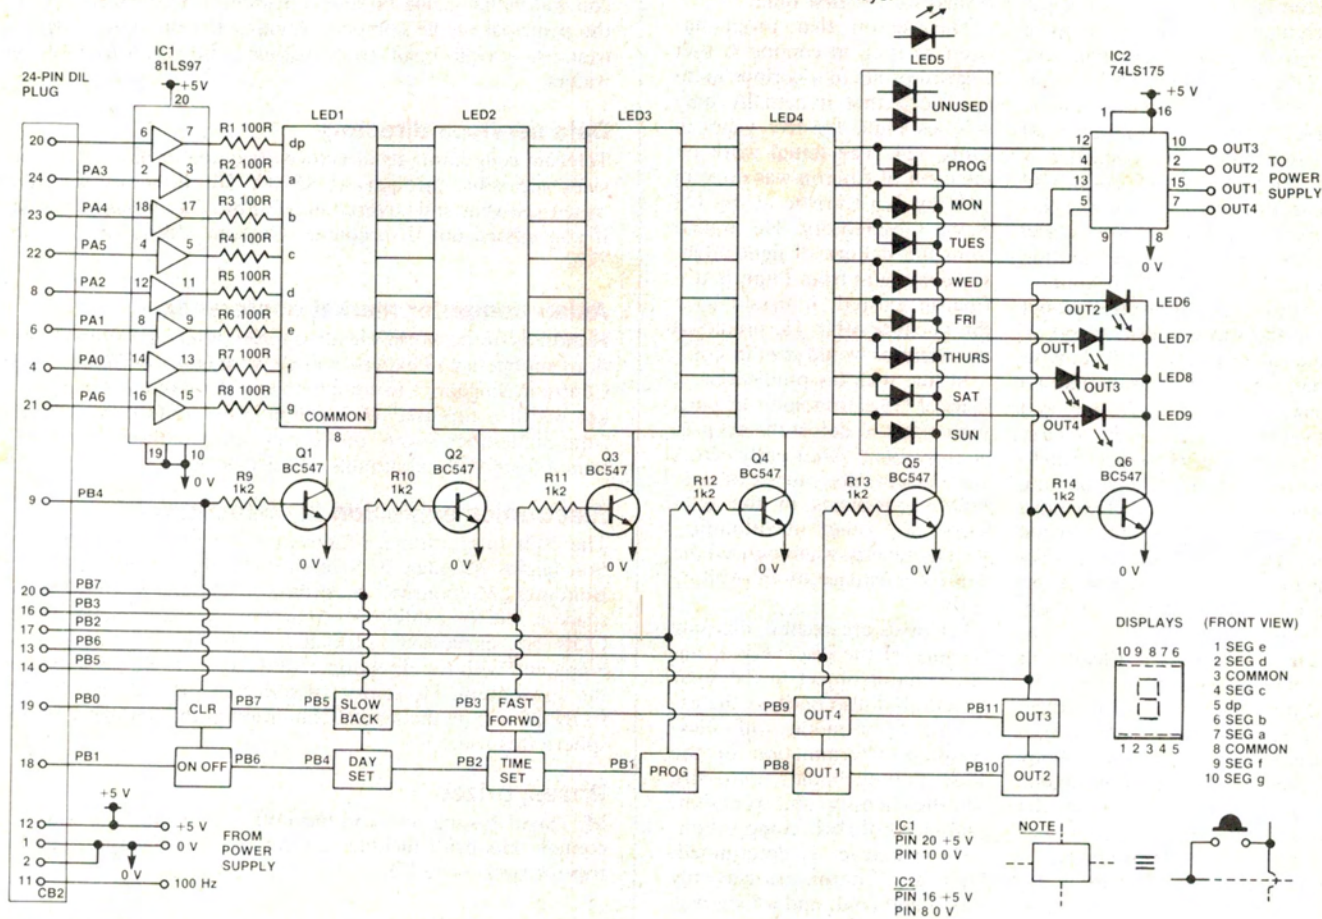
Other minor corrections are: Pin 20 of the 24 pin DIL plug is the PA7 connection. PB4 is on pin 9, not pin 15 as shown. IC1, pin 1 should be pulled down to ground.
